## **Cultural Heritage Buildings and the Abruzzo Earthquake: Performance and Post-Earthquake Actions**

**Abstract** The architectural heritage was seriously hit by the earthquake that occurred on April 6<sup>th</sup> 2009 in the Abruzzo region, especially considering the effects on a city with the size and with historical and strategic importance as a capital of a region, L'Aquila. The activities to protect that heritage have been centralized in the structure "Protection of Cultural Heritage" at Di.Coma.C. (Command and Control Quarter), managed by the Civil Protection Department. This allowed the cooperation among different involved subjects (Ministry of Cultural Heritage officers, experts on structural engineering from Universities and Fire Brigade teams), with their own specific knowledge. Keystone of the operating process was the standardization of the damage survey and of its immediate and correct interpretation, through dedicated survey forms for churches and palaces. The experience in the field of temporary safety measures was extremely interesting: ideas for engineering the process were developed, in cooperation with the work of the fire brigade men, that are highly experie

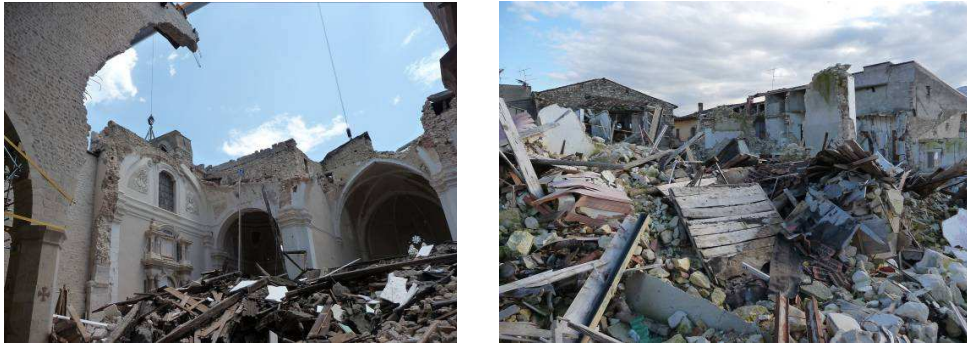
The seriousness and the extension (Fig. 1) of damage on cultural heritage buildings were without precedent in the recent Italian seismic history, since an organized civil protection action had been developed. This was mainly due to the dimension and the strategic importance of L'Aquila, as capital of Abruzzo region.

*Figure 1: Santa Maria di Collemaggio's Basilica in the historical centre of L'Aquila (left) and view of the destroyed village of San Gregorio (in L'Aquila province - right)*

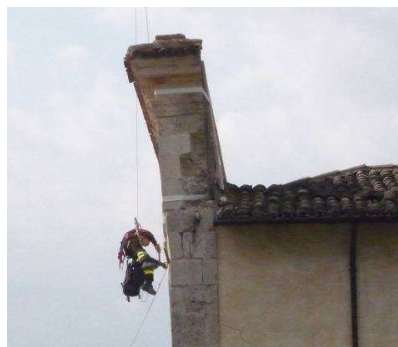
*Figure 2: Special National Fire Brigade Groups at work on the façade of Santa Maria degli Angeli's church in Bagno (in L'Aquila municipality)*

The Fire Brigade men had a decisive and irreplaceable role for their professional expertise, operational effectiveness and availability in the temporary safety measures. They were the only that could face extreme conditions (Fig. 2), which cannot be classified into standard and repeatable procedures, thanks to their background and to the legal provisions, in particular the possibility of acting in dispensation of the legislation on safety at work (Legislative Decree No. 81 dated 9 April 2008, on Health and Safety at Work).

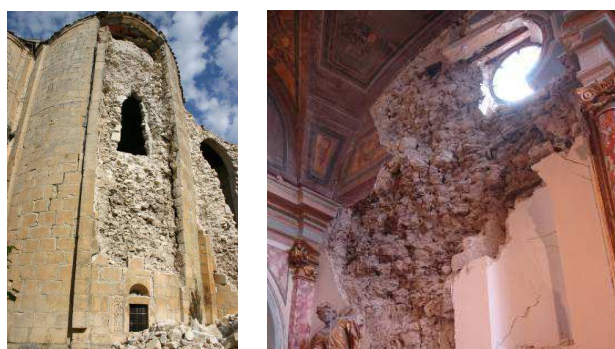
The kinematic mechanisms approach adopted by the damage survey forms and also used in national codes for the seismic evaluation of existing historic buildings, is based on the monolithic behaviour of masonry structural elements. The damage survey in Abruzzo region showed that the monolithic behaviour did not develop in many cases because of the composition and the intrinsic conformation of the masonry, which has often presented poor quality, causing the collapse of entire masonry walls. This is related to the construction typology of masonry: the walls are often of considerable thickness but made with irregular stones of various sizes, irregularly arranged and jointed with a mortar of poor quality, which does not ensure effective cohesion of the units, even in the case of monumental buildings (Fig. 4). Another vulnerability element is represented by the building constructive evolution which shows an articulated construction, as often happens in the historical buildings.

*Figure 4: Outside view of Sant'Eusanio church in Sant'Eusanio Forconese (left) and inside view of San Michele Arcangelo in Celano (right)*

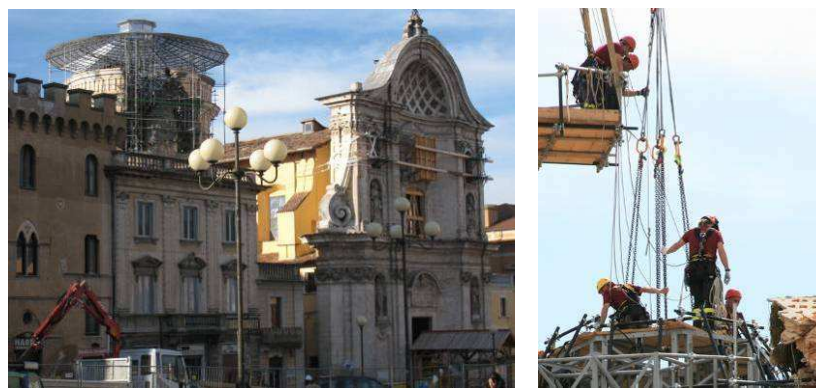
*Figure 6: Drum of the Anime Sante's church in the historical centre of L'Aquila (left) and special groups of National Fire Brigade Men at work on the Anime Sante's dome (right)*

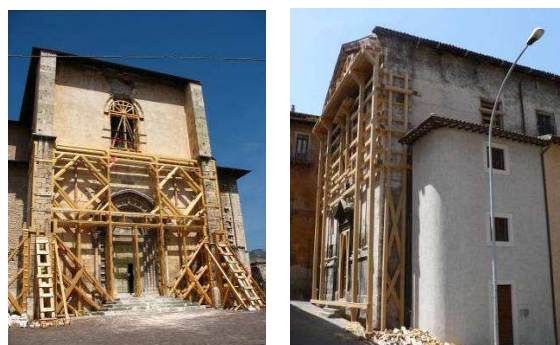
*Figure 9: Intervention during works at S. Domenico's church and concluded intervention at Evangelica's church in the historical centre of L'Aquila*

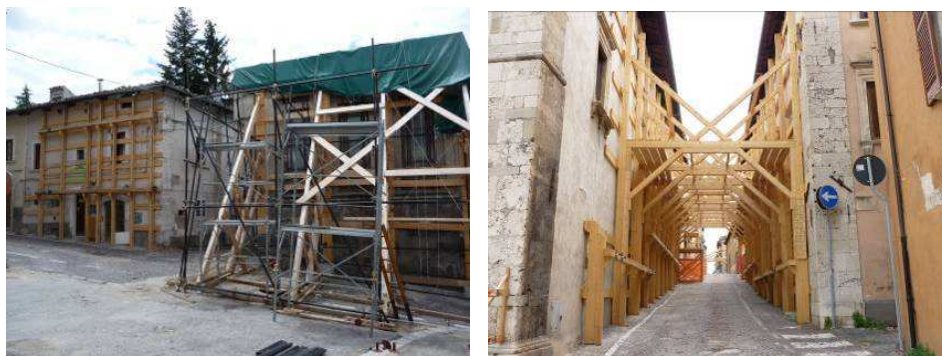
The methodological approach used for the temporary safety measures adopted on churches could be then used on a larger scale for intervening on historic buildings and palaces. The greater number of the latter, compared to churches, suggested to operate with the more rapid and less invasive methods. Interventions tested on churches, with bands or tie rods associated with wooden grids, appeared to be the best suited because they do not occupy the building entrances and the roadways, but they also achieve a better response to additional seismic actions. In historic centres, where streets are usually narrow, shoring systems acting on facing buildings (Fig. 11), which cause interactions and pounding between different structures, were as much as possible avoided.

*Figure 11: Three types of safety measures on façades in the historic centre of L'Aquila: wooden grids and ties, traditional props, shoring systems acting on facing buildings*

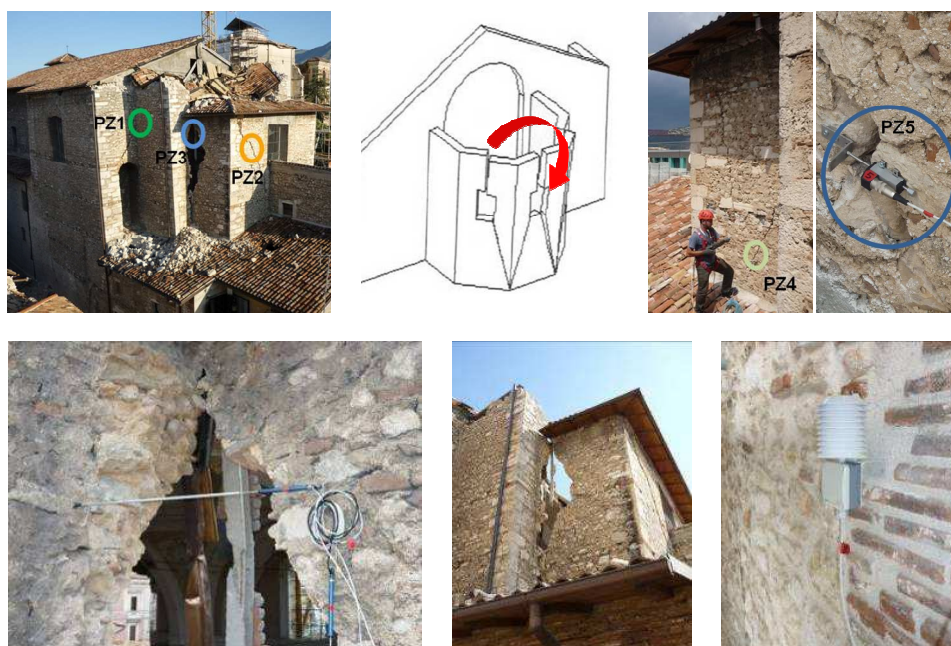
In parallel to the execution of the interventions, the structure was controlled by means of an automated low-cost monitoring system. This system is continuously acquiring data, and stores hourly the readouts coming from 5 linear displacement transducers, positioned across the main cracks of both apse and transept, where the worst damage scenario is observed (Fig. 14).

*Figure 14: view of the apsidal area of St. Mark church: displacement and Temperature-Relative Humidity sensors positioning*

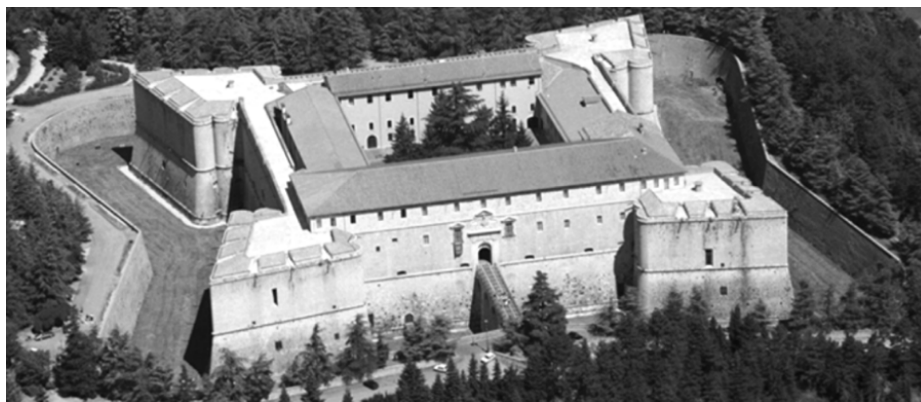
Figure 16: Aerial view of the Spanish fortress of L'Aquila before the earthquake

Following the 6th of April 2009 earthquake, the fortress was seriously damaged, especially in the upper floors. According to the damage survey form for palaces used in the inspections (Model B-DP PCM-DPC MiBAC 2006), overturning and flexural mechanisms on the external walls, shear damage in the external and internal walls, damage to vaults and arches, local collapses of floors and vaults, corresponded to the worst activated mechanisms (Fig. 17). Damage was remarkable both for intensity and distribution, and was considered so serious to likely prejudice the overall stability of the building.

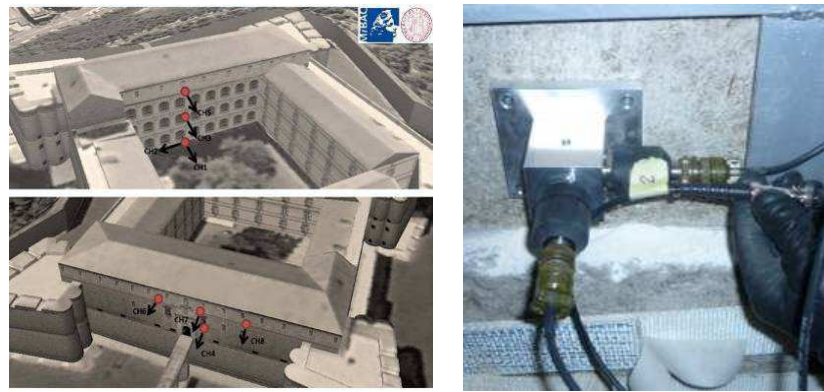
the previous dynamic identification. According to the predominant motion direction, sensors were fixed orthogonally to the façade, on the internal and external façades (Fig. 19).

Figure 19: L'Aquila castle: localization of the acceleration transducers (left) and base acceleration transducers (CH1, 2) and acquisition unit (right)
