Pathology of the Katholikon of Hosios Loukas Monastery and Preliminary Structural Analysis

Abstract This paper summarizes the work carried out in the Katholikon of Hosios Loukas Monastery with the aim to study the pathology of the monument. The load bearing structure of the church is briefly presented along with its historical pathology and damages observed after the 1981 earthquake of Boeotia and slightly deteriorated since then. Finally, the results of a preliminary analytical study performed with the purpose to interpret the observed pathology are also presented.

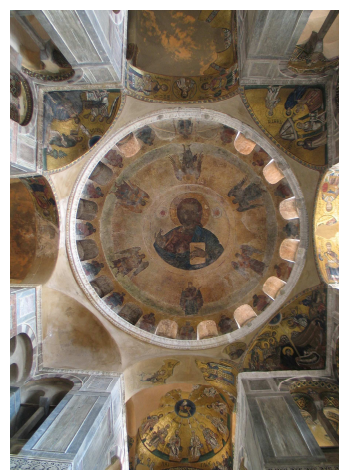
Figure2: Internal view of the dome

Due to earthquakes occurred the mosaic representing the Pantokrator was destroyed; thus during the 17th century the intrados of the hemispherical vault of the dome was decorated with frescoes (Fig. 2). Probably at the same period, the majority (10 from 16) of the windows of the drum of the dome were built to avoid further deterioration of the damage. Moreover, the west pier of the drum was demolished and a relieving arch was built to transmit the loads to the adjacent piers (Figure 1), probably due to serious damage observed in the vaulted structure below. A question is raised if at the same period severe damage led to the replacement of the groined vault of the south arm of the cross with a barrel vault, or this happened later, during the 18th century when, due to out of plane deformation of the south wall, three stone buttresses were added towards the external south façade (Fig. 1 and red colour in Fig. 3a). In the same period another buttress was constructed, connecting the NW masonry pier of the church with the existing structures to the north, to avoid further increase of its out of plane deformation (Fig. 1 and Fig 3a). During the 19th century, the exonarthex added to the west part of the Katholikon in the 12th century was demolished; it is not yet well documented if this was done due to extended damage or morphological reasons (Filippidou-Boura, 1970-1971). In the late 19th and early 20th century severe damage due to earthquakes, further deteriorated by rain water and vegetation (cracks 5-10 cm wide, local disintegration of masonry, etc) were reported (Troump & Balanos, 1895, Orlandos & Soulis, 1918, Eugenios 1921); the out of plane deformation of the piers of the west wall was estimated to reach the 1,5% of their height (Eugenios, 1921).

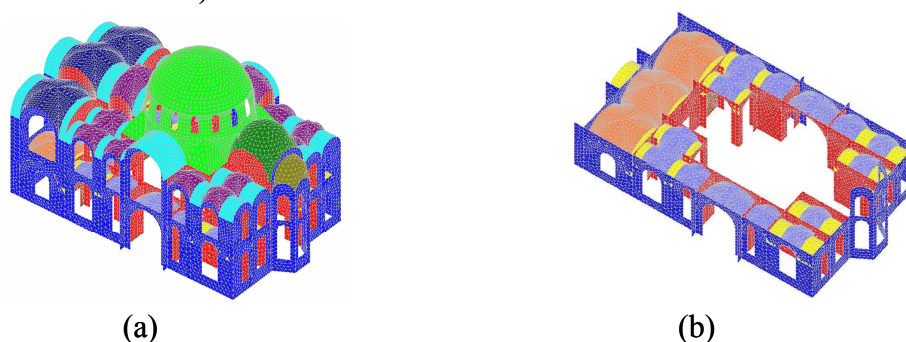
The structure was modeled-using the computer code ACORD 3.0.2 for Windows-with combined plane and shell elements (Figure 4a and 4b). The geometry of the monument (including thickness of each individual element) was reproduced in detail; in Figure 4 various colours indicate regions of different geometry and function (planar or curved elements) and/or of different mechanical properties (external and internal walls). Young's moduli were also allotted to the members depending on their material (stone or brick masonry), on the basis of the available data of the in situ and Laboratory investigations, as well as the experience gained from the analysis of a similar structure (Miltiadou-Fezans et al. 2005).

Figure 4: (a) The entire model of the structure; (b) view of vaulted elements of the ground floor
