Structural Changes Effect on Deflect of Tower St. Jiri on Prague Castle

Abstract The basilica st. Jiri on Prague Castle has two towers and three bodies. The north tower is deflected from vertical about 450mm. During the last measurement it was found, that the walls were diverted too. The reasons and beginning of fault genesis have not been known yet. It can be larger self weight of tower then weight of navy. It leads to different settlements during homogenous foundation conditions. The next reasons are not clear. I investigated: tower weakening by the door opening, influence of inside vault over middle navy, foundation conditions. The results obtained from numerical model show that every mentioned reason contributed to the deflection of the tower.

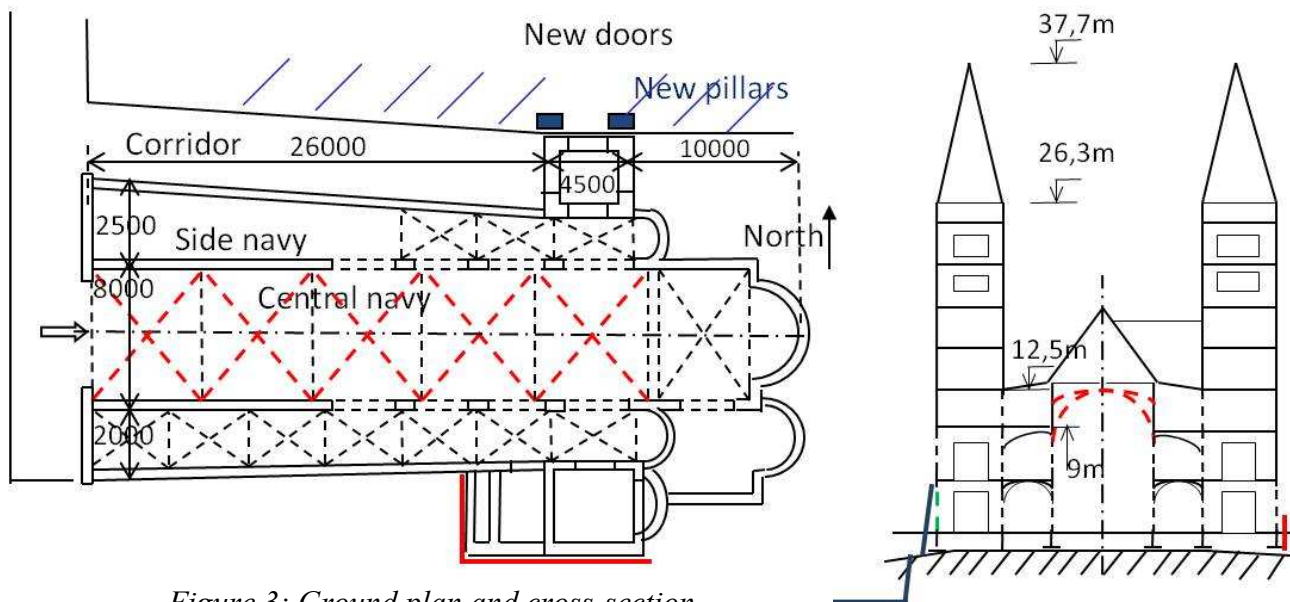
Figure 3: Ground plan and cross-section

The rock top line proceeds in a parallel way with longitudinal axis of basilica - see crosssection in Fig. 3. The rock under boundary wall is weathered and damaged into depth 3m.

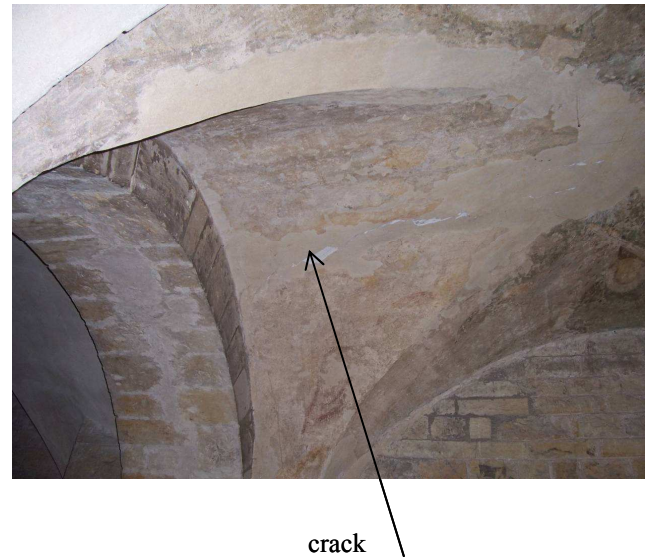
List of the reasons:

- historical construction activities
- non-uniform distribution weight
- soil degradation
- vault horizontal forces
