# **Structural Analysis of the Bell Tower of the Basilica De La Merced of Lima**

**Abstract** The Bell Tower of the Basilica de la Merced de Lima is a monument with its own personality in itself, was built by master masonry Alonso de Morales as contract signed May 12, 1589 whose original is in the General File Nation of Peru. Until now has been repaired several times due to damage to large earthquakes that destroyed the city of Lima in more than one occasion.

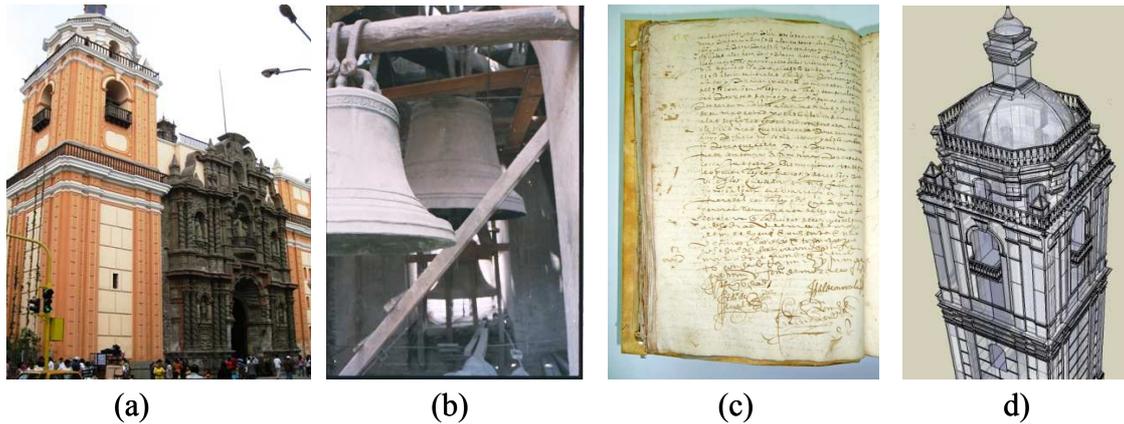
Figure 1: (a) Front View of the Tower, (b) Internal view of the bell Tower, (c) Employment contract existing, (d) Isometric view

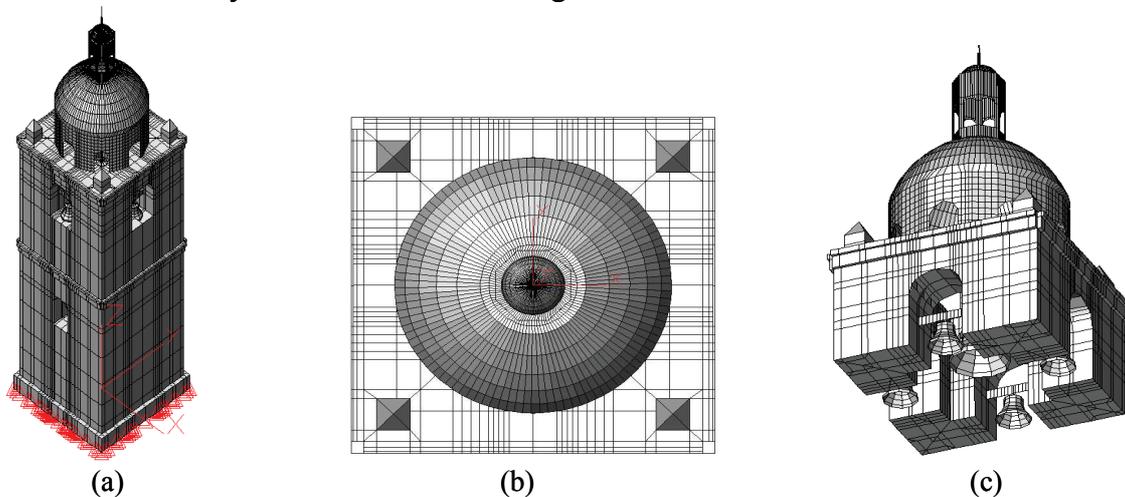
Figure 3: a) Global model of the Tower, b) Plan view of model, c) Isometric view
