## **Restoration and Strengthening of a Historical Structure in Antalya - Turkey**

KOÇAK A<sup>1,a</sup> and KILIT Z<sup>2</sup>

<sup>2</sup>Kilit Construction, Antalya, Turkey

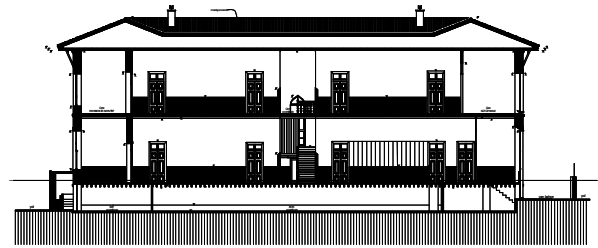
Figure 2: Section of existing situation of built

Result of burning next wood house, fire had started into school in 1989. it has been determined that ground floor and first floor of room in north west corner completely had burned, and some part of corridor and roof paneling and coating of the same room had burned also. After fire in 1989, wood beams have been consolidated and floor coating had been renewed. Fire and construction work that made after, get many harm to original of structure. It has been determined that was made first thin grout after grained paint on grout that occurred from sand, chaff and lime, almost whole doorjambes and floors was broached or broken, locked stairs that made by cutting from limra stone, first was lay over bulk mosaic and after wood.

Moreover it has been observed that west, east and south balconies was fell down, and reinforced concrete stairs was made instead of it, some part of ground floor windows was closed with brick., original roof covering and garden walls was changed.

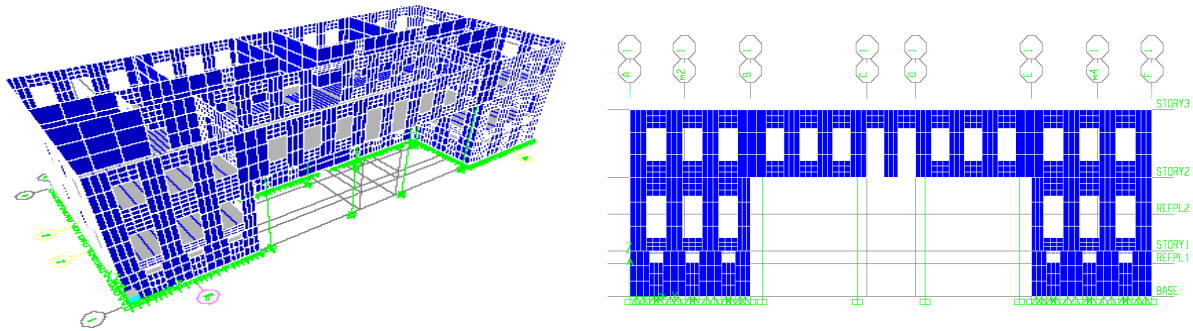
Figure 4: Structure that modeled in program

After all assigned values entered, load combinations had been created to define load of dynamic, stable and earthquake related with structure. Total area of one floor in building is 637.78 m<sup>2</sup> at model. After this process, model had become ready to analyze. Model shape that created in program has shown on Fig. 4.

that used on wall, wall split allowable stress ( $\tau_0$ ) has been taken as 0.1 Mpa for stone walls according to values into regulation. Slip stress on wall was shown on Table 4 for several point of wall. Insufficiency had been determined as shown on Table 4.
