Seismic Damage to Churches: Observations from the L'Aquila, Italy, Earthquake and Considerations on a Case-study

A Case Study: the Church of San Biagio Amiterno

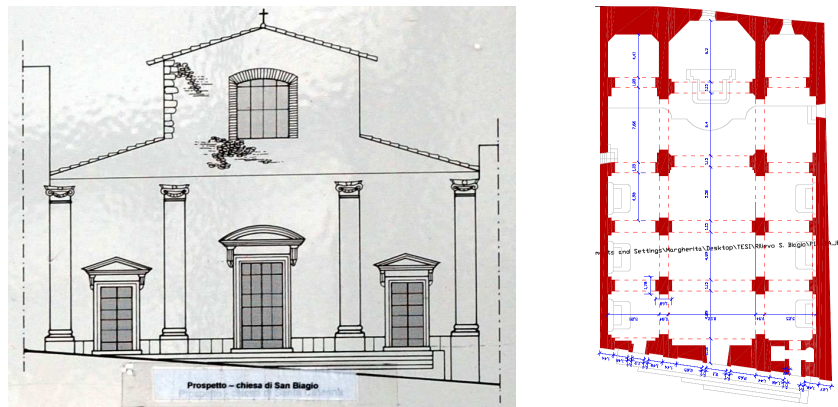
Figure 1: The church prospect before the earthquake from a street post (left) and the church plan (right)

In the current case, however, the main triggering cause of collapse seems to be the insufficient restraining of the collapsed part. By examining the collapsed area of the façade and the lateral walls, while no significant longitudinal displacement of the heavy concrete roof was noticed, the borders of the collapsed area revealed a particularly weak restraint situation. The façade top could be roughly considered an elongated plate, where the lower border, corresponding to the upper side of the large façade window, was basically free. At the top, the plate was very likely weakly connected to the new concrete roof. The roof border could be inspected by close after the collapse and showed no significant remains of interconnection. At the lower border just above the window, the presence of a timber tie-beam linking the lateral walls and visible in Fig. 2 constituted an additional discontinuity within the masonry. On the left side looking at the façade, a discontinuity in the masonry was present before the seismic event and is recognizable in pictures as well as in older drawings, like that in Fig. 1.
