Study on Relationship between Elastic Wave Profile and Stones' Condition in Angkor Monument

Keywords: Angkor Monument, masonry, elastic wave, deterioration

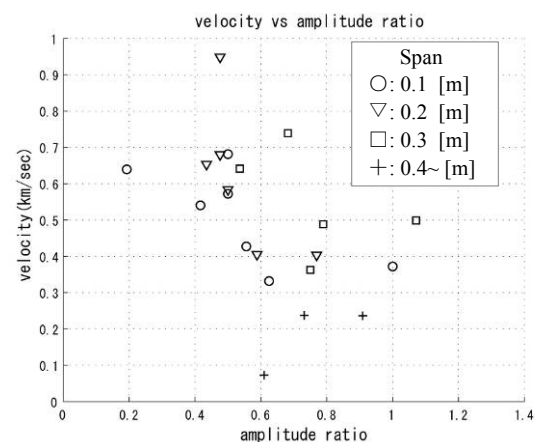
Figure 6: result of direction 1

Results of examination at each side are shown in Fig. 6-Fig. 8. These figures show the relationship between amplitude ratio (the horizontal axis) and velocity (the vertical line). In comparison of directions 1, 2 and 3, both characteristics have a scattering result in every span of 10, 20 and 30 cm. From this scattering result, but it is impossible to mention about the characteristics relied on the difference of bedding planes' direction in this examination.

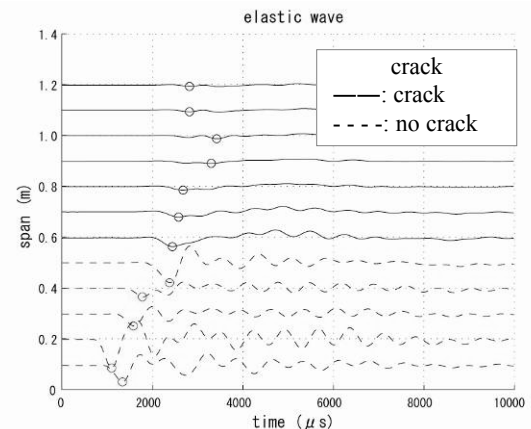
Figure 10: Normalized wave shape

Normalized time history profile of elastic wave at each measured point is shown in Fig. 10, in which higher number of vertical line means the span between the first terminal and second terminal. In Fig. 11, the vertical axis shows the time lag between two terminals, and the horizontal axis means the position of two terminals. In comparison of solid lines (there is a crack) and dotted lines (there is no crack), it is resulted that the velocity of waves is lower and amplitude widely decays when there is a crack. This phenomenon was not occurred at a sound beam of northern opening where we conducted same examination. Fig. 12 also proves that velocity of wave with cracks is lower when span is same.

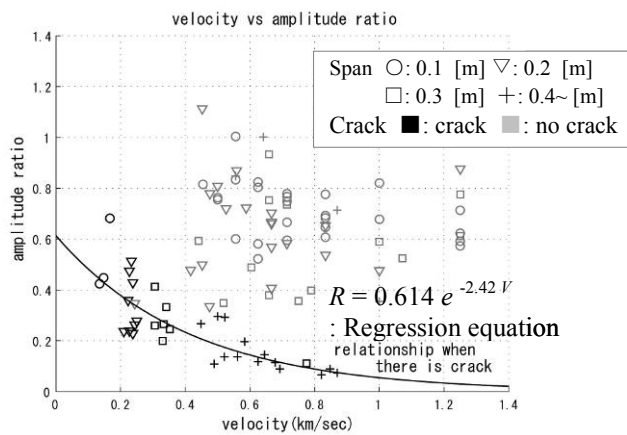
Figure 13: Velocity vs Amplitude ratio

As shown in Figs. 12, 13 and 14, when there is a crack between terminals, the regression equations of span S , velocity V and amplitude ratio R are represented as Eq.(3), (4) and (5).

$$R = 0.614 e^{-2.42 V} \quad (4)$$
