The Behaviour of S. Agostino Church during 6th April 2009 Earthquake in L'Aquila: Vulnerability and Damage Assessment

Abstract The church of S. Agostino in L'Aquila was built at the beginning of XVIII century, replacing an older church collapsed during the strong earthquake of 1703. The building has a central layout. During April 6th earthquake, it suffered many damage. The lantern collapsed. Severe cracks concerned the hall-drum-dome elliptical system, the apse and the bell tower. Moreover, the façade was subjected to an overturning mechanism. The elliptical layout of the building induced a mainly longitudinal seismic response. In the paper, an extensive description of the damage is provided. Moreover, the seismic behavior of the church is discussed on the basis of observation of damage and vulnerability features of the structure. A correlation between damage, vulnerability and seismic actions is finally proposed.

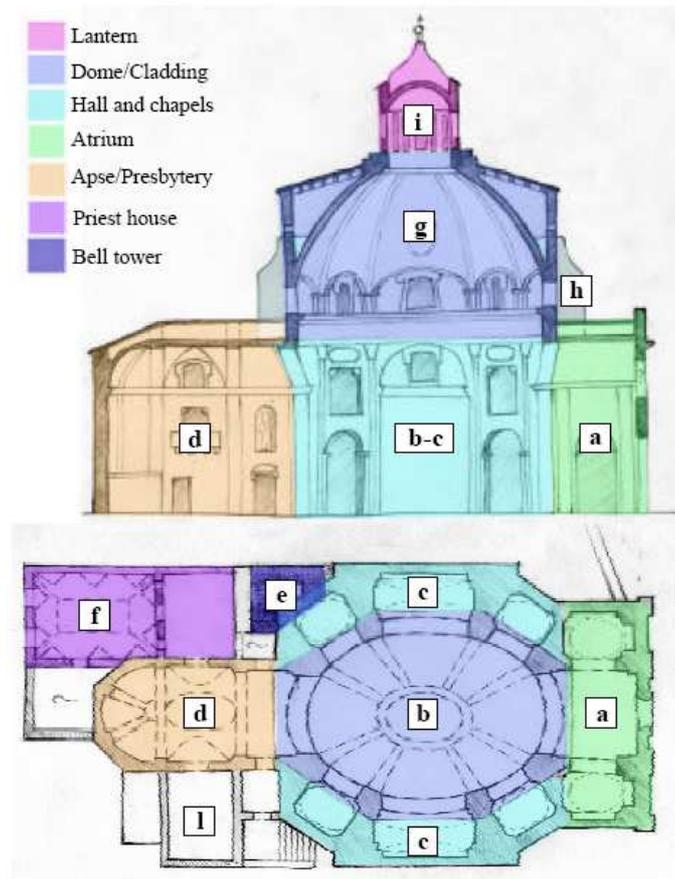
Figure 1: Scheme of the church

The main body of the church is made of three architectural elements, aligned along the principal longitudinal axis (Fig. 1): the atrium (a); the elliptical hall (b), with three couples of chapels (c); the presbytery, closed by a circular apse (d). On one side, a L shaped bell-tower stands out (e). Moreover, around the church, close to the presbytery and the apse, is the sacristy (f) and a set of other small buildings.

The central hall is covered by a big elliptical dome (g), which lays on a squat drum. The dome is closed by an octagonal dome cladding and is surmounted by a lantern (h). Eight buttresses stand in correspondence of eight internal strips (i). A rigid infill is likely upon the dome, up to the upper level of the buttresses (Fig. 2). The small chapels around the hall are covered by ribbed vaults, while the bigger ones are covered by barrel vaults.

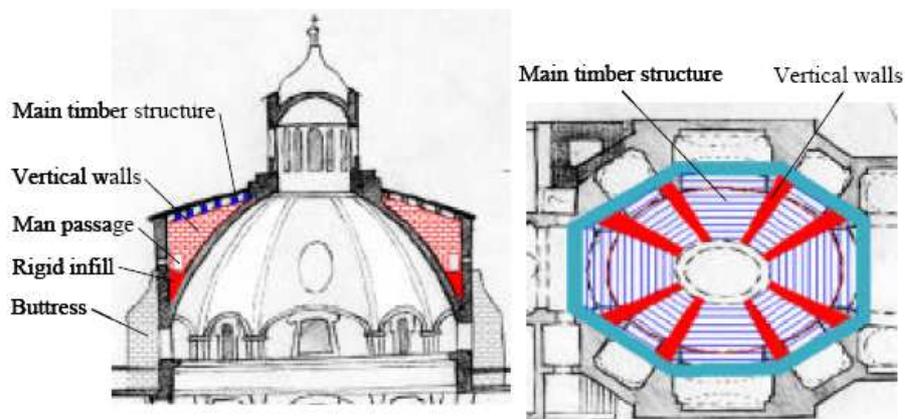
Figure 2: Scheme of the roof

From information provided by firemen, a timber roof covers the dome, according to the scheme shown in Fig. 2. The roof does not push on the walls of the dome cladding. In fact, in correspondence of the eight internal strips and the buttresses, eight vertical walls supporting the timber structure stand out. These walls play the fundamental role of connecting the dome to its cladding, acting as bracing.
