Seismic Vulnerability of the Dey's Palace (Algiers, Algeria)

AMINA Abdessemed-Foufa^{1,a} and HAYET Bendjedia²,

Keywords: Vulnerability, static weakness, wind-bracing, Palace of the Dey, Algiers, Algeria

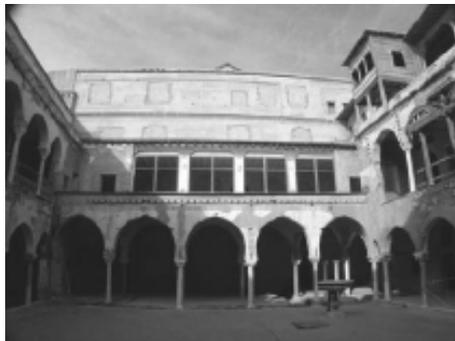
The stratigraphic units are characterized by the used materials. In this case we have traditional bricks masonry of 3 x12 X20 cm size bounded by lime and earth mortar having 3 cm thickness. Beside the layer of filling is built by industrialized bricks having 5 x10 X20 cm size and are bound by a cement mortar of 1cm thickness. If we consider, the northern frontage, the stratigraphic study showed us that the interventions are tinier and that this part of the building comprises only positive interfaces which represent the layers of repair (Fig. 6). The southern and western frontages underwent heightening which sheltered respectively the Harem and the private apartments of the Dey.

Figure 6: Different view of the southern patio's frontage (Foufa 2006)
