Seismic Behavior of Some Basilica Churches After L'Aquila 2009 Earthquake

Abstract In this paper the seismic response of four church buildings in the l'Aquila April 2009 earthquake is analyzed. The buildings are: St. Giusta church, St. Maria di Collemaggio Basilica, St. Silvestro church and St. Pietro di Coppito church. The analyses are carried out by employing a "two-step" procedure suggested by the authors and already applied to similar case studies. The first step consists in three-dimensional linear analysis, while in the second step, two-dimensional non-linear analyses of macro-elements are carried out. The results coming from the two-steps, allow for understanding the observed damage and for approximately assessing the seismic level of the building.

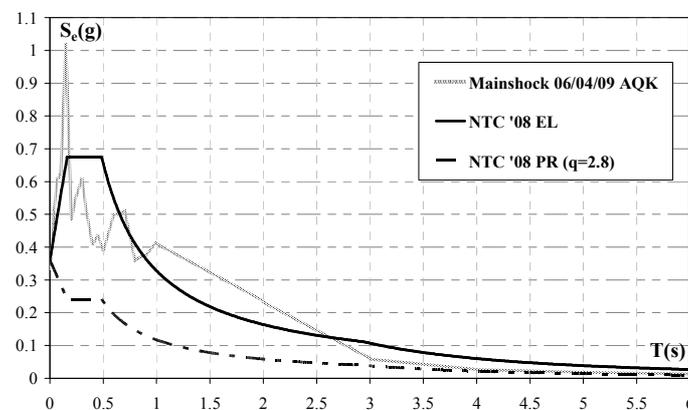
The comparison between the results of the modal analyses associated to the design spectrum suggested by the NTC'08 and the recorded spectrum (Fig. 5), in the following appointed as “06/04/09”, shows slight scatters in term of base shear force, with base shear action V in order of 30% of the vertical load W_{tot} both in transversal and longitudinal direction (Fig. 6).

Figure 5: Comparison among main shock spectrum (06/04/09 AQK), elastic (EL) and design (PR) spectra provided by Italian code NTC'08

The comparison between the L’Aquila recorded spectrum and the conventional acceleration spectrum provided by the Italian provisions NTC’08, shows that actual seismic demand is in good agreement with the Code values (Fig. 5).

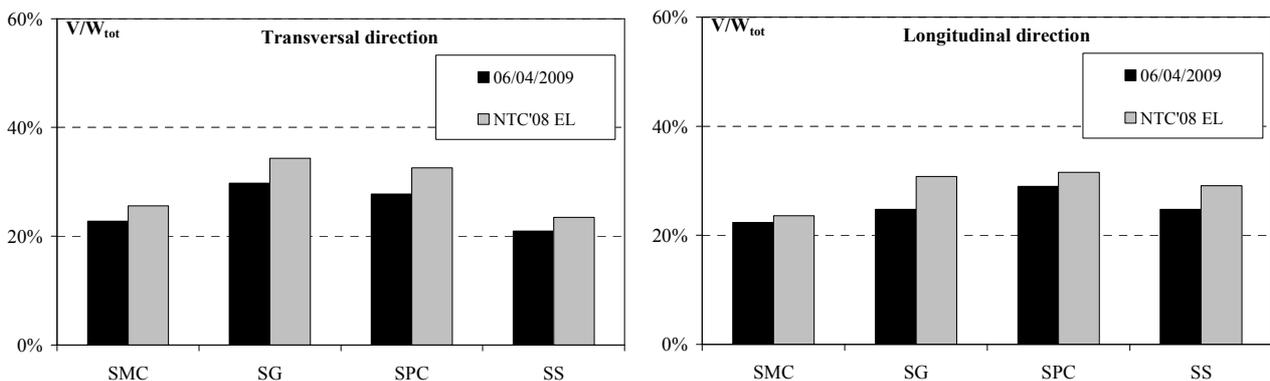
Figure 6: Normalized base shear in the four churches: NTC'08 VS. 06/04/09 main shock

Furthermore, the dynamic analyses of the case studies have shown that, the dispersion of the vibration modes, leads to normalised values of base shear demand V/W_{tot} in order of 30% (Fig. 6).
