## The Research on the Rust of Reinforced Bar and the Strengthening Measures to the Existed R.C. Frame nearby the Sea

**Abstract** The netlike cracks along the rebars at the bottom of concrete slabs as well as the circular cracks around the columns and beams were found in an underground park, which is a cast-in-site concrete frame. The building was about 300 m away from the sea.

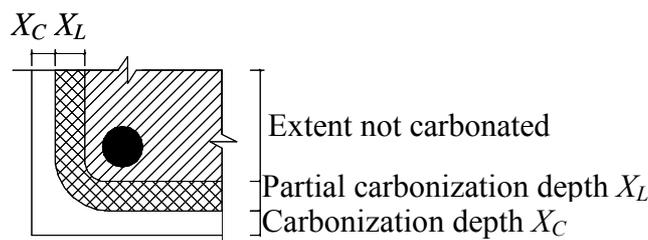
Figure 3. 1: Carbonization diagram of concrete members

Concrete carbonization was one of the necessary preconditions for rebar corrosion. However, the theory cannot explain the phenomenon described in Figure 2.1 that concrete around the rebar was not carbonized but the rebar had been rusted.

As shown in ref.[4], the rate of carbonization reaction was slower than the rate of  $CO_2$  diffusion in concrete, which leads to partial carbonization towards the rebar, when  $PH$  is less than 9, the rebar was impossible to be passivated, i.e., the rebar was in an active state, when  $PH$  is higher than 11.5, the rebar was completely passivated, when  $PH$  is between 9 and 11.5, the rate of rust became faster with the decrease of  $PH$ , at the same time, the rebar began to be activated. By ignoring the other factors such as  $Cl^-$ , mathematical formulas of full carbonization depth and partial carbonization depth were given in ref.[4,5] which was shown in formula 3-1, 3-2.
