STRENGTHENING OF THE TIMBER ROOF OF THE SECOND TURKISH NATIONAL ASSEMBLY BUILDING IN ANKARA

S. Toker Beeson¹, E. Ozkan Yazgan², and A. I. Unay²

Keywords: Timber roofs, Strengthening of historical buildings, Steel trusses in strengthening.

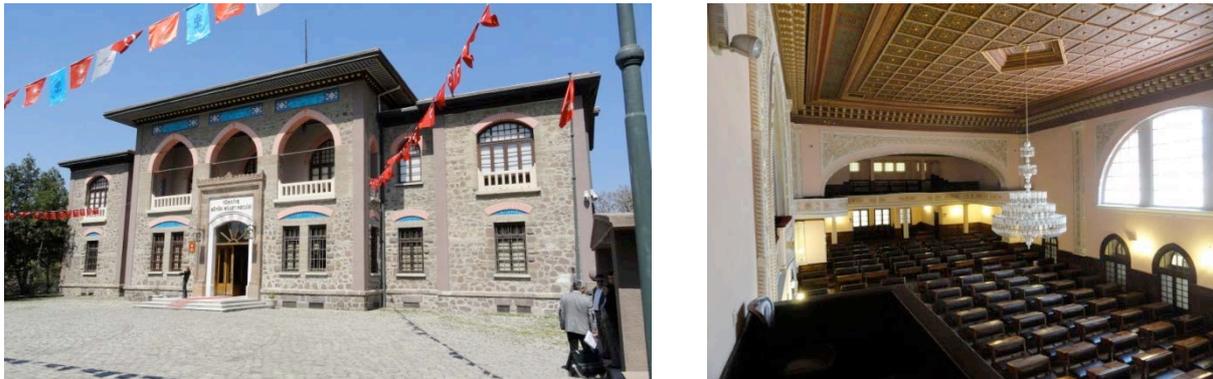
Figure 1: External and internal view of the Assembly Building.

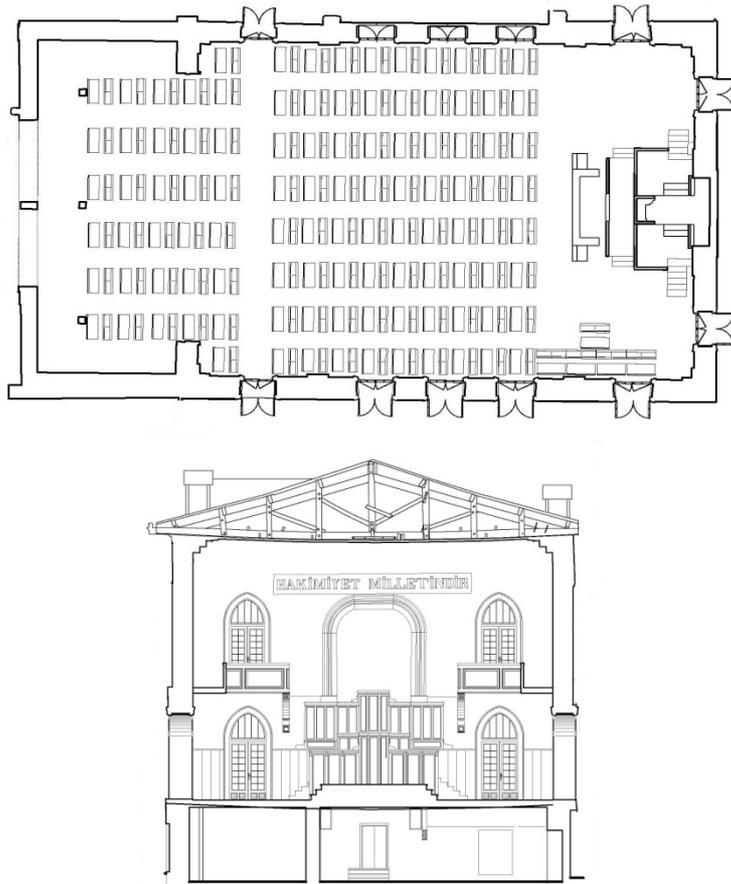
The structure that comprises the Main Hall has a rectangular plan with 27.5 m x 14.80 m. The height of the Main Hall reaches up to 14 meters from the foundation level. As it is seen in the Figure 2, there are two big arch-shaped openings on the one-meter thick stone masonry walls on the eastern and western wings. The plans and sections in Figure 3 show the 1.50 m x 3.00 m door openings at the ground floor level on the eastern and western façades. Also, there

Figure 3: General Assembly Hall (Main Hall) in plan and section [5].

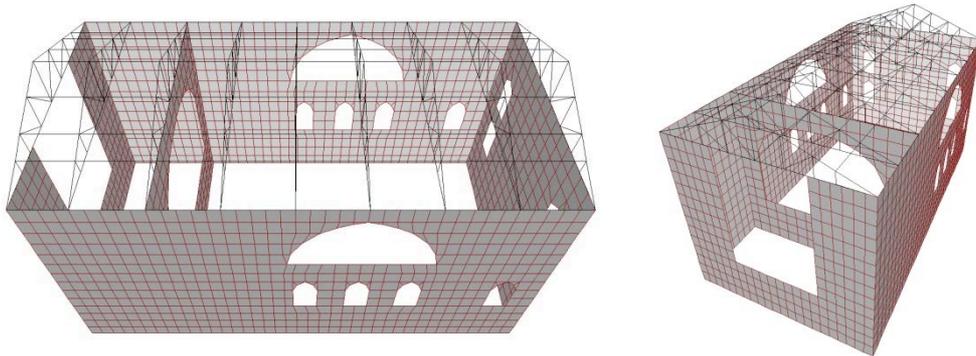
The detailed drawings of the timber ceiling and roof structure were produced by laser scanner. Based on these drawings, a 3D analysis model was developed as seen in Figure 7. Fake area elements were introduced to obtain accurate transfer of the weights of the tiled roof cover, ornamented ceiling diaphragm and the other loads. The 3D roof structure was analyzed for static loads first with its present condition, then with the addition of steel trusses proposed in the strengthening project. The dimensions of all the members of the existing truss members were arranged according to accurate measurements obtained from laser scanner. Notable defects at the connection points (shown in Figure 5) and element connectivity releases were considered in the model.

As it is seen in Figure 7, the one-meter thick stone masonry walls that surround the General Assembly Hall were assembled by using 1700 area elements. The roof structure, which was prepared by using 321 frame elements for the previous set of analyses, is supported by area elements at their actual locations. Material properties of the structure were obtained through the previous studies for similar stone masonry and the suggested values in the Turkish Earthquake Code since no tests or material sampling was possible for the material characterization due to the legal cultural heritage status of the building. Masonry units and mortar were assumed as one homogeneous material with a constant modulus of elasticity and unit weight as 450 MPa and 24.5 kN/m^3 , respectively. Linear elastic finite element dynamic analyses were carried out according to the inelastic spectrum suggested for Ankara region in Turkish Earthquake Code [9, 10]. For convenience in the evaluation of the results, the spectrum was applied to the building in two perpendicular directions as EQ_x in the longitudinal direction and EQ_y in lateral direction. Load combinations were made accordingly. Besides, allowable compressive stress values provided by the current Turkish Structural Design Code for stone masonry ($f_c=0.3 \text{ MPa}$) was increased by 3 instead of decreasing the forces imposed by the excitation (i.e. $R=1$) in order to compare the results with the capacity. The allowable tension was assumed as 15% of the compressive strength, as 0.135 MPa . The allowable shear stress of the wall was calculated through the formula $\tau_m = \tau_o + \mu\sigma$ where τ_o , allowable stress for cracking (0.3 MPa), μ , the coefficient of friction (0.5) and σ vertical stress (0.45 MPa), thus, obtained the value 0.53 MPa for the allowable shear stress of the stone [11, 12].

Figure 7: 3D Finite element model of the building.
