AN INVESTIGATION INTO THE ARCHITECTURE AND RESTORATION OF THE DİVRİĞİ MÜHÜRZADE HOUSE IN ANATOLIA

A. Erdem

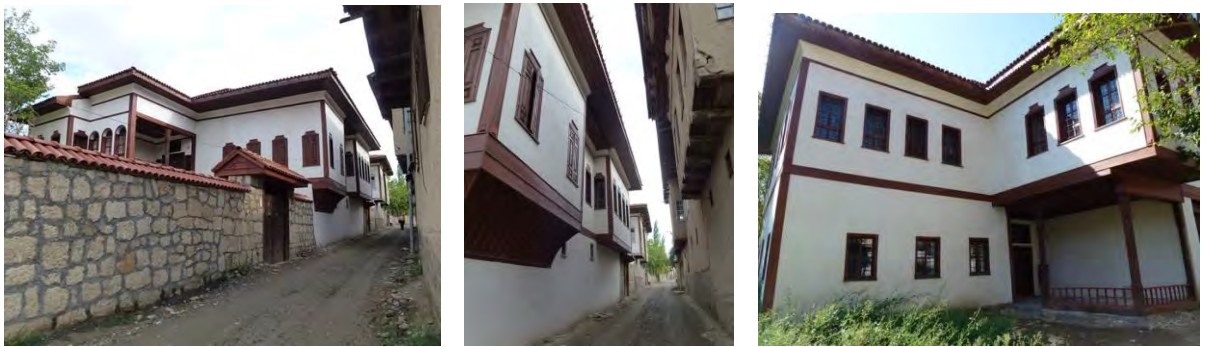
During the actual restoration work, for some unknown reason, the interior and exterior plasters were removed and the out-buildings that served to divide the courtyards of the house into two discrete spaces were torn down. After the plaster was removed, the building was left exposed for some time to the elements, causing the adobe brick packing to erode in some places and for the timber to degrade in others. While the restoration work did advance efforts to preserve the original architectural features of the house, the work was carried out in a careless and uninformed manner (Fig.33-49). Some examples of this include how the adobe brick courtyard wall facing the street was completely torn down and replaced with a new wall made of stone and cement and how the hipped roofing over the courtyard door was transposed into a gabled roof (Fig.33, 34). The area under the guest room projection that extends over the street was restored, but planks narrower than the originals were used. The wooden shutters are not the same as the originals (Fig. 35-36). In the restoration of the facade it was seen, however, that the adobe packing in the timber framing was completed, the mud mortar and gypsum plaster were reapplied, and the roof was repaired and covered with Turkish style tiles (Fig.37-39). The original details of the *divanhane*, *örtme* and staircase overhang railings were preserved, but in inadequate numbers (Fig.40-43). In the *toyhane*, the railings separating the seating "carpeted" area from the floor brazier area / *kürsübaşı* were omitted, as was the shelf in the entryway /*sekialtı* (Fig.44, 45). The floor planks in the hearth area were also laid in the wrong, opposite direction (Fig. 16,46), and – despite the fact that they had remained intact – the wood pillars were replaced by pillars that did not resemble the originals. The upper windows in the servant's room were replaced with those that were larger than the originals (Fig.47,48). The original features of the overhead windows in the *nimsekili* space in the small

Figures 37, 38: Street facade, 2013.
