THE MODELLING, ANALYSIS AND ASSESSMENT OF THE IRON BRIDGE, SHROPSHIRE, UNITED KINGDOM

James D Miller, Carl L Brooks

Abstract. *The Iron Bridge in Shropshire, UK is the world's first iron bridge. Dating from 1779, it is a Grade I listed structure – the highest national category - and lies in a UNESCO World Heritage site in the Severn Valley at the heart of the Industrial Revolution.*

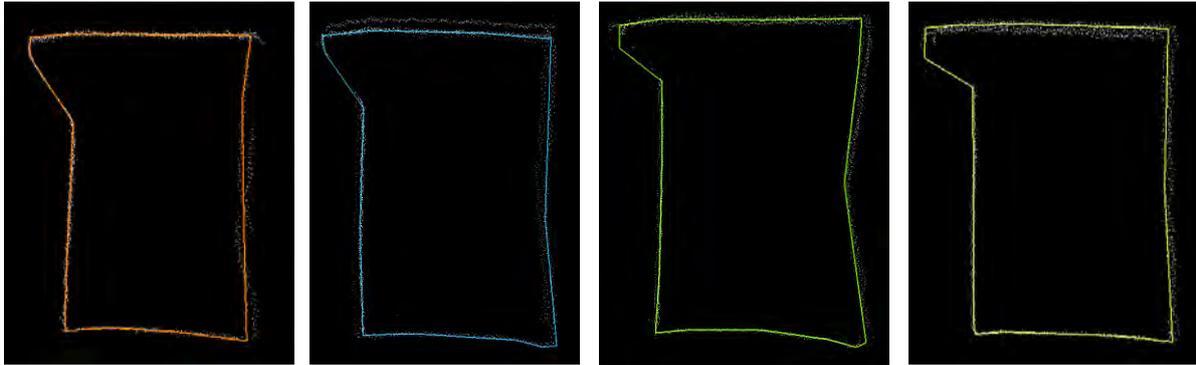
Figure 4: Typical Sections taken through the point cloud along one of the inner ribs.

During the process of developing surface and solid modelling some aberration in the point cloud was identified where bridge member surfaces were measured several times in slightly different places. This appears as shadowing in the cloud and is best illustrated by taking sections through the cloud as illustrated in Figure 4. It is appreciated that the laser survey was particularly challenging and generally measurement appears to be in accordance with the specification; the main bridge structure scanned with a 2 mm resolution and attempting to get 95% coverage.

A 3D beam approach would require thousands of geometric property calculations to represent the different shaped cross-sections, additional point cloud processing to define each different cross-section, and would not have sufficient resolution to predict behaviour close to important local features. It would also be time consuming to adapt materials to look at material variation within the cross-section to investigate factors such as porosity. Figure 4 also shows how the cross-section of a typical edge rib varies along its length.
