STRUCTURAL RESTORATION OF ANCIENT BASILICA DE GUADALUPE

José Luis Sánchez Martínez¹, René Serrano Márquez²

Abstract. *The Ancient Basilica de Guadalupe, today Expiatory Temple of King Christ, was built in 1709 by the architect Pedro de Arrieta. Through the years, it has been affected by modifications and has suffered damages that have resulted in a loss of structural strength, and have diminished the architectural qualities that once made it a masterpiece of Mexican Colonial Architecture. In 1994 it was decided to perform a total restoration of the monument to recover the original architectural values, and the structural retrofitting was essential to reach that then. This document describes that retrofitting process.*

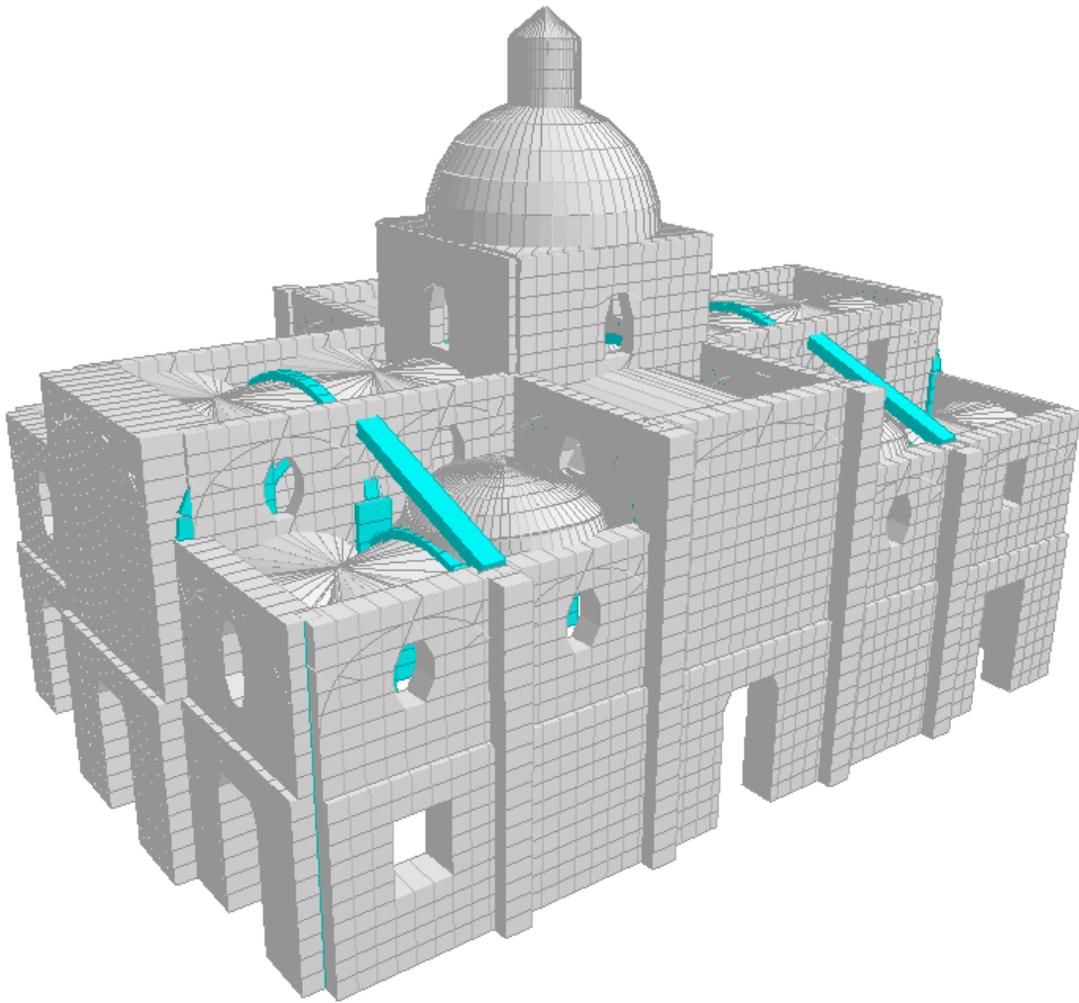
Figure 5: Model for analysis.

The model includes all elements that can be of significance to the structural response of the building, using the parameters of the geometrical and mechanical properties learned from the inspection results to the construction. (Figure 5)

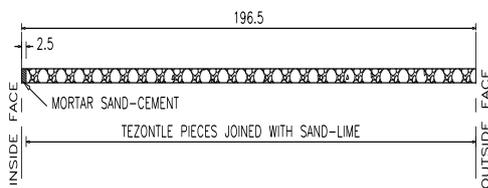
Figure 8: Typical wall construction system.

To proceed with the analysis it was first necessary to obtain the characteristics of the elements of the structure of the building [5]. (Figure 8, Figure 9 and Figure 10)

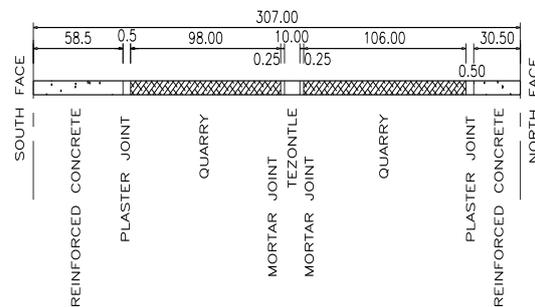
Figure 9: Typical column construction system.

During the work performed on the 1960's, all columns were coated with a thick layer of concrete. In 1994 when the restoration work was restarted, there were no records that explained the causes for this coating. It could have been done as a preventive measure to protect the columns during such works; or it could have been reinforcement to prevent deterioration of the columns. The decision of whether remove the lining or replace it with some other type, was postponed till further analysis of the structure in its current condition, including the tilt it nowadays presents, was completed.
