## STRUCTURAL ANALYSIS, CONSERVATION PRINCIPLES AND MONITORING APPLIED TO AN EVANGELICAL CHURCH IN ŻELISZÓW (POLAND)

**Abstract.** *Żeliszów (German: Giersdorf) is a village located in south-western Poland (120 km from Wrocław, 160 km from Dresden). According to many, the evangelical church was designed by the famous German architect Carl Gotthard Langhans in 1796. The church was built in classicistic style in accordance with an elliptical floor plan with exterior masonry walls and a timber construction comprising oval galleries covered with a wooden vault. A neo-gothic tower was added in 1872. The building has been abandoned since 1945. This means that aside from the need for conservation intervention to improve the technical condition of the building, it is also necessary to adapt the church to new uses. The goal of the research reported in this paper was to evaluate the degradation and deformation of the building structure using HDS 3D laser scanning, coupled with destructive, non-destructive and quasi non-destructive testing of the timber structure, brick and stone masonry walls and damp.. The poor technical condition of the church is the result of long-term degradation, natur

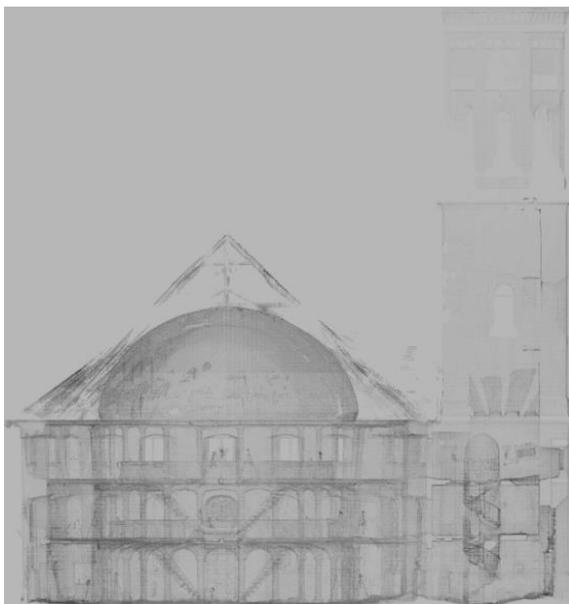
Figure 5: Picture from the 3D scan [3], [4].

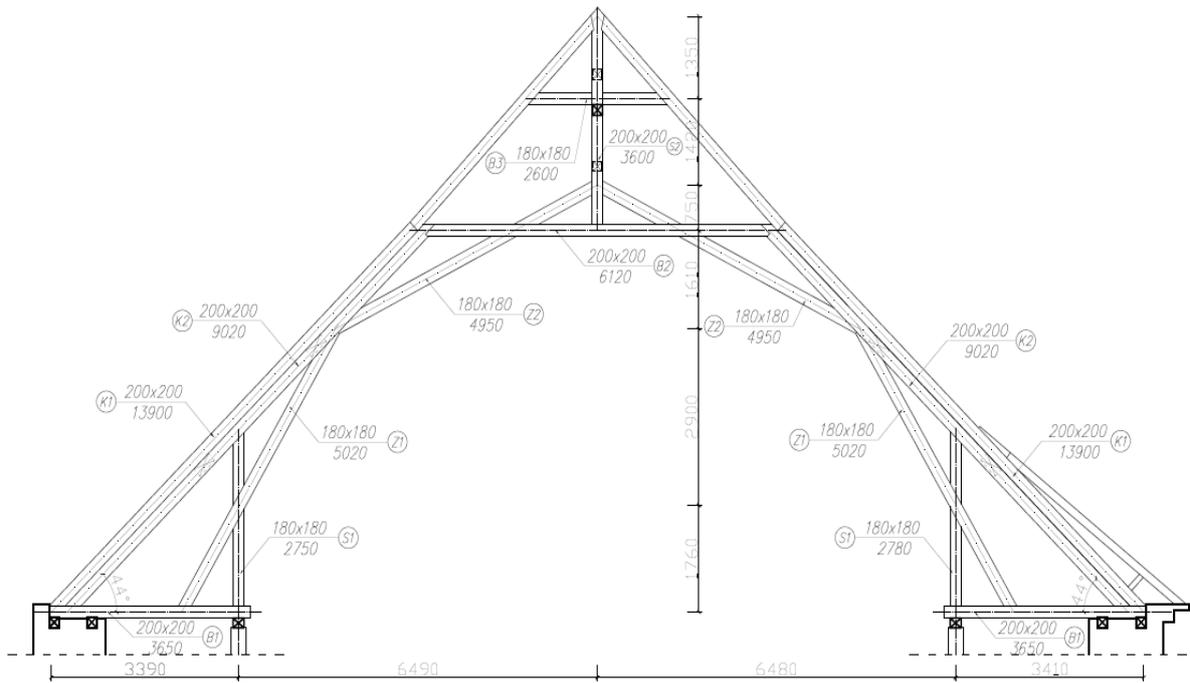
There is considerable damage to the structure caused by damp in places where the roof cover is damaged. Many years of moisture penetrating the structural elements and exposing them directly to atmospheric impacts have caused corrosion of many of the elements making up the rafter framing – damage to rafters, braces, loosening of joints, damp in the ends of the jack rafter beams where these are supported by walls and wall plates. Considerable displacement in joints was observed (links between the main rafter beam and the gallery pillar) – displacements of the pillar capitals in the highest gallery level in relation to the base reached 20 cm.

Figure 10: Main truss.

Missing elements along with wooden joints need to be restored, whereas damaged and loosened wooden structural elements need to be repaired. The application of toothed wood connectors ('Geka' rings) and screws is recommended as well as restoration of wooden joints by replacing damaged beam and rafter fragments and augmenting degraded cross-sections through insertion of steel rods (based on resistograph testing).

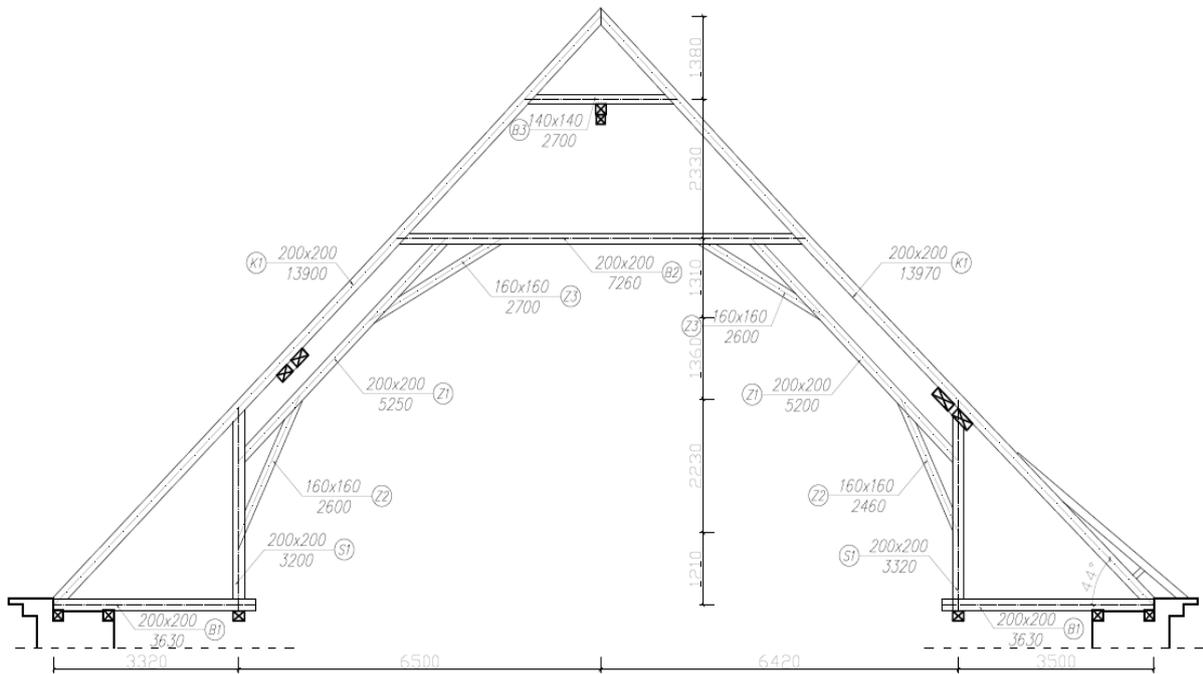
Figure 11: Secondary truss.

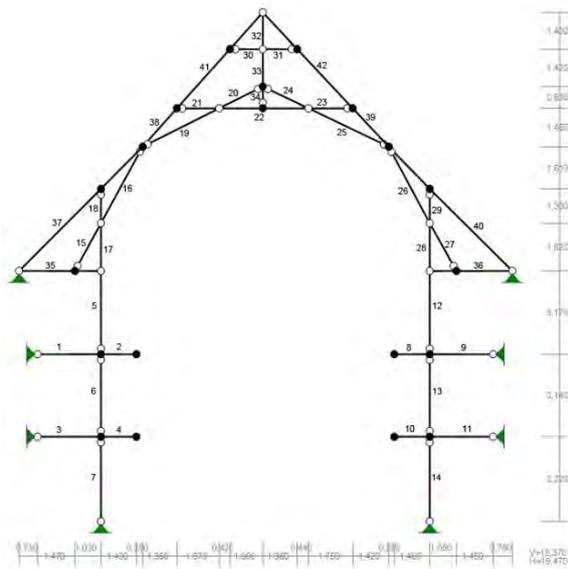
For the purposes of calculations relating to the wooden structure, it was assumed that the timber used for construction had parameters close to that of wood strength class C18. Calculations took into account the actual cross-sections and the condition of the wood as determined by the resistograph testing. Calculations of the strain of structural elements were carried out for four situations: assuming a 30% reduction in cross-section, lack of the gallery supporting pillar,

lack of the rafter and displacement of the supporting joint by 5 cm. The Autodesk Robot Structural Analysis 2011 programme was used for carrying out the relevant calculations.

Figure 12: Static diagram.

Structural stability calculations indicate that the load-carrying capacity of the timber elements is sufficient. Strain of some elements exceeds acceptable levels in situations where the cross-section is reduced by 30%. Although these are not significant, it should be noted that the condition of the rafter framing especially where there is constant damp can experience a more rapid deterioration of durability parameters, and different types of damage can accumulate within a single truss.
