ON-SITE INVESTIGATION AND DYNAMIC MONITORING FOR THE POST-EARTHQUAKE ASSESSMENT OF A MASONRY TOWER

Carmelo Gentile¹ and Antonella Saisi²

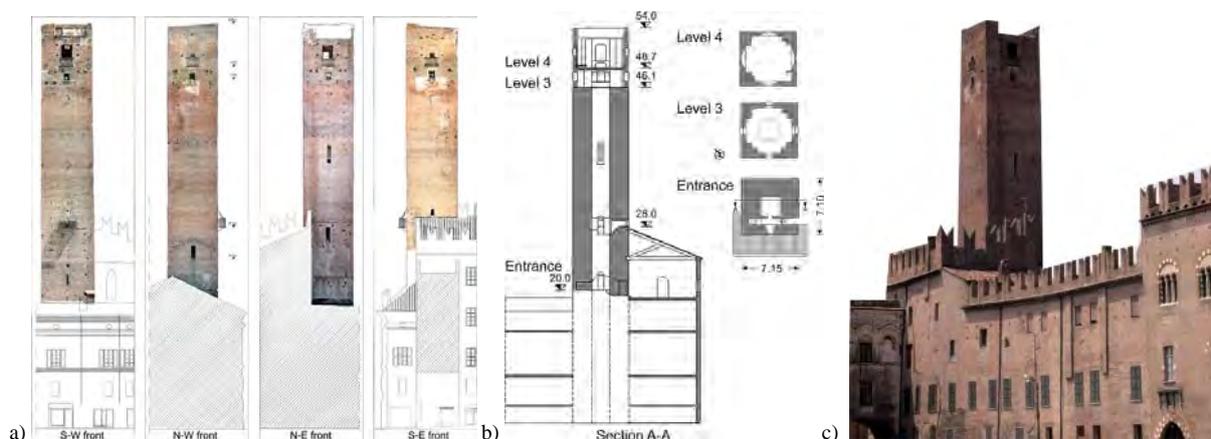
Figure 2: Fronts (a) , section (b) and view from East (c) of the Gabbia Tower.

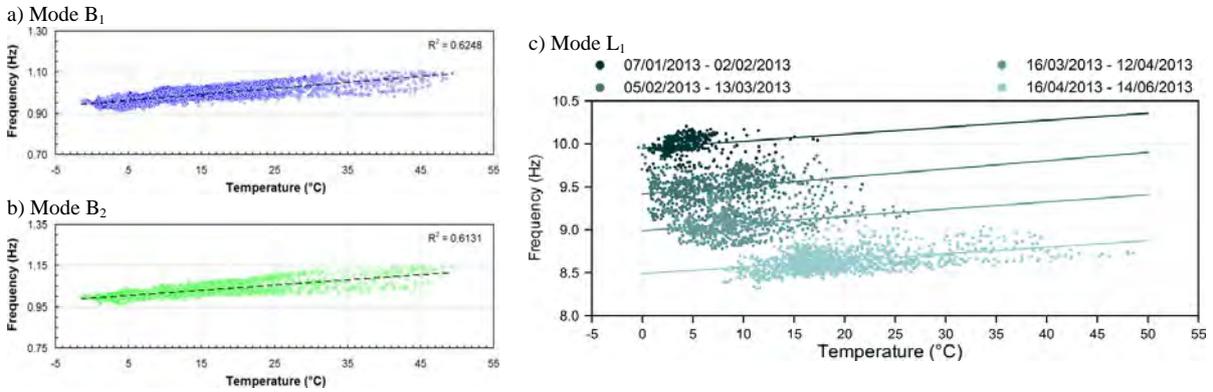
The time evolution of the natural frequency of the upper mode, i.e. the local mode L_1 (Figs 7b,c), deserves some concern because the trend of this frequency is very different from the others (Fig. 10): the modal frequency exhibits more significant fluctuations and clearly decreases in time, from an initial value of about 10.0 Hz to a final value of about 8.5 Hz at the end of the examined time period.

Figure 10: Natural frequency of modes B₁ (a), (b) and L₁ plotted with respect to the outdoor temperature in the period between 07/01/2013 and 14/06/2013
