## STRUCTURAL AND CONSERVATION SOLUTIONS FOR THE TREATMENT OF THE SEA FRONT WALLS OF OLD AKKO (ACRE), ISRAEL

**Abstract.** *Between the years 2009-2013, the southern sea wall of the Old city of Akko underwent planned rehabilitation and conservation works funded by the Old Akko Development Company. The southern section of the wall, measuring some 300 m long with an average height of 8 m, was severely damaged by years of marine erosion and flaws in the ancient structural foundation techniques that were comprised of materials unsuited to a marine environment. Moreover, stabilization and rehabilitation attempts carried out in the 1930's of the 20<sup>th</sup> century also caused irreparable damage to the wall's foundations. The ancient city and its walls are subject to statutory limitations and considerations, as it has been declared an antiquity site by the Israel Antiquities Authority and a world heritage site by UNESCO, and is also a modern bustling town. In addition to these limitations, there are implementation restrictions for construction inside an ancient port, lacking the option to carry out works in an underwater environment. These limitations required creative thinking and

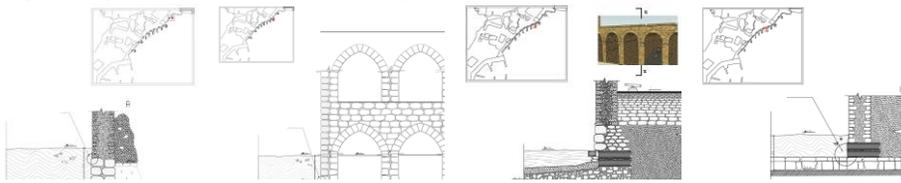
Fig. 7 sect. A

foundations. The excavation also yielded decorated capitals, fragments of columns and scanty remains of Byzantine-Crusader pottery, which could be remnants of the Clarissian Sister's Convent that was destroyed in 1281 when the Muslims conquered the city, as documented by Mondril in 1697 (Schiler 1983) (Fig 7,8).
