## RE-STRENGTHENING 20<sup>th</sup> CENTURY ARCHITECTURAL HERITAGE: A CASE STUDY OF BRISBANE CITY HALL RESTORATION

Arturo Cruz

Queensland University of Technology (QUT)  
2 George St, Brisbane QLD, Australia  
[arturo.cruz@qut.edu.au](mailto:arturo.cruz@qut.edu.au)

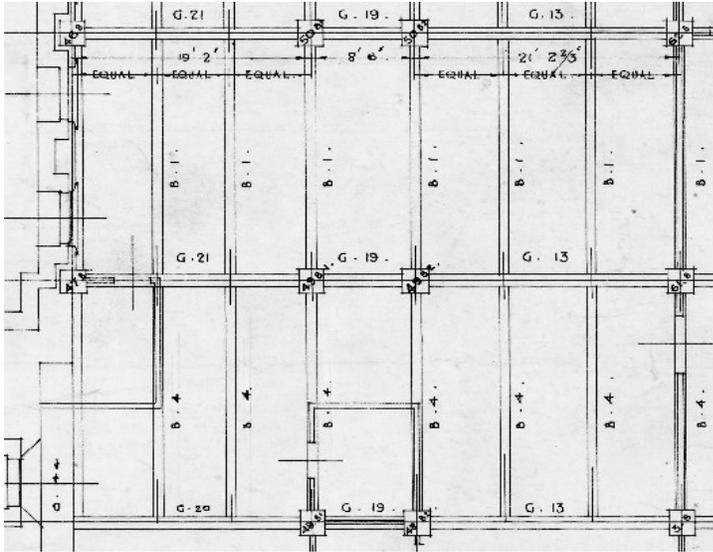
Figure 3 Brisbane City Hall typical floor beam layout (Source: Brisbane City Council, Cartwright & Belperio 2012)

layout of the structure consisted of one way spanning slabs that were supported by a series of secondary beams at 2.2 metre centres and spans at 6.6 metres from the primary beams (See Figure 3 and Table 1).

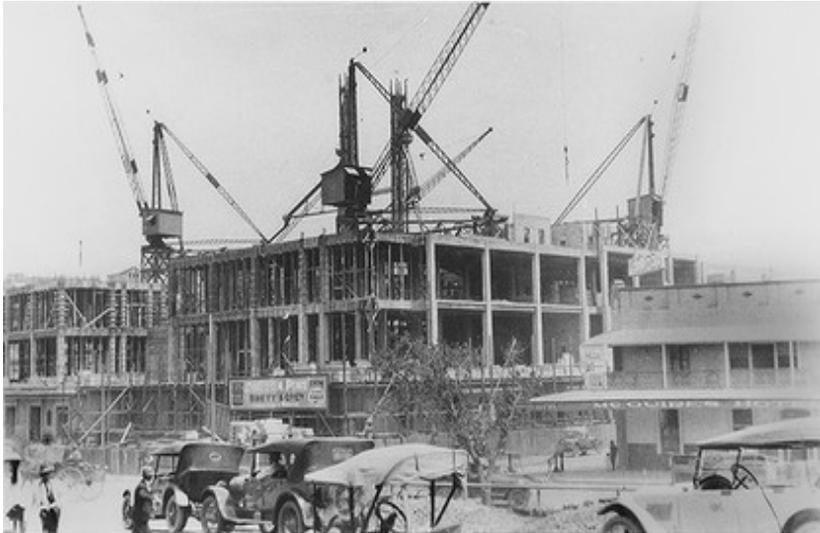
The Brisbane City Hall was constructed using a reinforced concrete structural system (See Figure 5). Australian buildings were mostly made of reinforced concrete as it was one of the widely used materials in the 20<sup>th</sup> century [6]. Contrary to earlier beliefs, reinforced concrete is similar to other exposed construction materials in the way that it eventually corrodes and deteriorates. When exposed, a reinforced concrete structure is very vulnerable to different forces of nature and other internal stresses. Its resilience is also compromised especially with ever-changing construction techniques and methodologies, as in the case of the Brisbane City Hall where its original condition soon lagged behind technology and building standards. Therefore,

Figure 5 Reinforced concrete framing construction of Brisbane City Hall in the 1920's (Source: brisbanetimes.com.au)

the Brisbane City Hall, given the age of the building, was very susceptible to advanced concrete deterioration because the problems described previously had not been properly mitigated.

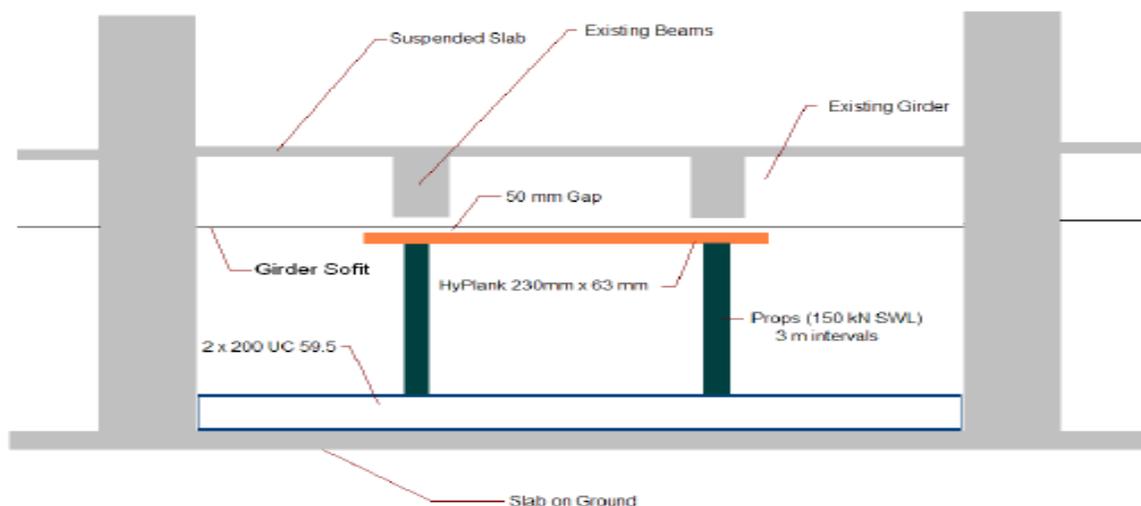
Figure 10 Propping set up devised by Aurecon to check the deflection of beams and girders under loads (Cartwright, 2011)

The beams and girders in the location where the test was to be executed have heavy duty back propping placed under them. A gap of 50 mm was provided between the top surface of the Hyplank and the soffit of the beams and girders in the loading zone. No gap was provided between the top surface of the Hyplank and the soffit of the girders located at the perimeter of the loading zone. Figures 10 illustrates the testing method that Aurecon devised to ensure the strengthening method was correct.
