DIAGNOSIS AND STRUCTURAL REHABILITATION OF A XVI CENTURY STONE MASONRY ARCH BRIDGE

Abraham R. Sánchez Ramírez¹ and Roberto Meli²

Keywords: Historical construction, stone masonry, seismic safety, damage evaluation, structural rehabilitation.

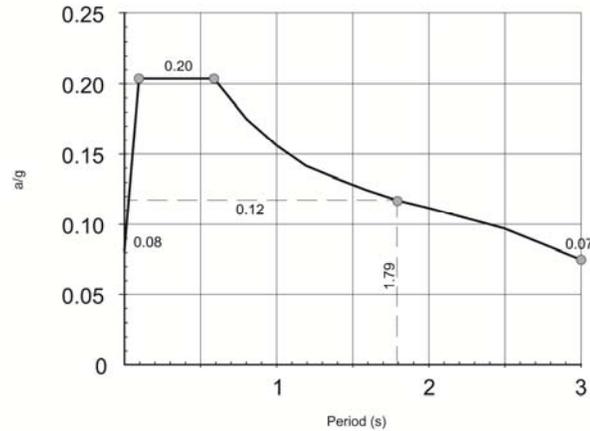
Figure 18: Seismic design spectrum.

the arch bridge is moderate, also because the structure is founded on very firm soil. The code specified design spectrum is shown in Figure 18 and includes correction factors taking into account the importance of the work, the type of soil and the non linear behavior of the structure.

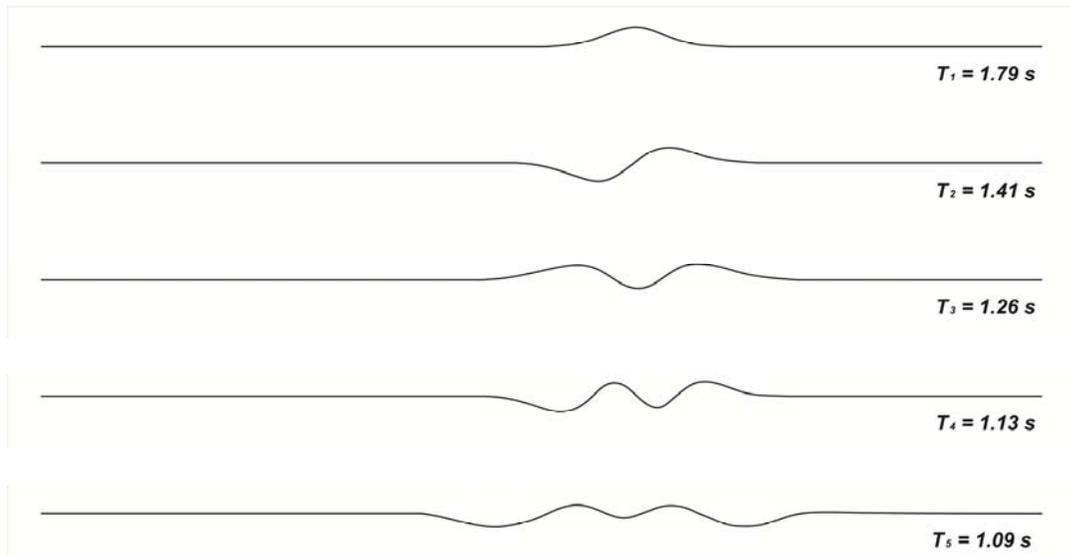
Figure 19: Natural modes of vibration (plan view).

The finite element model that had been employed to study the effects of gravity loads across the whole bridge was also used to determine its dynamic properties and response to the design spectrum, through a modal dynamic analysis. The first mode of vibration has a period of 1.79 s, and corresponds to the vibration of the structure in the direction perpendicular to its plane. As can be appreciated in Figure 19, lateral displacements are concentrated in the central zone of the bridge. The relatively long period of vibration of the fundamental mode is due to the flexibility of the cantilevered columns in the transverse direction, and is favorable in this case of a very firm ground, because it falls into the descending branch of the design spectrum, where the spectral ordinate is rather small (0.12 g). In the first six natural vibration modes correspond to the displacements in the transverse direction, and their participation in the overall response of the bridge show a fast decrease with the order of the mode.
