DAMAGE SURVEY AND STRUCTURAL ASSESSMENT OF THE ROSARIO CHURCH IN FINALE EMILIA AFTER THE MAY 2012 EARTHQUAKE IN EMILIA-ROMAGNA, ITALY

Abstract. *The paper is aimed at presenting some results regarding the causes of damage of a masonry church (Chiesa del Rosario) located in Finale Emilia, a town stricken by the May 2012 Emilia Romagna seismic event. The church exhibits a diffused state of damage on the façade (rocking along a horizontal hinge), lateral nave walls (shear), transept (shear and out-of-plane bending) and bell tower (detachment at the connection of the tower to the church and subsequent rotation along a vertical axis). The approach adopted is multidisciplinary and it is conducted within a research project that involves the Technical Universities of Milan, the Technical University of Bari and the Italian Cultural and Architectural Heritage Ministry (MiBAC). The survey analyses conducted comprise a detailed geometric recover of the volumes and materials used, basing on post-seismic photogrammetric studies, historical research on existing documentation and repeated in situ investigation. Preliminary structural analyses are conducted in agreement with the Italian Code. In p

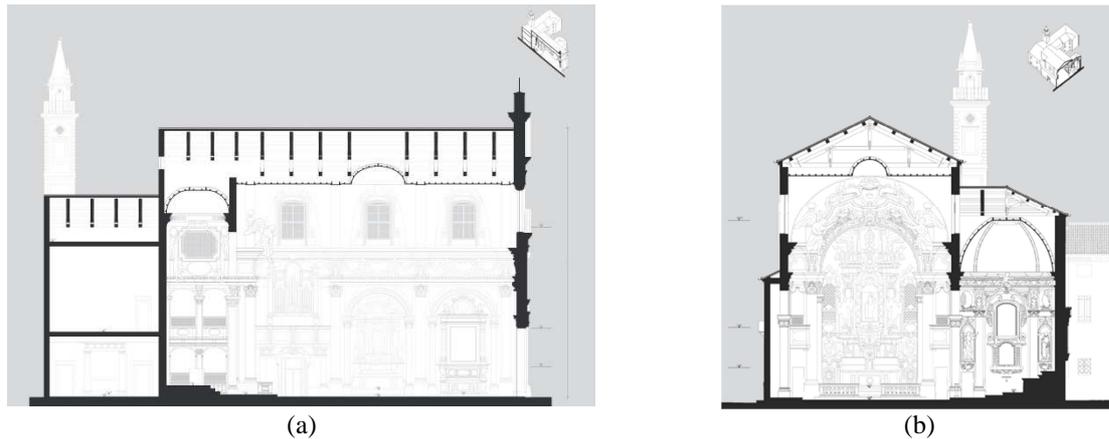
Figure 2: (a) longitudinal and (b) transversal section obtained from standard topographical survey and photogrammetry.

From the conducted survey, it was found that the church exhibits a diffused state of damage on the façade (rocking along a horizontal hinge, with detachment from perpendicular walls), lateral nave walls cracks due to shear (especially in correspondence of openings), transept partial collapse for shear and out-of-plane bending and a quite relevant detachment at the connection between the bell tower and the church, with subsequent rotation along a vertical axis of the tower.
