LABORATORY TESTING OF UNREINFORCED MASONRY WALLS RETROFITTED WITH GLASS FRP SHEETS

H. MAHMOOD, A. P. RUSSELL, J. M. INGHAM

Department of Civil & Environmental Engineering
The University of Auckland
Auckland, New Zealand

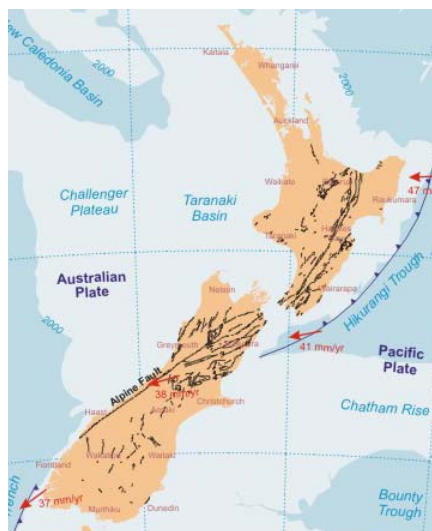
Figure 1. The geological setting of New Zealand (Reproduced with permission of GNS)

New Zealand is one of the most active seismic places on the earth (Natureandco.com). It lies at the edge of the Australian and Pacific plates (Figure 1). Past earthquakes in the region have caused major losses. The most significant of these earthquakes was the 1931 Hawke's Bay Earthquake that resulted in the death of 256 people and caused widespread damage in the Hawke's Bay region (Dowrick 1998). Most of the dwellings in the area were URM. The popularity of URM in New Zealand decreased after that earthquake. Use of URM was also restricted under government regulations after the introduction of the building bylaws NZS 1900 (Holmes 1965). The current New Zealand masonry design standard NZS 4230:2004 refers only to reinforced masonry structural elements (Standards New Zealand 2004). However, the current New Zealand building stock consists of a significant number of URM structures. Many of these buildings form a part of New Zealand's architectural heritage. Unfortunately, these structures also constitute seismic hazard to New Zealand's citizens. The New Zealand Building Act 2004 (Department of Building and Housing 2004) requires such

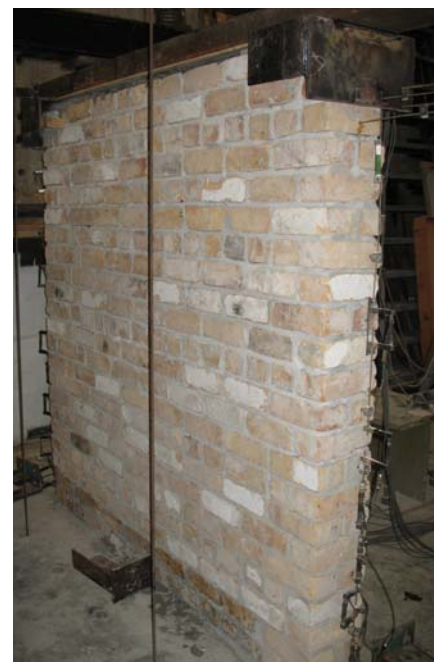
Figure 2. As-built wall

The test walls were built by a professional bricklayer using recycled bricks. The bricks were obtained from demolished buildings and cleaned for use in the tests. A weak mortar mix, ASTM type 'O' (1:2:9 cement/lime/sand by volume) was selected to simulate decayed mortar in old URM structures. Each test wall measured 1970 mm long \times 1970 mm tall \times 240 mm thick. The walls were built two leaves thick in the common bond pattern, with header courses every fourth course. The masonry materials and bond pattern were selected to replicate the construction materials and practices most commonly encountered in old New Zealand URM structures. The walls were built intentionally in a way that closely reproduced the observed, often deteriorated, finish quality of walls in real buildings.

One wall was left as-built for comparison of the test results and behaviour with the retrofitted wall. Figure 2 shows the as-built test wall. The other wall was retrofitted using uni-directional glass FRP (GFRP) sheets. The manufacturer-provided typical properties of the sheet are given in Table 1. The decision to use GFRP was taken on the basis of cost and often-reported lack of additional strength gain with the more expensive alternative, carbon FRP (CFRP) (e.g. Albert et al. 1998). The wall was retrofitted on one face only. This is consistent with FRP retrofit practice. FRP is generally applied only on the inside face of URM walls in a building in order to preserve the architectural façade. The test wall was strengthened in shear only to allow the wall to fail in a flexural mode, which is a ductile/pseudo-ductile mode of failure. Due to time constraints, the retrofit was applied before the as-built test had proceeded. Two layers of GFRP sheet were applied for the retrofit. The glass fibres were oriented horizontally for both sheets. Figure 3 shows the fibre layout and the retrofitted wall.

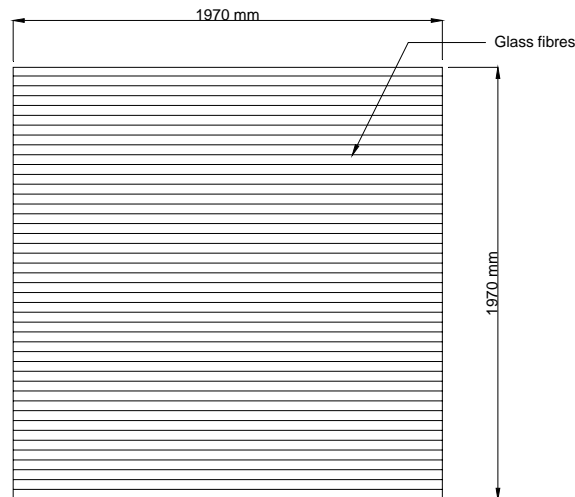
(a) schematic FRP layout

Figure 3. FRP configuration

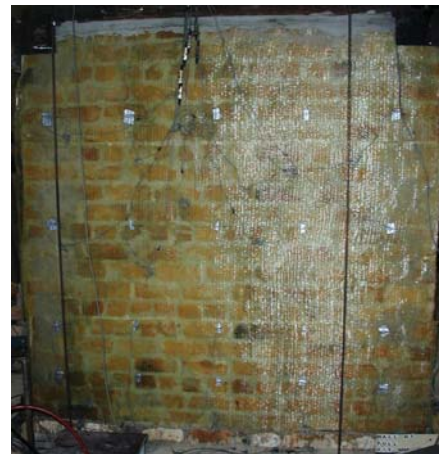
(b) FRP-retrofitted wall

The GFRP sheets were applied using a multi-stage process. First, the wall surface was ground level by an angle grinder. After grinding, the imperfections in the wall surface were filled with putty to obtain a near smooth surface. The primer epoxy coat was then applied to the wall using paint rollers. Separately, a GFRP sheet was saturated with epoxy. The saturated sheet was positioned on the wall by hand and worked against the wall by paint rollers to achieve a good bond. The sheet was anchored at its ends to the wall by fibreglass anchors to avoid premature delamination failures. The second sheet was bonded to the first sheet using epoxy. The FRP sheets were left to dry for a period of two weeks. During this period, heating lamps were used to accelerate the curing process.

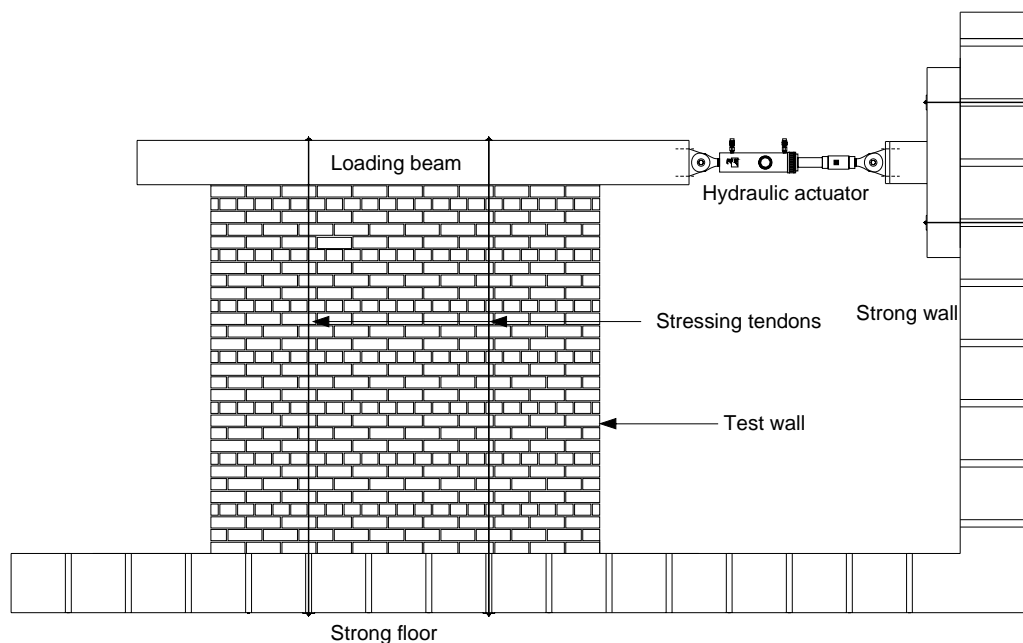
Figure 4. Test Setup

Figure 4 shows the test setup. The test walls were built directly on the strong floor. A layer of strong cement/sand mortar was spread on the strong floor before laying the first course of the wall, to provide adequate bonding with the strong floor. Two loading systems were incorporated into the test setup: to apply lateral forces and provide axial loads. Displacement-controlled lateral forces were applied by means of a hydraulic actuator. The hydraulic actuator was connected between the strong wall and a steel beam bonded to the top of the test wall, for uniform distribution of the lateral force over the length of the wall. This arrangement approximated the diaphragm-wall earthquake force transfer mechanism in a URM building. Vertical load was simulated using four external stressing tendons, two on each side of the wall. The tendons were anchored to the strong floor. The required stressing force was applied to the top of the tendons by a hydraulic jack. The force was transferred to the test walls by stiff steel beams pivoting on the steel beam bonded to the wall top. Coil springs were provided to facilitate the maintenance of a constant prestress load.

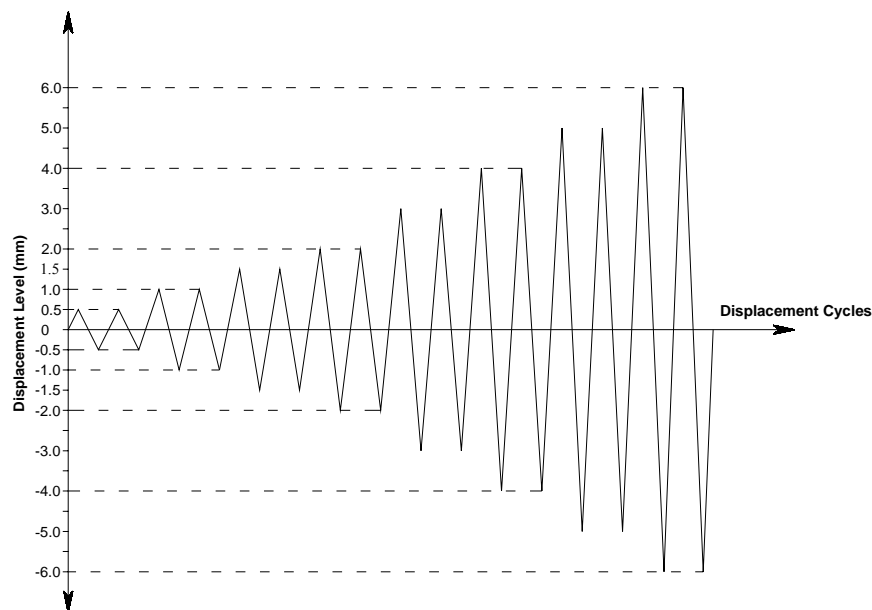
Figure 5. Displacement cycles

After the application of axial load, the lateral cycles were commenced. All loading cycles were displacement-controlled, with two cycles at each displacement level to obtain a stabilised crack pattern. This also verified the lateral force values at each displacement level. A test wall was initially pushed to 0.5 mm. The test was paused at this displacement level to inspect the wall and FRP sheet for any damage/debonding. The displacement was then released to bring the wall back to the original position. After this, the wall was pulled to 0.5 mm and the procedure was repeated. The displacement increment was maintained at 0.5 mm up to a displacement of 2 mm. For displacements greater than 2 mm, the increment was increased to 1 mm. The complete displacement cycle history is shown in Figure 5. The test was stopped after a definite failure mode was established.

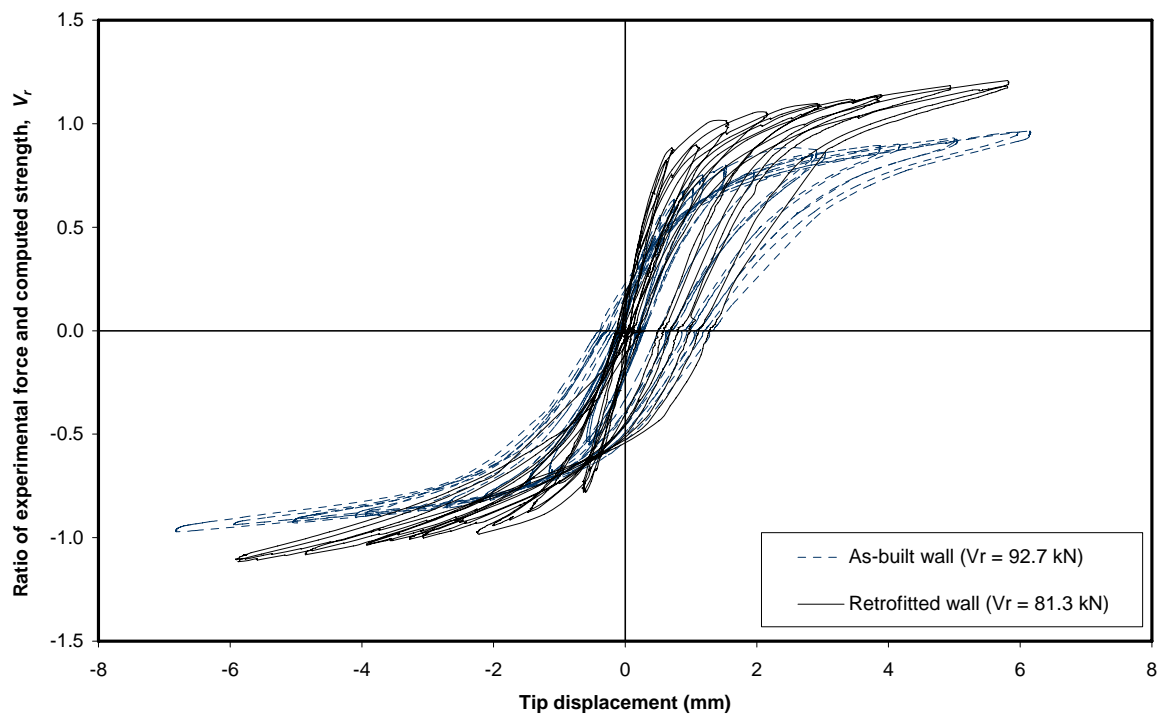
Figure 6. Ratio of the experimental force and computed strength versus tip displacement

Fig. 6 shows a comparison of the hysteresis plots for the both walls. The ratio of lateral force and computed lateral strength for each wall is plotted along the y-axis. Wall tip displacement is plotted along the x-axis.

Some preliminary observations have been made by comparing the hysteresis behaviour of both walls. First, the slope of the retrofitted wall is much steeper, indicating a higher stiffness than for the as-built wall. This can be attributed to the presence of vertical fibres holding the main glass fibres. Second, the graph ordinate for the retrofitted wall corresponding to first displacement level of 0.5 mm is about 25% greater in value than that for the as-built wall. This difference in ordinate values is constant until the end of the displacement cycles. Reasons for this are still being investigated. Third, a strain-hardening type behaviour is observed following the initial displacement level of 0.5 mm. This is due to increase of the post-tensioning forces as the walls rocked.
