The reconstruction of the Frauenkirche in Dresden

W. Jäger

T. Burkert

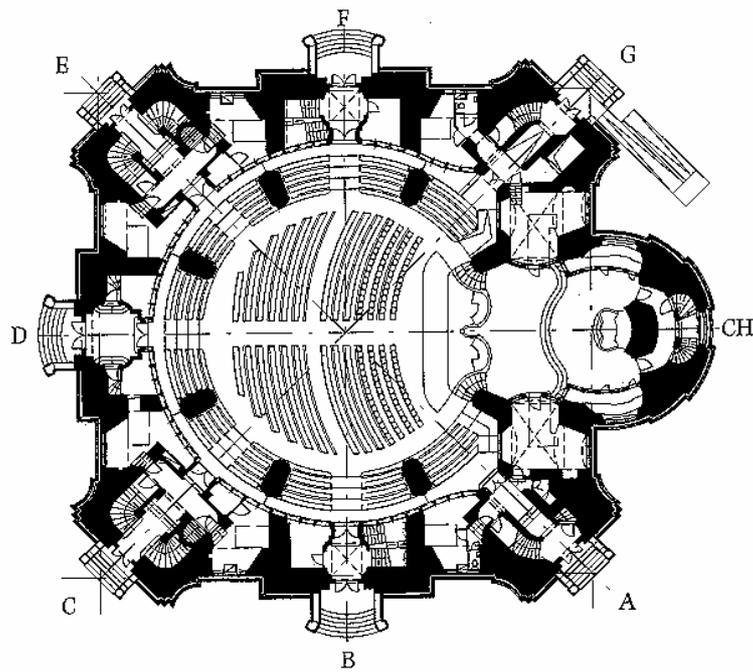
Figure 3 : Ground plan of the church

The dimensions of the ground plan were 43 x 43 m (Figure 3). The main cornice had a height of 26 m, the thrust collar of the cupola was located at a height of 65 m and the tip of the cross on the lantern was 93 m high. The main cellar was laid out in the shape of a Greek cross. Above the cellar rose a central, round church hall, its outline being formed by eight slim stone columns (Figure 4). Above the columns there was an arch of a cylindrical vault, which carried the flat inclined interior cupola and the double-walled exterior cupola with a diameter of 26 m. The slim interior columns were an architectural design element.

from the slim interior columns (see Figure 3). According to the scientific knowledge of his time and his background as a craftsman, George Bähr was unable to substantiate his structural concept with calculations. The birth of architectural statics did not happen until late in the 18th century. Due to settling of the building site and compression of the masonry and the columns the estimated load distribution to the outside was disturbed. It was not realized to the extent that Bähr had hoped for. This led to a very high load on the interior columns. The result was that soon after construction of the cupola the masonry, the cupola and particularly the columns started to develop cracks.

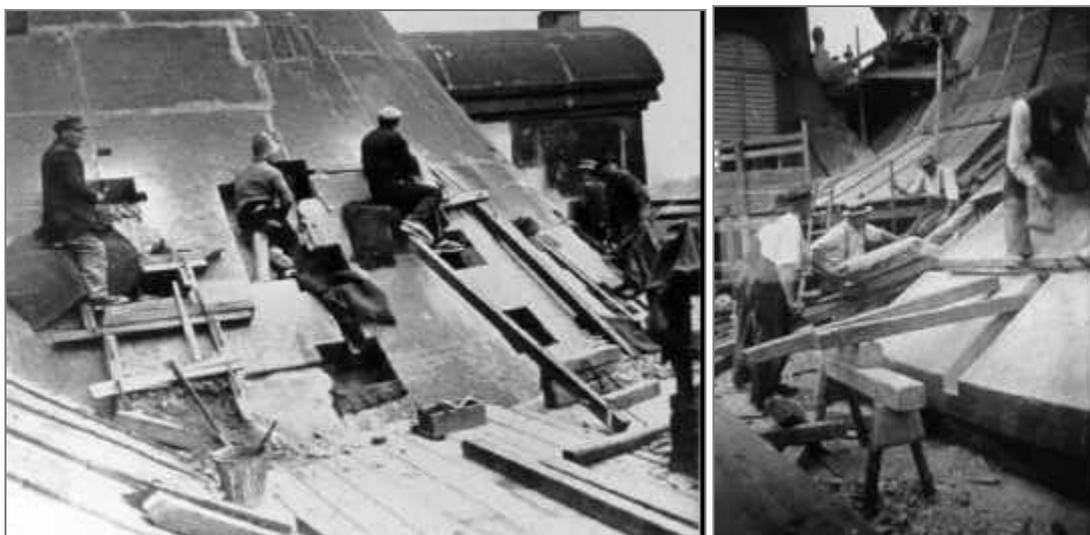
Figure 5 : Photo taken during restoration period at 20th century
(left: stone roof of the choir; right: stone roof between main cornice and cupola)

In the twenties of this century the condition of the building was causing great concern, so that it was decided to carry out comprehensive refurbishment measures. In the first stage, the interior columns were extended with steel bands. Later, in the thirties, the foundations were reinforced and three reinforced concrete anchors were added to the interior walls of the main cupola shell.

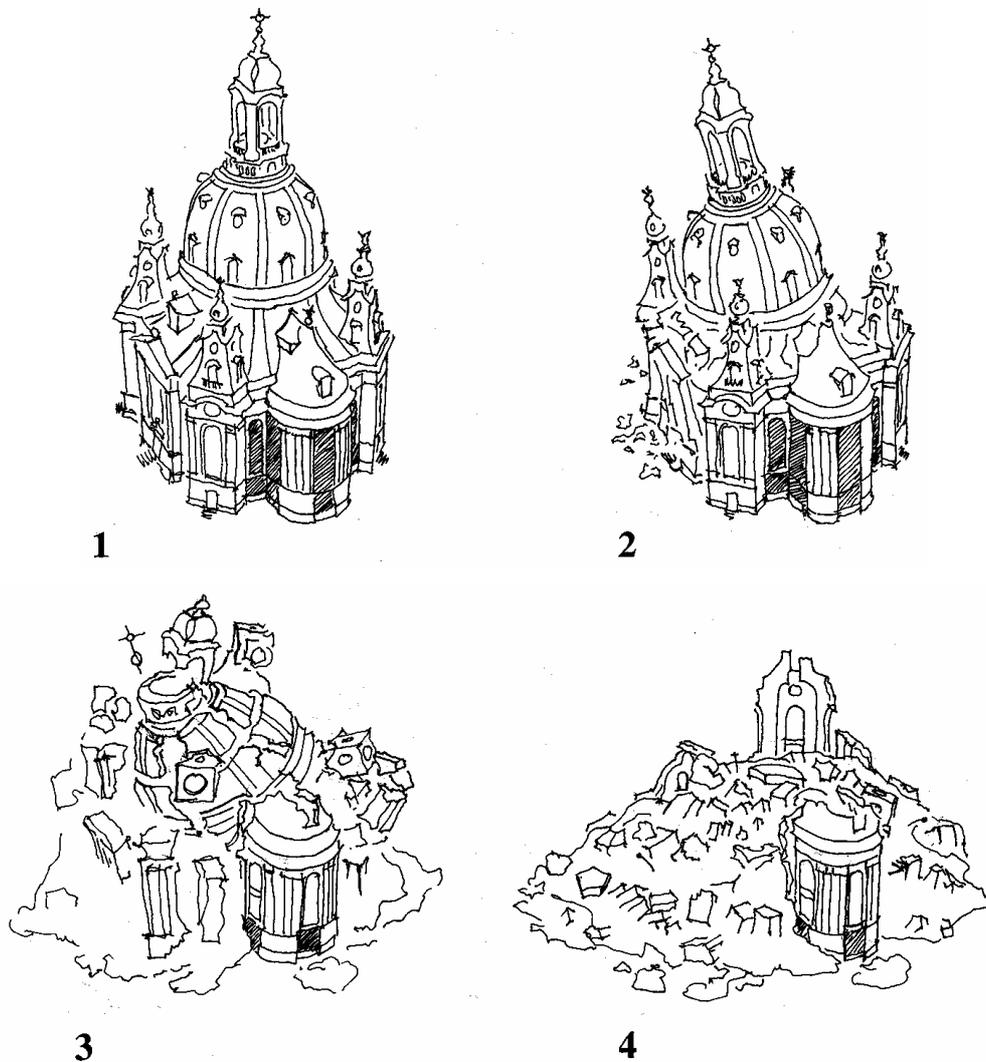
Figure 6 : The collapse of the Frauenkirche on 15th of February 1945 (sketch: D. Rosenkranz)

sections at the height of the gallery. Rather, the steel girders for the galleries probably must be considered the triggering factor for the collapse. These formed a ring in four tiers around the church nave; however the ring was open to the chancel, so that counteracting forces were not present. It can be assumed that the substantial expansions of the steel girders of this ring decreased again as cooling set in, causing the girders to fall because their supports were no longer in place. This undoubtedly caused exertion of lateral forces on one or more of the interior piers, which could no longer absorb them. One of the two southeastern interior piers failed.

With the lapse of this single support, the load of the dome was deposited onto the remaining piers. The extreme stress that was already on them was increased even more. The dome began to tilt slightly to the southeast, but was still held for the moment by the interior piers of the north side. This force caused them to lean outward. Around the bases of the piers the stones were literally crushed and pulverized. Now without stable support, the dome began to sink into the church interior. Already as it began to go downwards - still held together by Bähr's wrought iron anchor rings and the reinforced concrete tie beams installed in 1938/39 - the dome pushed the mighty facade walls of the north and south sides outward.

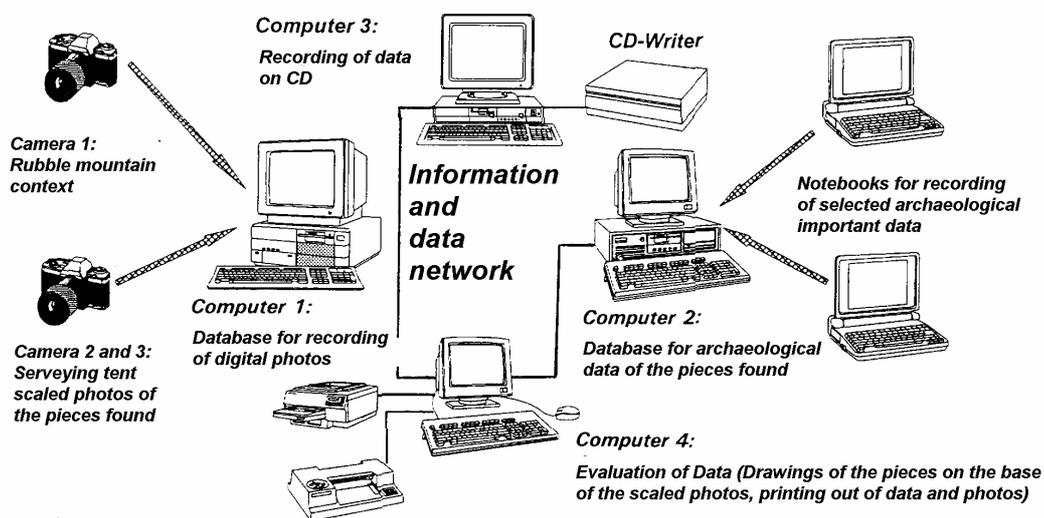
Figure 8 :The algorithm of recording of information during the recovery process (flowcharts: IVD/AVI Dresden)

- Collection of all the information about the findings with regard to their location as well as to the piece itself and documentation of all the information received
- Processing of the information received of the pieces and of the place where the pieces were found, clear orientation and designation of the places
- Evaluation of the individual pieces found regarding whether they are worth recording or not
- Recording of the surrounding of the pieces that have been found

- Clear and unequivocal labelling of pieces found and recording of all information pertaining to the finding
- Description, illustration and graphic representation of the piece found
- Decision on storage or filing
- Documentation of all the work stages
- Preparing drawings for mapping the place in horizontal projection and in sectional drawing depending on the work's progress
- Identification of the pieces found on the basis of all knowledge gained and available up to that point of time
- Archaeological evaluation of all the information gained and available up to that point with a view to the reconstruction of the original condition as a continuous process
- Preparation for the reutilization of parts, pieces or structures to be reconstructed

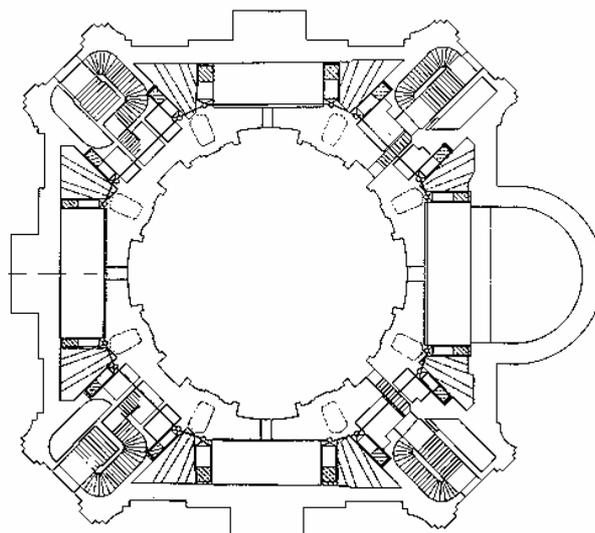
Figure 9 : Assembly of the additional anchor ring in the height of the main cornice (cross section)

The Foundation Frauenkirche Dresden decided very early to follow the proposal of *Wenzel* and install an additional polygonal ring in the height of the main cornice and to apply additional forces with the help of these anchor ring. So it is also possible to reduce the danger of cracking especially in the supporting arches bearing the cupola.

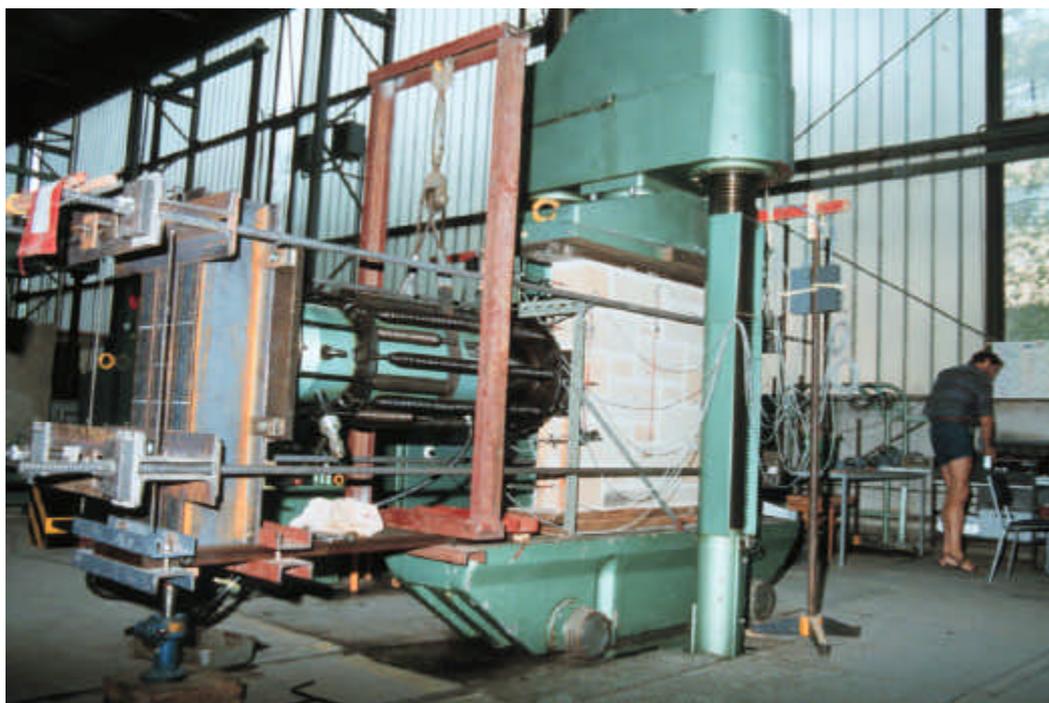
Figure 10 : Shear-compression test with high compression

The shear-compression tests (see Fig. 10) formed the prerequisite for concrete evaluation approaches for this type of load. These were again developed by *Berndt* (1996) according to the ultimate limit state method with consideration of partial safety factors and were taken into consideration in planning work for the reconstruction.

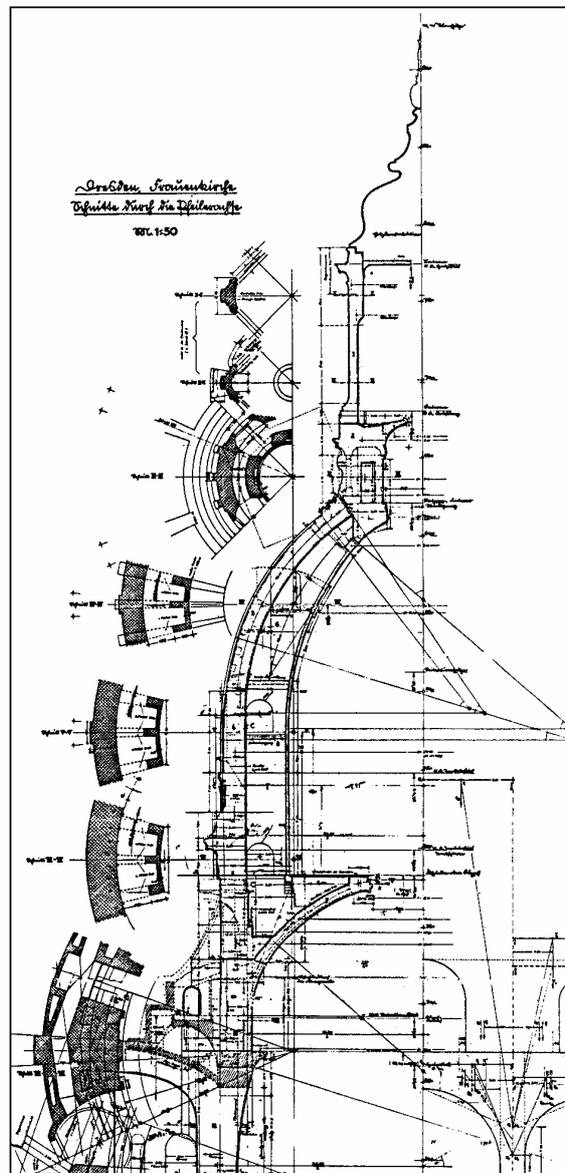
Figure 12 : Cross section through the historic stone cupola

The cupola of the Frauenkirche was a double-shell construction, which had consisted of an outer shell of 1.3 to 1.5 m thickness and an inner shell of 0.25 m thickness. Both shells were interconnected by transverse masonry pieces (see Fig. 12). The outer shell had no additional roofing skin. Weather protection was provided a sandstone top layer of approx. 0.25 m thickness, which was connected to the lining masonry throughout. Wrought-iron ring anchors were located between the top layer and the lining masonry. The cupola had relatively large window openings permitting the light to penetrate. The cupola was topped by a lantern with a height of approx. 18 m (refer to Fig. 12). It is intended to reconstruct the cupola of sandstone according to the archaeological principles.

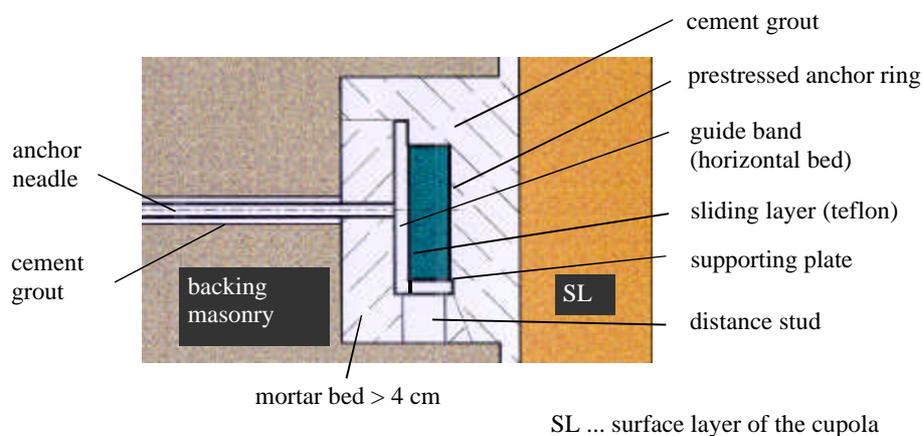
Figure 13 : Cross-section of the anchor ring of the cupola in detail (principle sketch)

The FEM analyses were carried out in the linear range, since it is intended to pre-stress the cupola moderately for the reconstruction (Jäger, et. al 1995). Thus, no tensile stresses will occur in meridian and tangential direction (Jäger, et. al 1996). Initially, the cupola was considered separately under observation of compatibility conditions to the supporting structure. The cupola was first calculated without pre-stresses in order to determine the necessary value of these pre-stresses. The case of a pre-stressed cupola was subsequently implemented by the introduction of pre-elongated rods at the element edges of the outer surface. The design of the pre-stressed ring anchors has been decided upon in the meantime. Six flat steel ring anchors made from high-quality fine-grained structural steel will be used. They have dimensions of 3 x 15 to 4 x 18 cm, depending on the required pre-stresses. In order to keep the friction between straining ring and masonry to a minimum, the individual sections of the straining ring are supported on teflon strips. The friction losses to be considered here are minimal. After tensioning the remaining straining channel will be injected with cement mortar, filling in the spaces between masonry and steel. In this way, a solution is created which is characterized by its high durability.

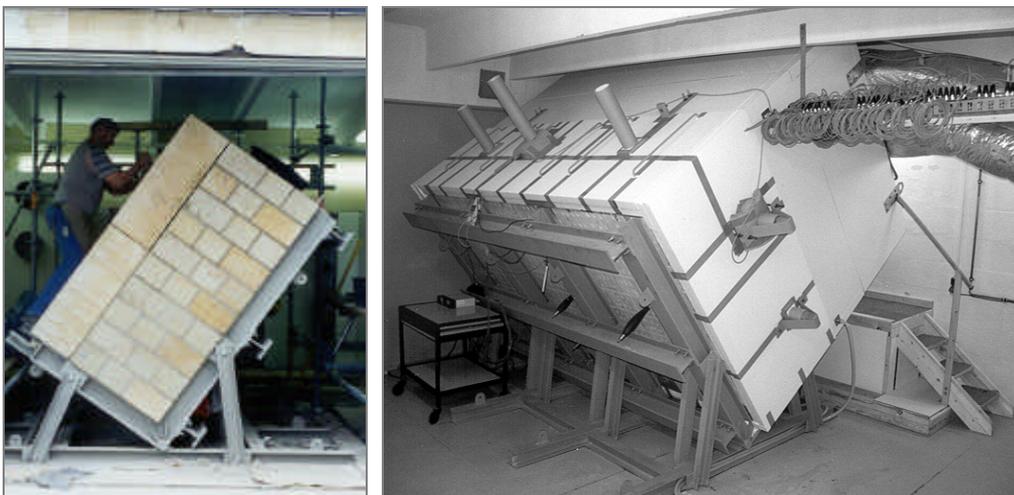
Figure 14 : Full scale test at the test laboratory of the Chair for Planning of Load Bearing Structures, Dresden University of Technology

The issues and problems with regards to building physics in the sandstone top layer make high demands on planning and material selection. Here, building material issues with regard to sandstone and the jointing material to be used as well as the design in view of durability must be investigated. Beside of an enormous numerical simulation work were carried out full scale tests at wall specimens of the cupola.

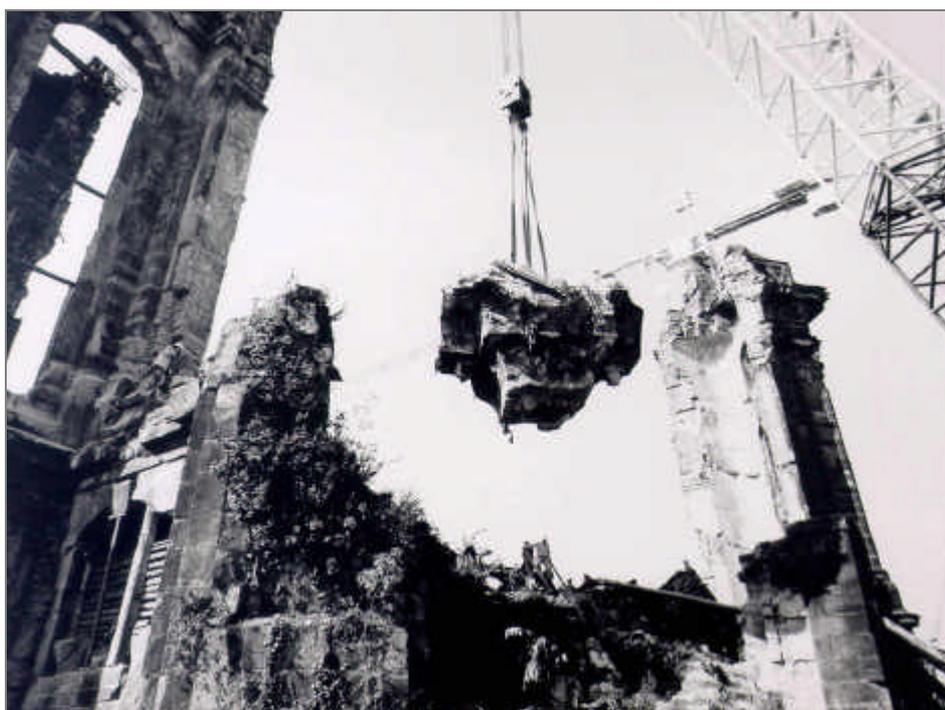
Figure 15 : Removal of the top of the north-east corner tower (GT 35) from the heap of ruins in 1993

One of these large debris pieces has been the roof of the North East staircase tower with a weight of around 95 t. In 1993, after preparing and strengthening the so-called 'butterfly' has been removed from the heap. The piece was lying upside down on top of the heap of ruins. By means of a special mobile crane and with the aid of a reinforced concrete tube which was connected with the masonry by needles it was possible to lift and remove the large piece.

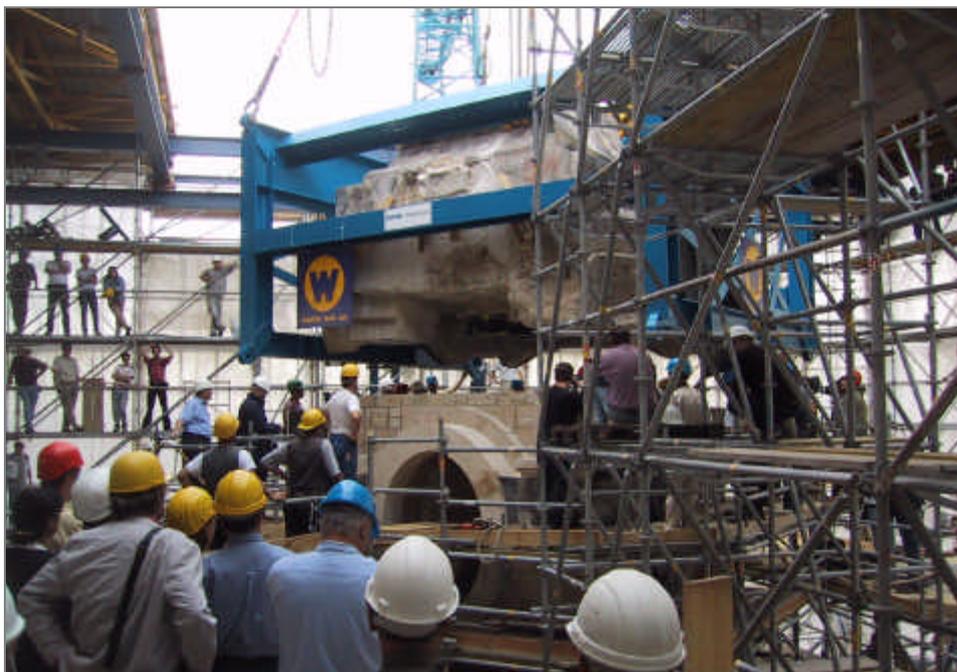
Figure 16 : Assembly of the large debris piece (GT 35) on 10th August 2001 to its original place

On 10th August 2001 the large piece GT 35 was assembled to its original place at the top of the North-East staircase tower (see Figure 16). A steel framework was necessary to turn the large piece into its right position. This framework also helped to justify the horizontal position and to drive it to the fitted points at the supporting masonry or the tower. Both removals needed an exact preparation and were only possible within the network of all architects, engineers and skilled workmen involved.

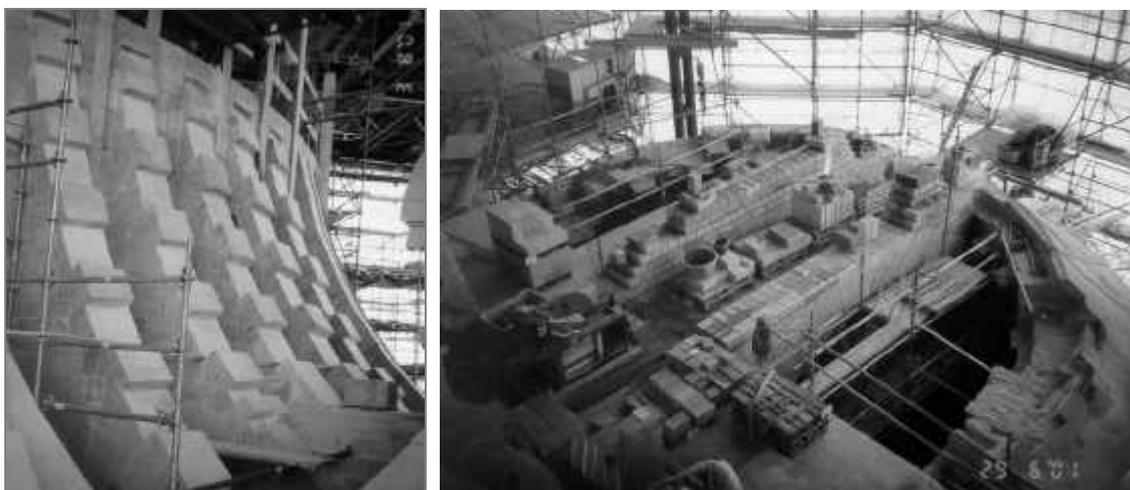
Figure 17 : View onto the building site in Summer 2001 (left: the supporting arches of the negative curved roof; right: the beginning of the choir roof)

Construction work in the region of the curved roof between the exterior walls and the drum of the cupola is currently underway (Figure 17).

- closing the inner cupola with the light opening of the interior
- finishing the staircase towers up to the bottom of the top (due to the limited height of the weather protection roof)
- laying the first plates of the double curved roof between the main cornice and the drum of the cupola (see Figure 17, left (stage before))
