The use of FRP in the strengthening of timber-reinforced masonry load-bearing walls

This paper presents the results of the experimental study carried out at LNEC, within the European research project COLORETIM in which these various topics were addressed. The specific programme of work hereby described intended to assess the possibility and the efficiency of using FRP rods and glass fibre fabric, together with epoxy adhesives, in the strengthening of damaged timber-reinforced masonry load-bearing walls from Portuguese traditional buildings.

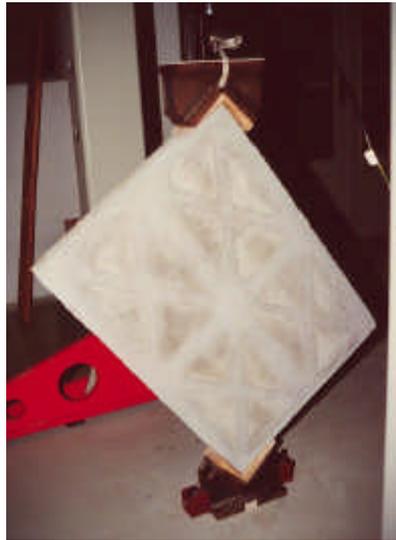
The test panel was simply supported on a V-shape steel plate; thin hardwood wedges were inserted between test panel and metal supports to provide suitable bearing for the rectangular wall panel and vertical alignment of its two loaded corners. A similar V-shape plate and wedges group was intercalated between the top corner and the loading head of the machine. No lateral restraint was necessary during the test as no instability developed (figure 2).

Figure 2 : Diagonal compression of the wall panels

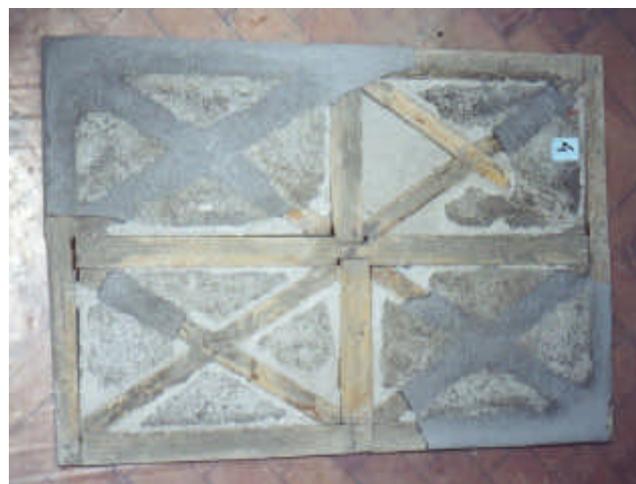
For every one of the six test panels (wall panels), from an early stage of the test deformation, the render fissured on the contact line between timber frame elements and the in-filling mortar and eventually detached from the panel. Soon after this, the tensioned joints started to open, although no lateral instability developed. Test was finished when the outer timber member of the frame (on the shortest sides of the panel) failed in bending (typical panel failure and detail are shown in figures 3 and 4).

Figure 3 : Original wall panel after diagonal compression test (typical failure)

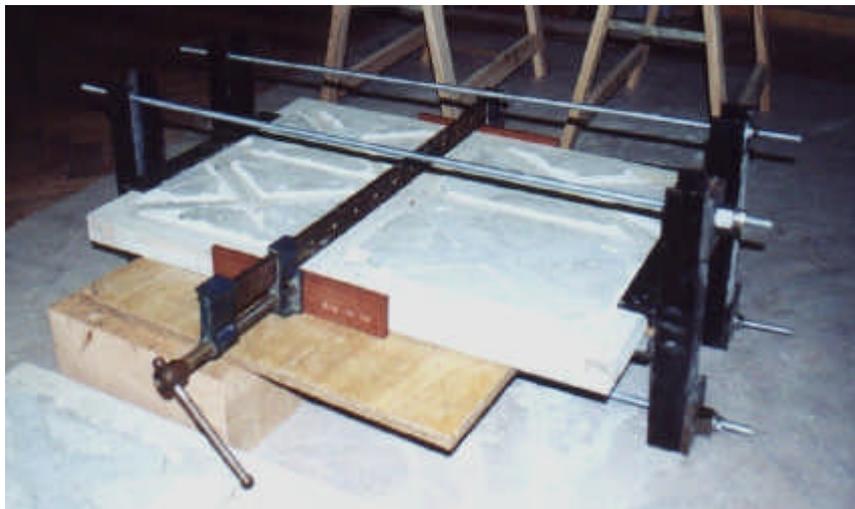
After testing, any loose render and fractured in-filling mortar was taken out and nails were removed, in order to allow the straightening of the tested panel (bringing it back into a rectangle). This was done by creating a rig with steel U-profiles and long bolts, and applying pressure to two parallel sides of the test panel each time (figure 5).

Figure 5: Rig where tested panels were straightened

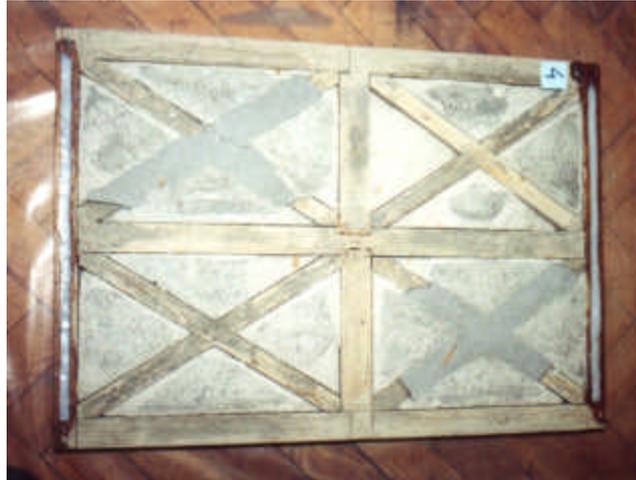
Every test panel was strengthened by repairing both outer timber members of the frame on the shortest sides of the panel. This was done by opening one slot in the broken timber member and placing in it one 10mm diameter glass fibre reinforced polymer (GFRP) bar glued with SlowSet 10T tyxtotropic epoxy adhesive from ROTAFIX. Each GFRP bar was positioned the nearest possible to the centre of the corresponding member cross section, in order to avoid non-symmetrical strengthening effect. Two bars were therefore used for each panel (figure 6).

Figure 6 : Strengthening by inserting FRP bars (done in all panels)

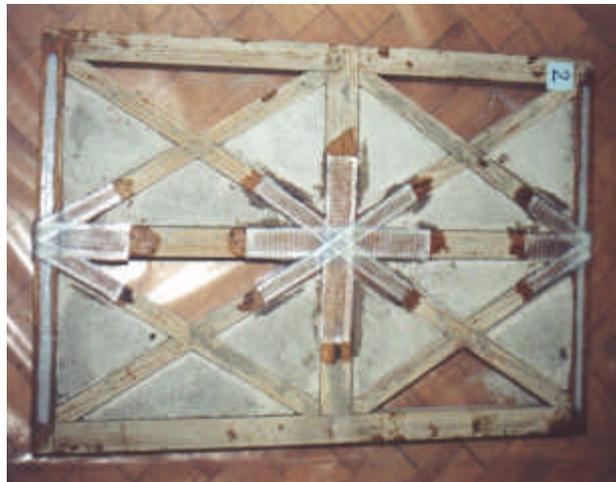
The GFF stripes were as wide as the timber member they were glued to and 25cm long; in the case of extreme joints, glass fibre (GF) fabric stripes were therefore folded around the edge of the panel. (figure 7).

Figure 7 : Further strengthening of panels 1, 2 and 3 by gluing GFF stripes

In panels 1,2 and 3, further to the reinforcing bars, glass fibre fabric (GFF) stripes were glued to the joints where tension conducted to the separation of timber elements during previous testing. This was done on both faces, after the above-mentioned slot had been filled with epoxy adhesive and this left to cure.

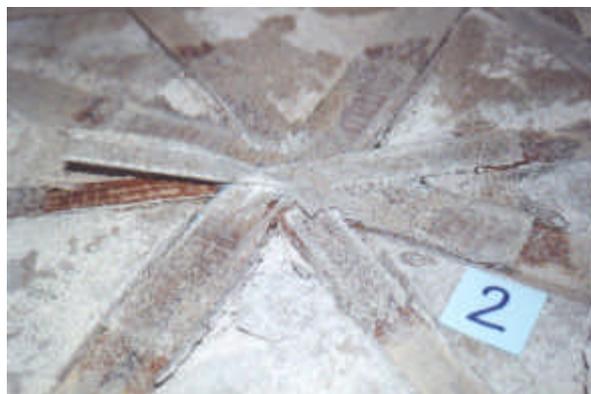
In panels 1, 2 and 3, which joints were also strengthened with GFF stripes glued to timber, the ends of GF fabric peeled of the timber by delamination of glue line near the end of testing (figure 9).

Figure 9 : GFF delamination in strengthened panels 1, 2 and 3 after test (typical failure)
