Construction Techniques and Materials of the 19th Century Military Buildings of İstanbul

A. Çiftçi

Yıldız Technical University, Faculty of Architecture, Department of Architecture, İstanbul, Turkey

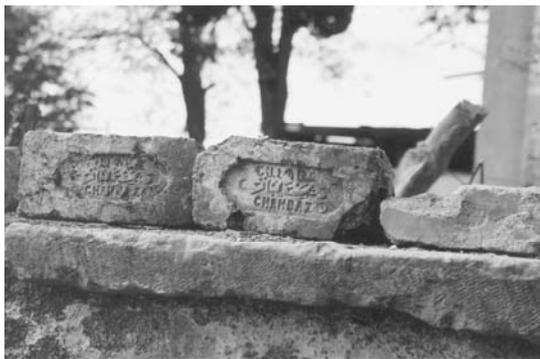
Figure 1 : Bricks of Topçu Police Station.

On the “Kırmızı Kışla” (Red Barracks), the Selimiye and Rami Barracks and the Çinili Police Station that were built in the first half of the 19th century the outer main walls are built in alternating technique with stone/brick material and the wall facades are not plastered. On these buildings the fill brick is 10-12 × 22-27 × 2-3.5 cm in size, and as for the other buildings constructed in the last quarter of the 19th century, the fill brick was thicker, 10-11 × 22-23 × 5.5-6.5 cm in dimension. At the Maçka Police Station dated to the last quarter of the 19th century, it has been shown that the inner side of the main wall of the basement floor is rough stone and the exterior side of it has been plastered over a brick weave. On some of the bricks there are some marks, text and forms that belong to the manufacturing firm. In one part of the Rami Barracks the stamp is dated “١٣٢٨” (1327/1909-1910), in the Topçu Police Station is the stamp “Chahbaz” (“Şahbaz”) is in Armenian, Ottoman and French, see Fig. 1, and at the Topkapı Palace Police Station (3) with fill bricks stamped “M. Pierre Salomon Briqeterie De Toutes Qualités,” “Büyükdere” has been shown to have used specially curve cut corner bricks.

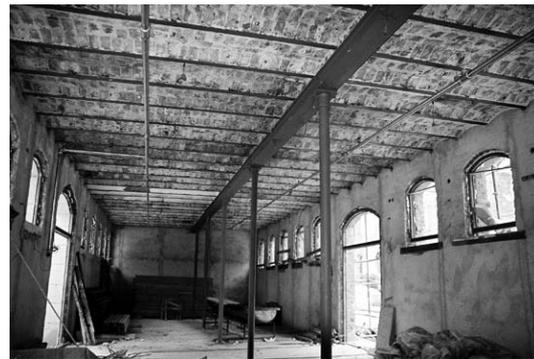
Figure 2 : “I” profile beams used in the jack arches.

In the Pazarbaşı Police Station built in the last quarter of the 19th century, the Zeytinburnu Hospital and the “Mekteb-i Tıbbiye-i Şahane” (Imperial School of Medicine) applied jack arches. The parts of the sections of the “I” profile beams used in the jack arches ranges between 5.5-9.5 × 16.5-22.3 cm, see Fig. 2. On the beams used in the Imperial Medical School there is the “Burbach 22 NP” mark. In the period when the Selimiye Barracks were first built wooden beams were used but in the second half of the 19th century they were renewed as jack arches.

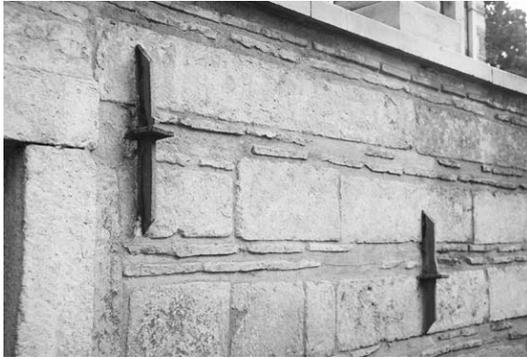
Photo 3: Metal ties of Çinili Police Station

At the level of the floorings of the buildings, at the points where the partition walls and the main walls meet, and at the corners of the buildings metal ties have been used as fasteners. The length of these elements where they can be measured ranges between 58 and 60 cm, see Fig. 3.

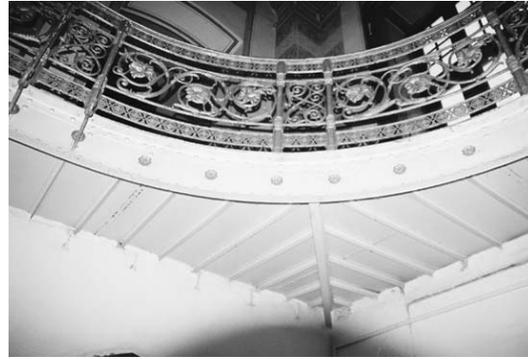
Photo 4: Metal staircase gallery of the Imperial Medical School

The metal ties on the façade of the water depots at the Zeytinburnu Factory and Yıldız Palace Police Station (1) which are 154 and 190 cm in length are among the longest seen. The staircases that provide access between floors were masonry or wood up to the last quarter of the 19th century. The large staircase in the entrance hall of the Imperial Medical School whose construction began at the end of the 19th century and the staircases between the floors are of metal construction, see Fig. 4.

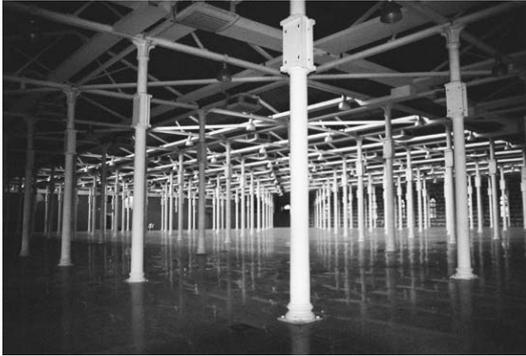
Figure 5 : Cast iron columns of Fez Factory.

In the military depots at Gülhane and in the Zeytinburnu Factory wooden poles carry the roof. It was shown that the sections of wooden spars are 20×35 cm, 24×24 cm, 26×27 cm and 36×3 cm. As for the roof of the “Feshane” (Imperial Fez Factory) textile salon 274 cast iron columns were imported from Belgium’s “Fokkeril” Company (Batur 1994) and were marked “Providence Marchienne Belgique” and were 25 cm in diameter, see Fig. 5. The body of the columns in the entrance corridor of the building was fluted. At the Zeytinburnu Factory metal columns 21 cm in diameter were used as carriers. The wooden truss of the military depots at Gülhane and Küçükalyı and the buildings of the Zeytinburnu Factory and the metal truss roofing systems of the Zeytinburnu Factory and the Imperial Medical School can be seen still today, see Fig. 6.

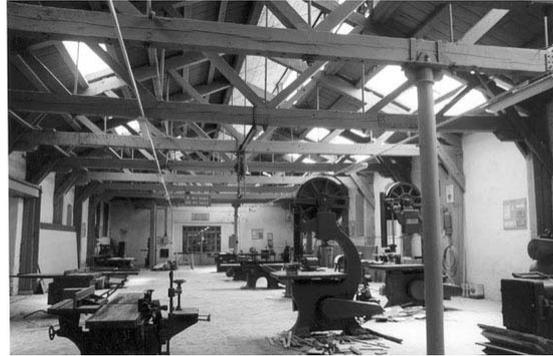
Figure 6 : Cast iron columns and wooden truss roofing system of the Zeytinburnu Factory.

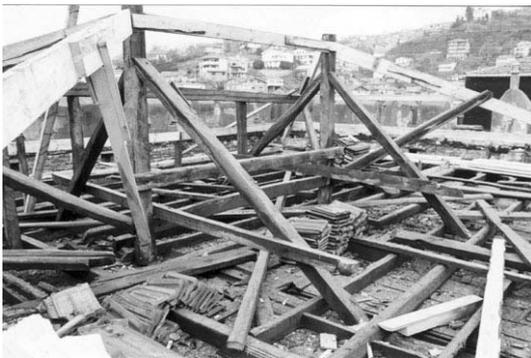
Figure 7 : Roof of the Topçu Police Station.

At the roofs, tiles were used as the cladding material. It has been determined that some part of the tiles was imported from Marseille and Thessalonica and there are figures and marks that have the date and manufacturer on them. For example the roof of “Taşkışla” has been covered with tiles imported from five separate companies carrying the marks of “Arnaud Etienne Cie 1890 Marseille St Henri,” “Saccoman Frères St Henri Marseille,” “Guichard Carvin & Cie Seon St Andre Marseille,” “Guichard & Pierre Frères Seon St Henry Marseille”, and “Fratelli Allatini Salonicco”. On the roof of the Topçu Police Station tiles marked “Marseille 1890” have been found as well, see Fig. 7. It was proven that the roof on the Topkapı Palace Police Station (3) was covered with tiles belonging to two separate firms “Grande Ecaille Pour Toiture, Brevetes S.G.D.G. St. Henry-Marseille, Roux-Frères” and “Fratelli Allatini Salonicco”, see Fig. 8.

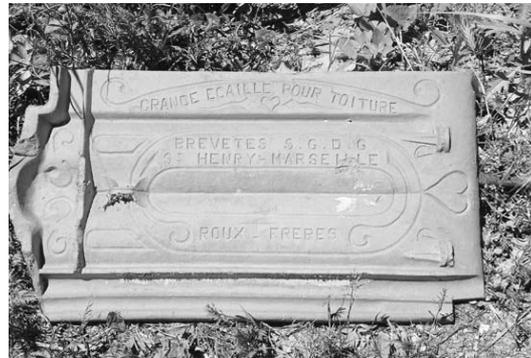
Figure 8 : Tile of Topkapı Palace Police Station.
