Making-safe Sydney's sandstone buildings within accepted conservation guidelines

J.D. Swann

*Jasper Swann Stonemasonry Pty Ltd, Sydney, Australia,
Masters of Heritage Conservation Program, Faculty of Architecture, Design & Planning,
University of Sydney, Australia*

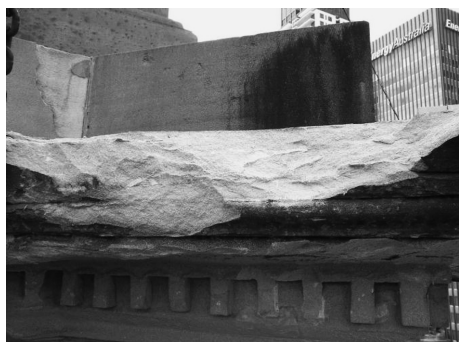
Figure 2. A portion of coping nosing 'loose and easily removed'. (Source: www.sydneymedia.com.au/html/3246).

Stone that is 'loose and easily removed' is not difficult to identify. Figure 2 shows an example where the nosing of a parapet coping has clearly suffered from the effects of weathering. A portion of the stone has become partially separated from its substrate, which itself exhibits the effects of weathering within what had formerly been the crack betraying its separation. This is

readily removed by hand. Stone that has 'the potential to fall', on the other hand, is less easily identified, and it is here that the contractor somewhat predictably deems that removal of more material rather than less will provide him with a greater security of cover against liability in the task for which he is engaged.
