Behaviors of Historic Masonry Walls Retrofitted with GFRP under Axial Load

Abstract The purpose of this research is to determine the mechanical properties of historic masonry walls retrofitted with Glass Fiber Reinforced Polymer (GFRP) under axial load through experimental method. Four ancient masonry wall specimens were tested under axial load acted at the top surface. Two wall specimens were served as reference without retrofitting. The third wall was retrofitted with GFRP on full surface before loading. The fourth wall was strengthened with three GFRP strips before loading. The behaviors of historic masonry walls in Thailand were particular because of their special bond manner and dimension. The tested results demonstrated that the bearing capacity of historic masonry walls was distinctly improved after GFRP strengthening.

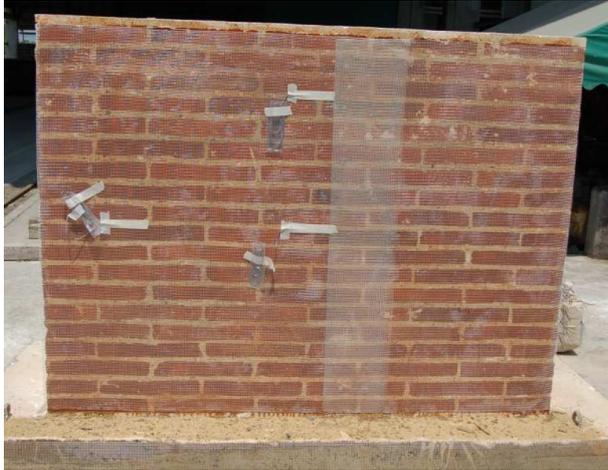
(a) Specimen N-3

Four walls are in the same dimension, as shown in Fig.2. The thickness of the walls is 600 mm, as the ancient wall in Ayutthaya, Thailand. Specimen N-1 and N-2 are used as reference wall without any retrofitting. Specimen N-3 was fully reinforced with GFRP sheets on only one face of the wall. Specimen N-4 was reinforced with three GFRP stripes of 20cm width at spacing of 35cm on center on only one face of the wall. Fig.3 shows the different retrofit scheme.

Figure 3: Different retrofit scheme

For Specimen N-3, GFRP sheet was pasted on the full surface. When the load reached 71.42 ton, 48% of the ultimate load, vertical crack appeared on one side face with length of 48.5 cm. At the load of 79.62 ton, vertical cracks also appeared on the other side face with 58 cm long from the top edge. At the same time, some vertical cracks opened on the face of the wall without GFRP sheets. However, no cracks appeared on the face with GFRP sheets until wall failure. Finally, the wall was fail at the load of 148 ton due to cracks on the side face of more than 2mm wide. It is observed that the color of some local parts in GRFP sheets changed, and pop cracking voice can be heard clearly. This can be taken as the peeling-off of GFRP from wall surface. Thanks to the good quality of paste work, only few local peeling-off happened.
