Compressive Strengthening of Damaged Historic Masonry Walls Repaired with GFRP

JING Meng^{1,a}, RAONGJANT Weresak^{1,b} and
KERDMONGKON Ratchaneewan^{1,c}

¹School of Civil Engineering, Rajamangala University of Technology, Thanyaburi, Thailand

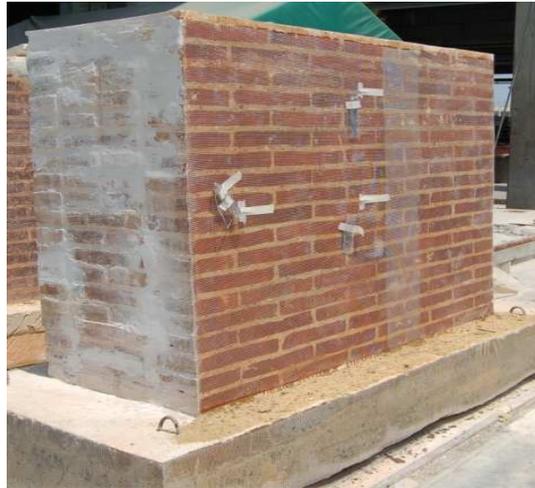
Figure 1: Sizes of five specimens

Five wall specimens were constructed in the stretcher as English bond with a mortar joint of 10 mm thickness. The nominal dimensions of these walls are 1200 mm height, 1500 mm length, and 630 mm width (Fig.1)

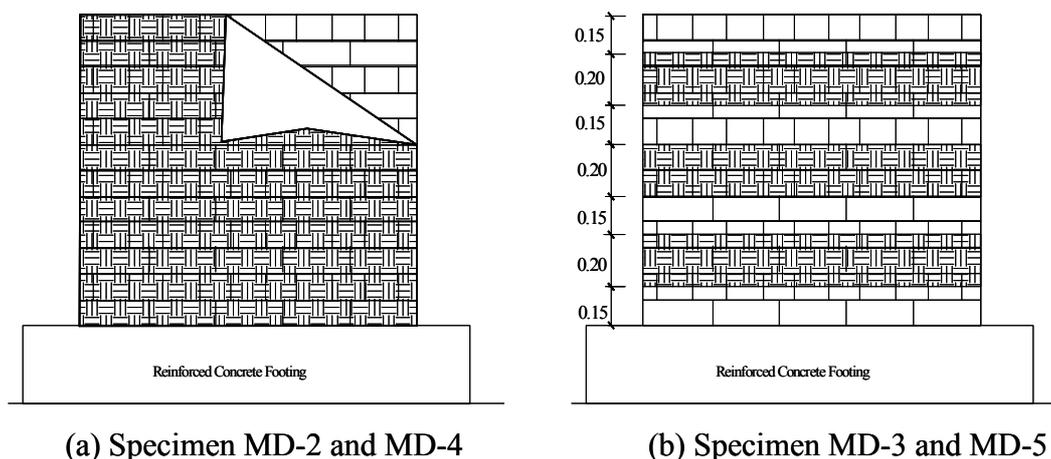
Figure 2: Retrofitting schemes of specimens

Repairing Method and Retrofitting schemes Specimen MD-1 was un-reinforced as reference wall. Other four specimens were retrofitted in different modes before or after defined damaged (shown in Fig.2). Specimen MD-2 was fully reinforced with GFRP sheets on only one face of the wall before loading. Specimen MD-3 was reinforced with three GFRP stripes of 20cm width at spacing of 35cm on center on only one face of the wall before loading.

For specimen MD-4 and MD-5, at first step they were subjected to vertical axial load applied on the top surface until its ultimate compressive strength of 85 ton and 45 ton, respectively. Then GFRP repair scheme was applied as following. All loose particles were removed and the wall was readjusted to vertical position. The missing parts of the bricks as well as the mortar joints were patched with new mortar after being wetted and allowed to dry. All cracks were patched using epoxy. Quick-setting hydro cement, dried with a heat gun, was used to stop epoxy leaks from the surface. Later, the cement and epoxy patches were removed from the surface using hammers and grinder. After these processes, the cracks were closed tightly by the epoxy grout. Then, specimen MD-4 and MD-5 were

strengthened with GFRP sheets in the same modes as specimen MD-2 and MD-3, respectively. The GFRP repair system was left to cure for at least one week.

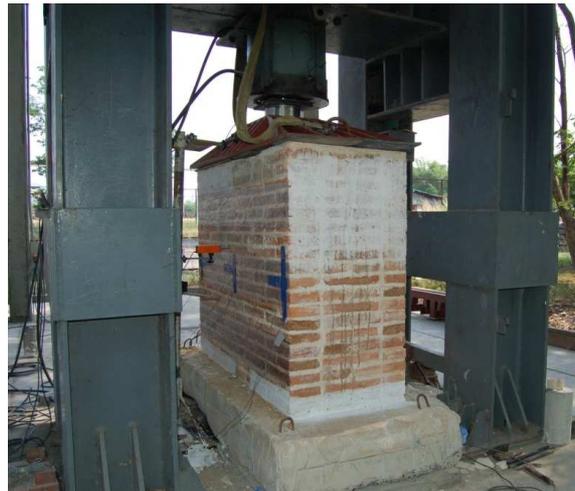
Figure 3: Test set-up and instruments

The vertical axial load was transferred through steel distribution beam to the top of the wall uniformly and increased gradually until specimen failure. Four LDVT (Linear Variable Differential Transformer) were erected at top surface and mid-height of the wall to control in-plane vertical and out-plane lateral displacements. Six strain gauges were pasted on the face of the brick and the GFRP sheets at mid-height to monitor the strain development, as shown in Fig. 3.

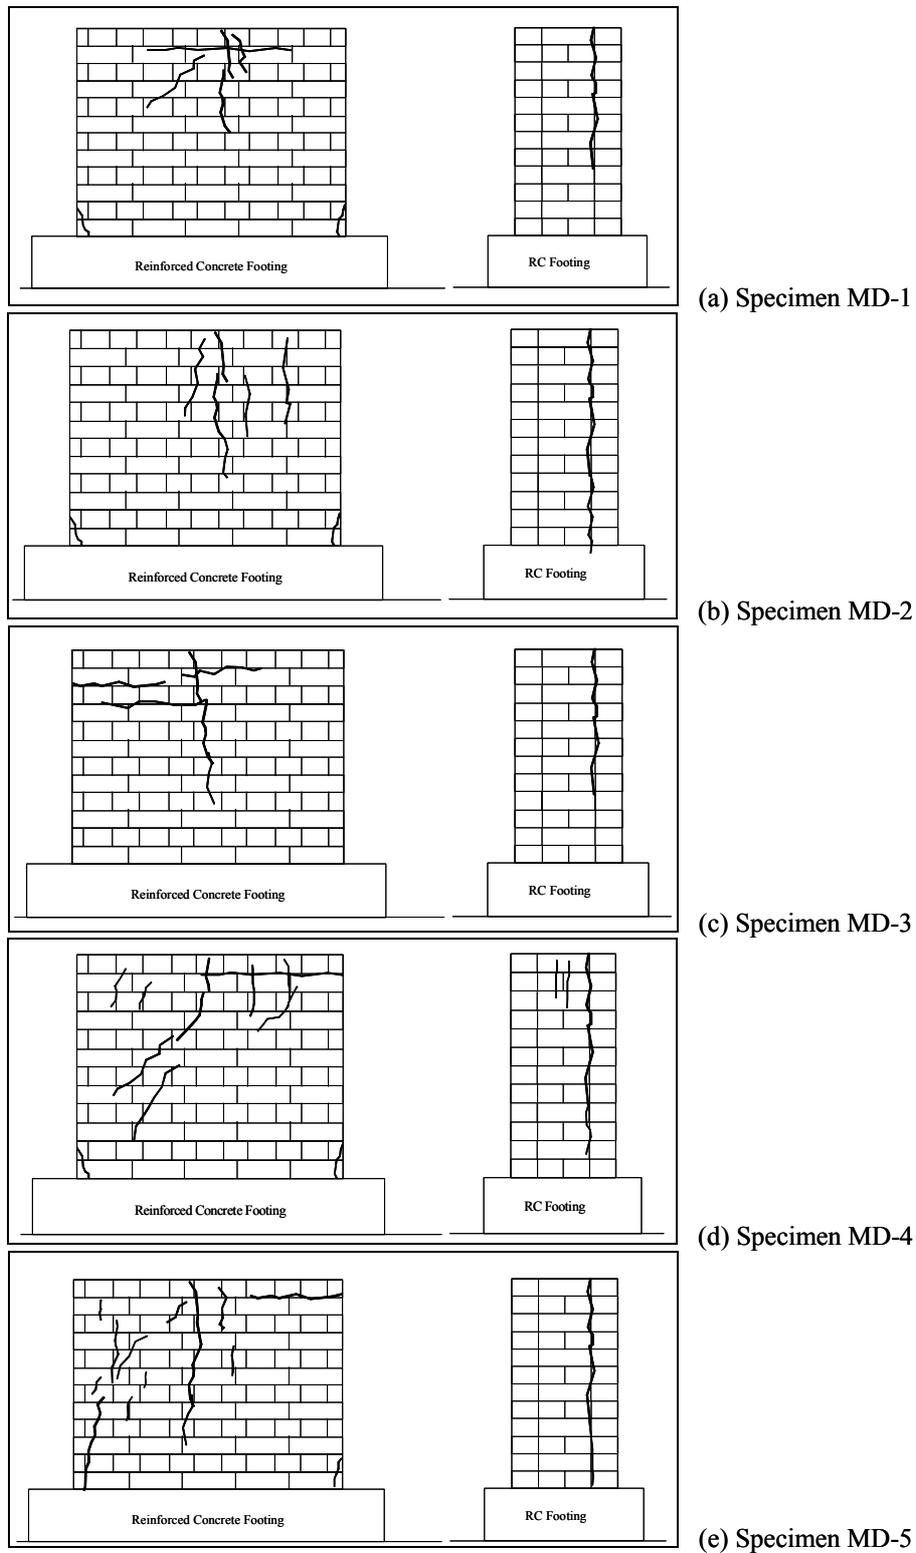
Figure 4: Crack pattern of five walls

Un-retrofitted Wall MD-1. When the load of 48.96 ton was applied and the vertical deformation 2.72 mm, cracks began to appear at the vertical mortar joints at the top center of wall length. When the wall was loaded to 60 ton, the main crack is extended to 17 cm long and 0.20 mm wide. The vertical displacement of 3.28 mm was measured. At vertical displacement 4.06 mm, the measured load was 70 ton. Crack appeared in the first horizontal mortar joint from the top, extend from center of the wall length to left and right of about 20 cm. At the ultimate load of 84.27 ton, horizontal crack developed to both side faces. At the same time, cracks up to 1.6 mm wide with 74 cm long and 0.3 mm with 37 cm long respectively throughout the vertical mortar joints at the side face were observed. The vertical displacement is 4.61 mm. The crack pattern of wall MD-1 is shown in Fig. 4 (a).

Retrofitted by Full GFRP before Damaged, Wall MD-2. At the load of 71.42 ton, vertical cracks appeared on one of the side face of the wall and extend about 48.5 cm long from the top. Vertical deformation of 3.90 mm was measured. At the load of 79.62 ton, vertical cracks initiated on the other side face, extend 58 cm long from the top. Some vertical cracks throughout several layer of mortar and bricks appeared only on the face of the wall without GFRP sheets. Vertical displacement was 4.7 mm. Due to the constraints effect of GFRP sheets, no cracks were observed on the face pasted with GFRP until wall failure. With the load increasing, the constraint roles of GFRP sheets delay the emergence of new cracks. Finally, compared with MD-1, the ultimate compressive strength of specimen MD-2 was improved at about 50% to 125 ton. Crack on the side face up to 2 mm was observed and vertical displacement 7.20 mm. The crack pattern is shown in Fig.4 (b).

Retrofitted by Three Strips GFRP before Damaged, Wall MD-3. When the load reached 113 ton, transverse strain began increased rapidly with the appearance of initial vertical and horizontal cracks at top center of the wall. With the load increasing, vertical crack developed downward through may layers, about 80 cm long. At the load of 120 ton, vertical cracks opened on both side face and more horizontal cracks initiated on the wall face. Finally, when compressive load reached its ultimate

value of 125 ton, the width of cracks on both side faces reached 2.00 mm, which denoted the failure of the wall. Nevertheless, on the wall face with GFRP strips, no crack appeared and no peel-off of GFRP is observed (Fig.4 (c)). Compared with MD-1, the ultimate compressive strength was improved 50%.

Damaged, Repaired and Retrofitted with Full GFRP, MD-4. After repaired with epoxy and pasted with GFRP, specimen MD-4 was retested using the same test setup and the vertical loading was increased gradually until specimen failure. At early loading stages, about 83.5% of its original ultimate strength before damage, some vertical cracks began to open at the top center on the wall face

without GFRP sheets. At the load of 77.05 ton, horizontal crack appeared also on the face in the mortar of top layer. At the load of 77 ton, vertical crack opened on one side face, 52.5 cm long and 0.7 mm wide. It was noticed that, all the cracks appeared at new positions which were different from the damaged cracks before repair. It revealed that a new pattern of cracks developed and that the old cracks did not open. The crack development is shown in Fig.4 (d). It was observed that at failure point, the cracks densely covered almost the whole wall face. However, no crack was observed on the face with GFRP sheets. It should also be noted that the compressive strength of the repaired wall even exceeded the strength of MD-1 and MD-2 to 129 ton.

Damaged, Repaired and Retrofitted with Three GFRP Strips, MD-5. Specimen MD-5 was also retested after repaired under vertical loading until failure. When the load reached 60% of original ultimate strength of wall MD-3, initial cracks appeared at top center on the wall face without GFRP strips. Vertical crack on the side face was observed at load of 42 ton and 59.4 ton, respectively. It is same to specimen MD-4 that, a new crack pattern developed. With the increasing of load, more new cracks appeared and the initial cracks opened downward continuously. At the load of 101 ton, cracks emerged on the wall face between top and middle GFRP strips and opened to the bricks under top GFRP strips. When the load reached 124 ton, these cracks developed downward through the middle strips to the top edge of the bottom strips. Finally, when peak load of 125 ton was reached, no crack is observed under bottom GFRP strips and no GFRP sheets peel-off happened (Fig.4 (e)).

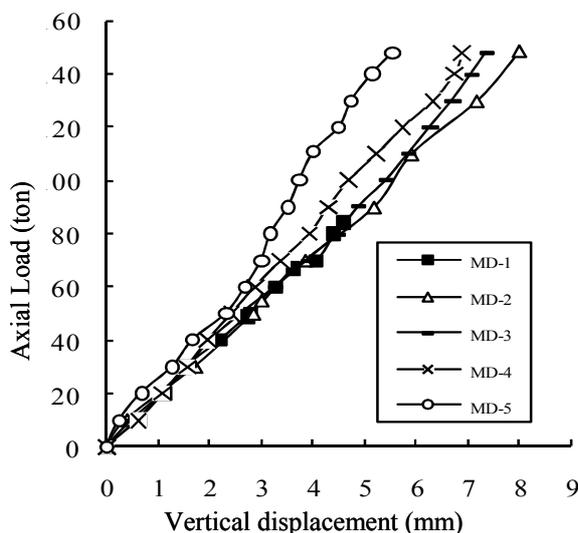
Figure 5: Load-vertical displacement response Figure 6: Strain developments in GFRP sheets and wall surface

The load-vertical displacement responses of five specimen walls are described in Fig.5. The vertical displacements of all five test walls show linear direct proportion with axial loading increasing, which means that GFRP retrofitting don't change the elastic properties of masonry walls. Ultimate displacements of specimen MD-4 and MD-5 are obviously smaller than that of specimen MD-2 and MD-3, which indicates that the stiffness or the elastic modulus of MD-4 and MD-5 were increased due to repairing of epoxy resin.
