## SHAKE TABLE TESTS ON MASONRY WALLS STRENGTHENED WITH MORTAR-BASED COMPOSITES

**Abstract.** *The paper presents the preliminary results of a shake table test carried out on a tuff masonry, natural scale, U-shaped assemblage (façade adjacent to transverse walls). The specimen has been subjected to scaled natural accelerograms with increasing intensity, inducing the detachment of the façade from the transverse walls and the activation of its rocking motion up to the out-of-plane overturning. The structure has been then repaired and strengthened with externally bonded reinforcement systems (SRG) comprising steel and slate textiles embedded in a hydraulic lime mortar matrix. Test results before and after the strengthening are compared in order to investigate the effectiveness of the SRG reinforcement in improving the seismic capacity of the structure, in the perspective of applying mortar-based composites for the seismic retrofitting of historic structures and the safeguarding of cultural heritage.*

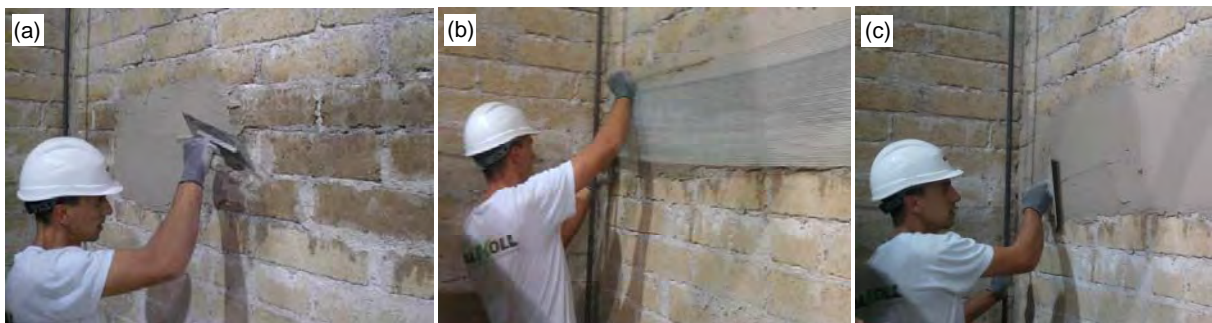
Figure 5. Installation of the mortar-based reinforcement: laying of the first layer of hydraulic lime mortar on the consolidated substrate (a), application of the steel textile (b), and laying of the covering mortar layer (c).

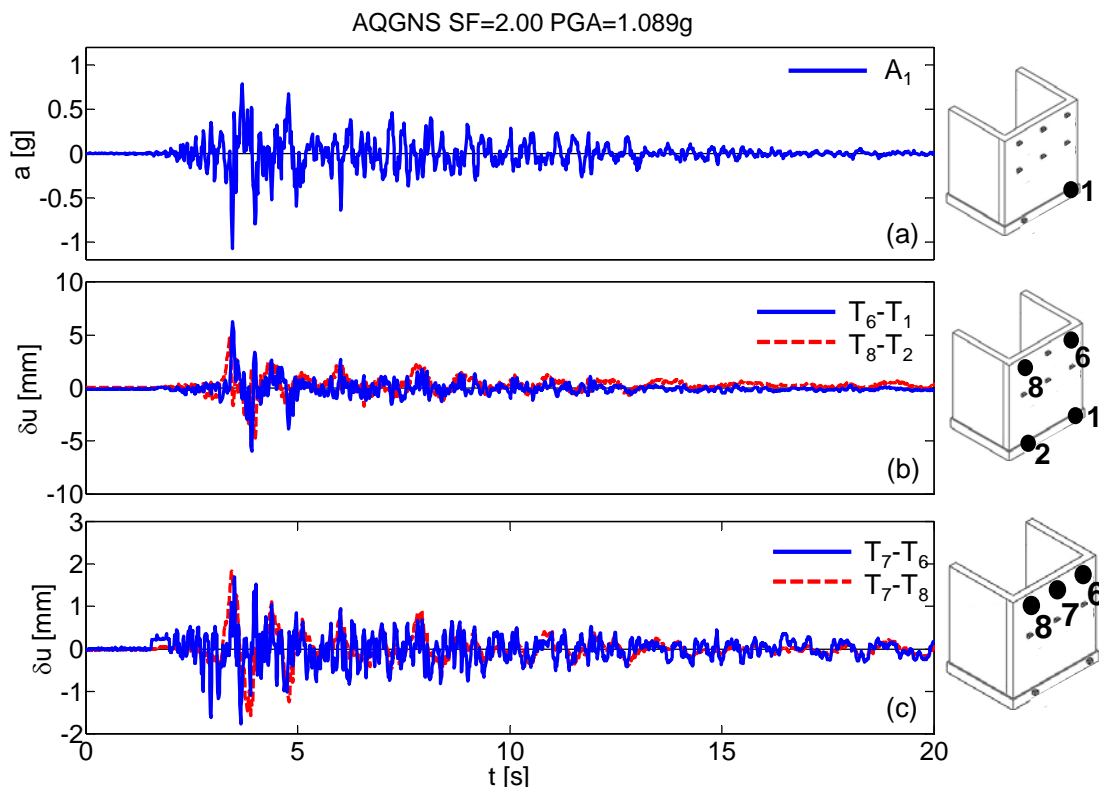
Figure 8. Time histories recorded during tests under AQGNS, SF=2.00 signal: base acceleration (a); horizontal bending ( $T_6-T_1$  and  $T_8-T_2$ , b); vertical bending ( $T_7-T_6$  and  $T_7-T_8$ , c).

The results derived for the instruments installed on the specimen (Figure 1) are represented in terms of vertical and horizontal bending, the former being expressed as the relative displacement ( $\delta u$ ) between two measurement points vertical aligned (e.g., T<sub>6</sub>-T<sub>1</sub> or T<sub>8</sub>-T<sub>2</sub>), and the latter being the relative displacement between two measurement points horizontally aligned (e.g., T<sub>7</sub>-T<sub>6</sub> or T<sub>7</sub>-T<sub>8</sub>). Finally, the record of the seismic input assigned to the specimen is provided by the time histories acquired in the measurement points 1 and 2. Figure 8 shows the response to 2009 L'Aquila earthquake (M=6.3), amplified with a scale factor of 2.0, corresponding to a peak ground acceleration of 1.089g (Figure 8a). The horizontal bending is induced by a relative displacement of about 70mm (over a height of about 3m) (Figure 8b), while the vertical bending is related to a relative displacement of the centre of the façade of nearly 2mm with respect to the corners (Figure 8c). The two time histories plotted in both these graphs are in good agreement, thus indicating that the behaviour of the specimen is practically symmetric. Moreover, despite the high intensity of the input, the residual displacement is negligible in all cases.

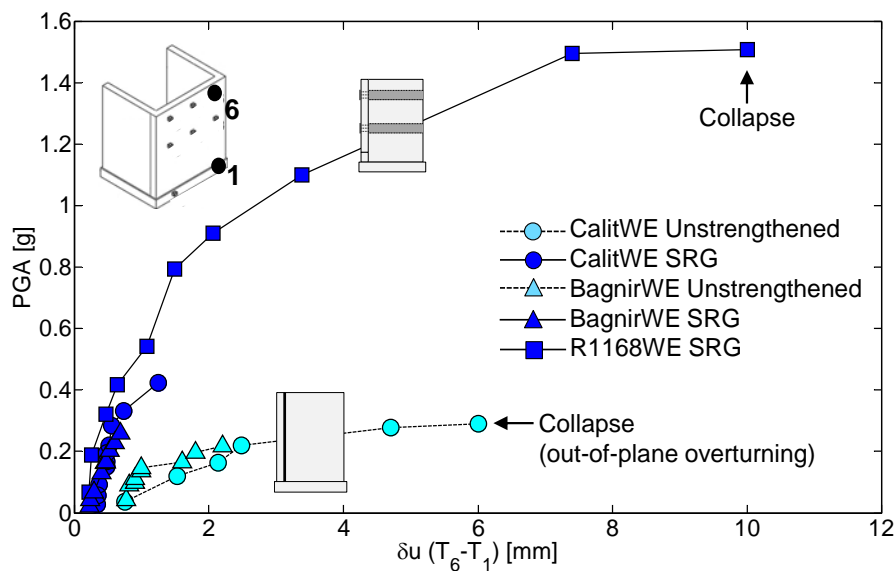
Figure 9. Seismic capacity of unstrengthened and retrofitted specimens.

The behaviour before and after strengthening during the entire test series is shown in Figure 9, in which the recorded PGA and the horizontal bending are on the y-axis and on the x-axis, respectively. The retrofitted specimen, as already said, collapsed after R1169WE record at 1.5g PGA, while the out-of-plane overturning of the unreinforced specimen occurred under CalitWE record at 0.29g PGA (1980 Irpinia earthquake, SF=1.75). From this moment on, tests were carried out on the detached wall behaving approximately as a rigid body undergoing a rocking motion.

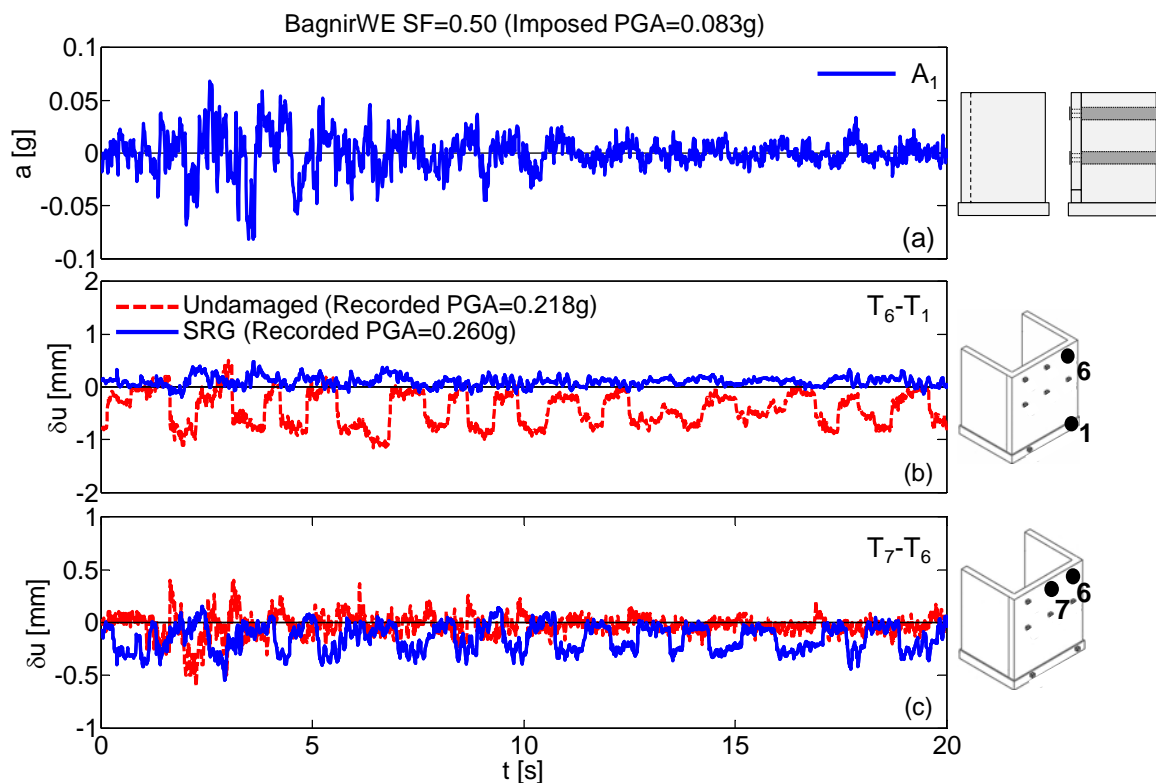
Figure 11. Time histories recorded during tests under BagnirWE, SF=0.50 signal on undamaged and retrofitted specimens: base acceleration (a); horizontal bending ( $T_6-T_1$ , b); vertical bending ( $T_7-T_6$ , c).

The seismic response of the specimen can be studied with reference to a total of four different configurations (Figure 10), such as undamaged (unreinforced, before crack development, a), damaged (façade detached from the side walls, before collapse, b), rocking (façade overturned out-of-plane, and behaving as a rigid body under rocking motion, c), and, finally, SRG (retrofitted with mortar-based composites, d). Figures 11 and 12 show the time histories recorded during the same input (same signal with same scale factor) on different configurations to allow comparisons. Under BagnirWE record with SF=0.50 (PGA=0.083g, Figure 11a), the response of the undamaged and of the retrofitted specimens are similar, especially in terms of vertical bending (Figure 11b), while the SRG reinforcements entails smaller relative displacements between points horizontally aligned (Figure 11c), which is related to the horizontal bending. Conversely, the comparison under CalitWE SF=1.50 signal (PGA=0.271g, Figure 12a) shows that occurrence of damage entails much larger displacements for both horizontal and vertical bending (Figures 12b and 12c), as well as a slower damping of oscillations.

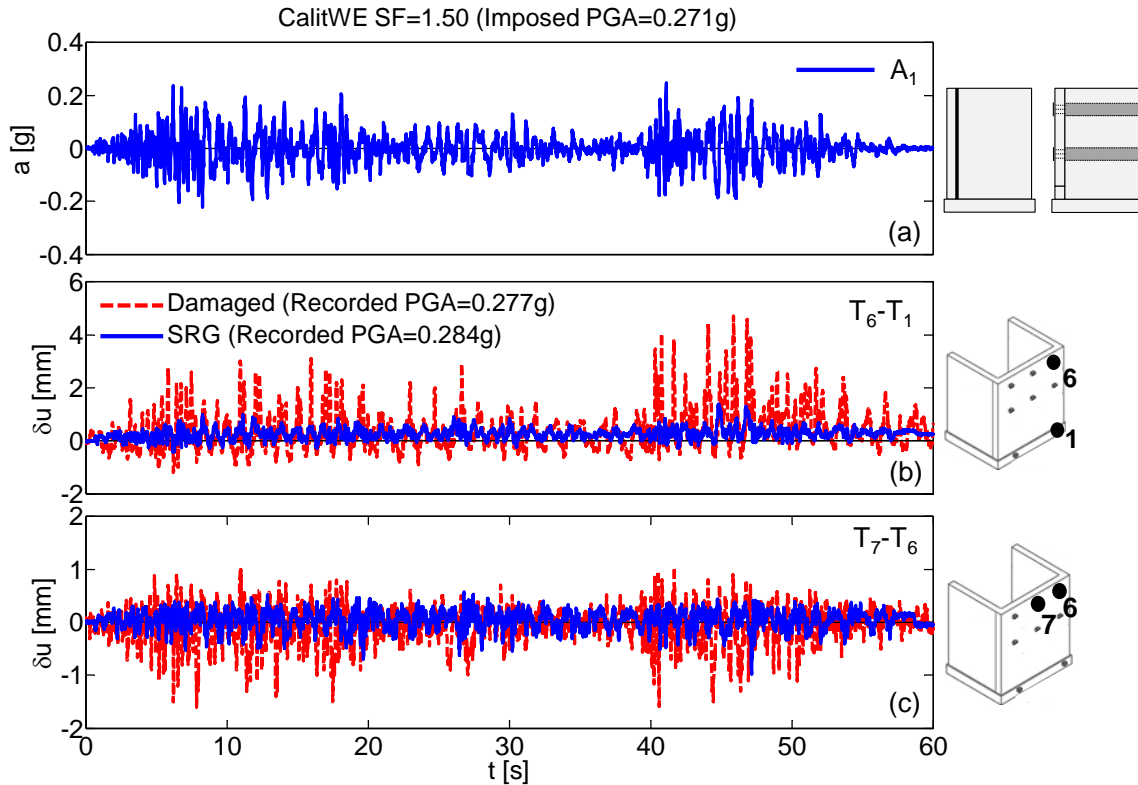
Figure 12. Time histories recorded during tests under CalitWE, SF=1.50 signal on damaged and retrofitted specimens: base acceleration (a); horizontal bending ( $T_6-T_1$ , b); vertical bending ( $T_7-T_6$ , c).

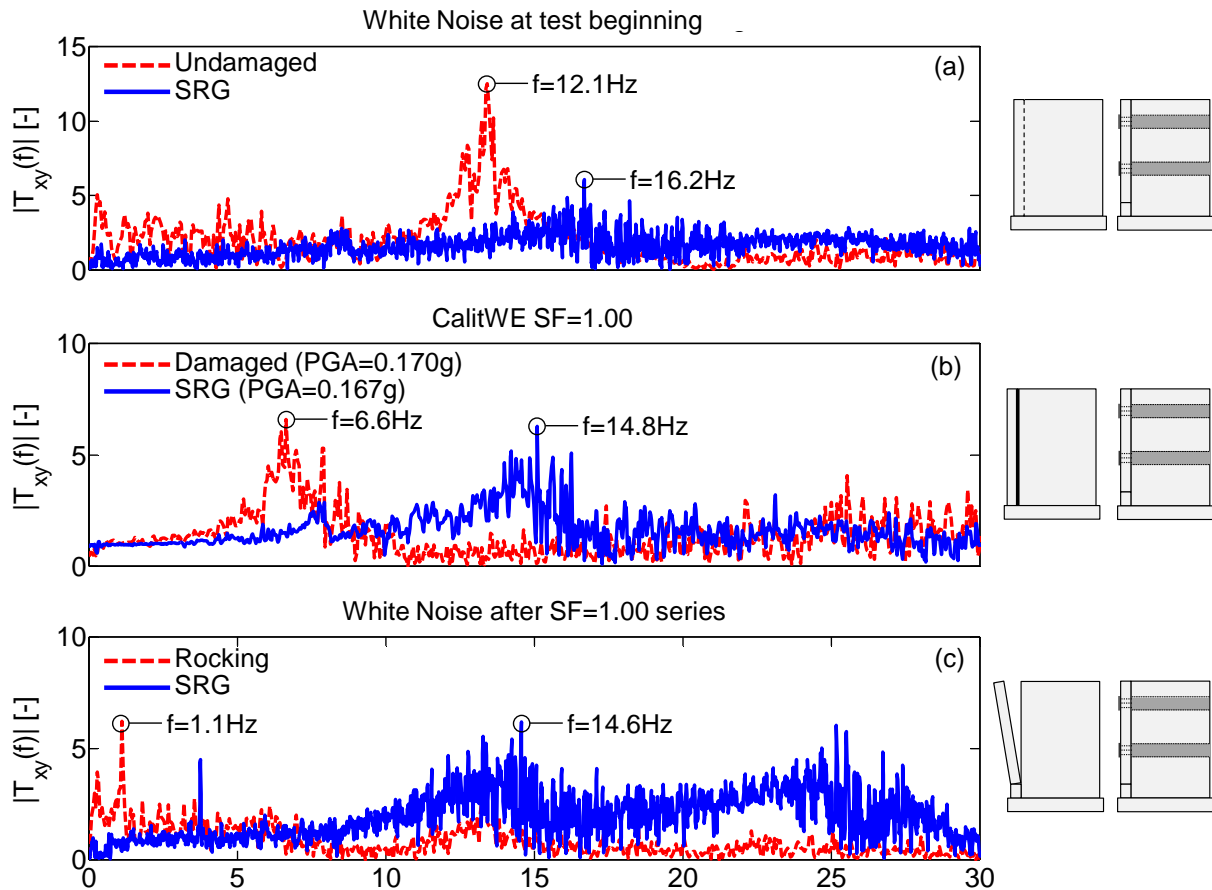
Figure 13. Fundamental frequencies of undamaged (a), damaged (b), rocking (c) and SRG (a,b,c) specimen configurations.

The four configurations are compared in Figure 13 in terms of dynamic properties. The fundamental frequency of the specimen is derived on the base of the transfer function ( $T_{xy}$ ), which represents the filter effect of the structure by comparing the input signal ( $x$ ) and the output signal ( $y$ ).  $T_{xy}(f)$  is defined as the ratio between the cross power spectral density ( $P_{yx}$ ) of  $x$  and  $y$  and the power spectral density ( $P_{xx}$ ) of  $x$ . It is a complex function depending on the frequency  $f$ , and its modulus is represented on the y-axis of the graphs. The fundamental frequency of the undamaged specimen and the retrofitted one are 12.1Hz and 16.2Hz, respectively, as detected before the beginning of the test series, assigning a white noise with PGA=0.01g to the shake table (Figure 13a). The occurrence of damage causes a significant stiffness reduction, as indicated by the decrease of the frequency to 6.6Hz. The application of inputs with equivalent intensity up to CalitWE with SF=1.0 caused a much smaller deterioration on the retrofitted specimen, displaying a frequency of 14.8Hz (Figure 13b). Finally, the frequency of the rocking façade is one order of magnitude lower than that of the reinforced wall (1.1Hz versus 14.6Hz, Figure 13c).
