**INFLUENCE OF THE DIVINE PROPORTION IN THE SEISMIC  
BEHAVIOR OF RELIGIOUS HISTORICAL BUILDINGS  
LOCATED IN MORELIA CITY, MEXICO**

***Abstract.** In this paper the structural behavior of the naves of thirteen religious structures built between the sixteenth and eighteenth centuries on firm soil of the historical downtown of the city of Morelia, which were modified geometrically following the Golden Ratio is studied. The naves were characterized by macroelements in the transversal and longitudinal sections of the building which were analyzed using eleven seismic records and nonlinear analysis. In all cases the seismic records were scaled for the maximum ground acceleration expected on site for return a period of 475 years. Finally damage degrees and damage index for each case were established and the influence of the Golden ratio or Divine Proportion over the original structures was analyzed.*

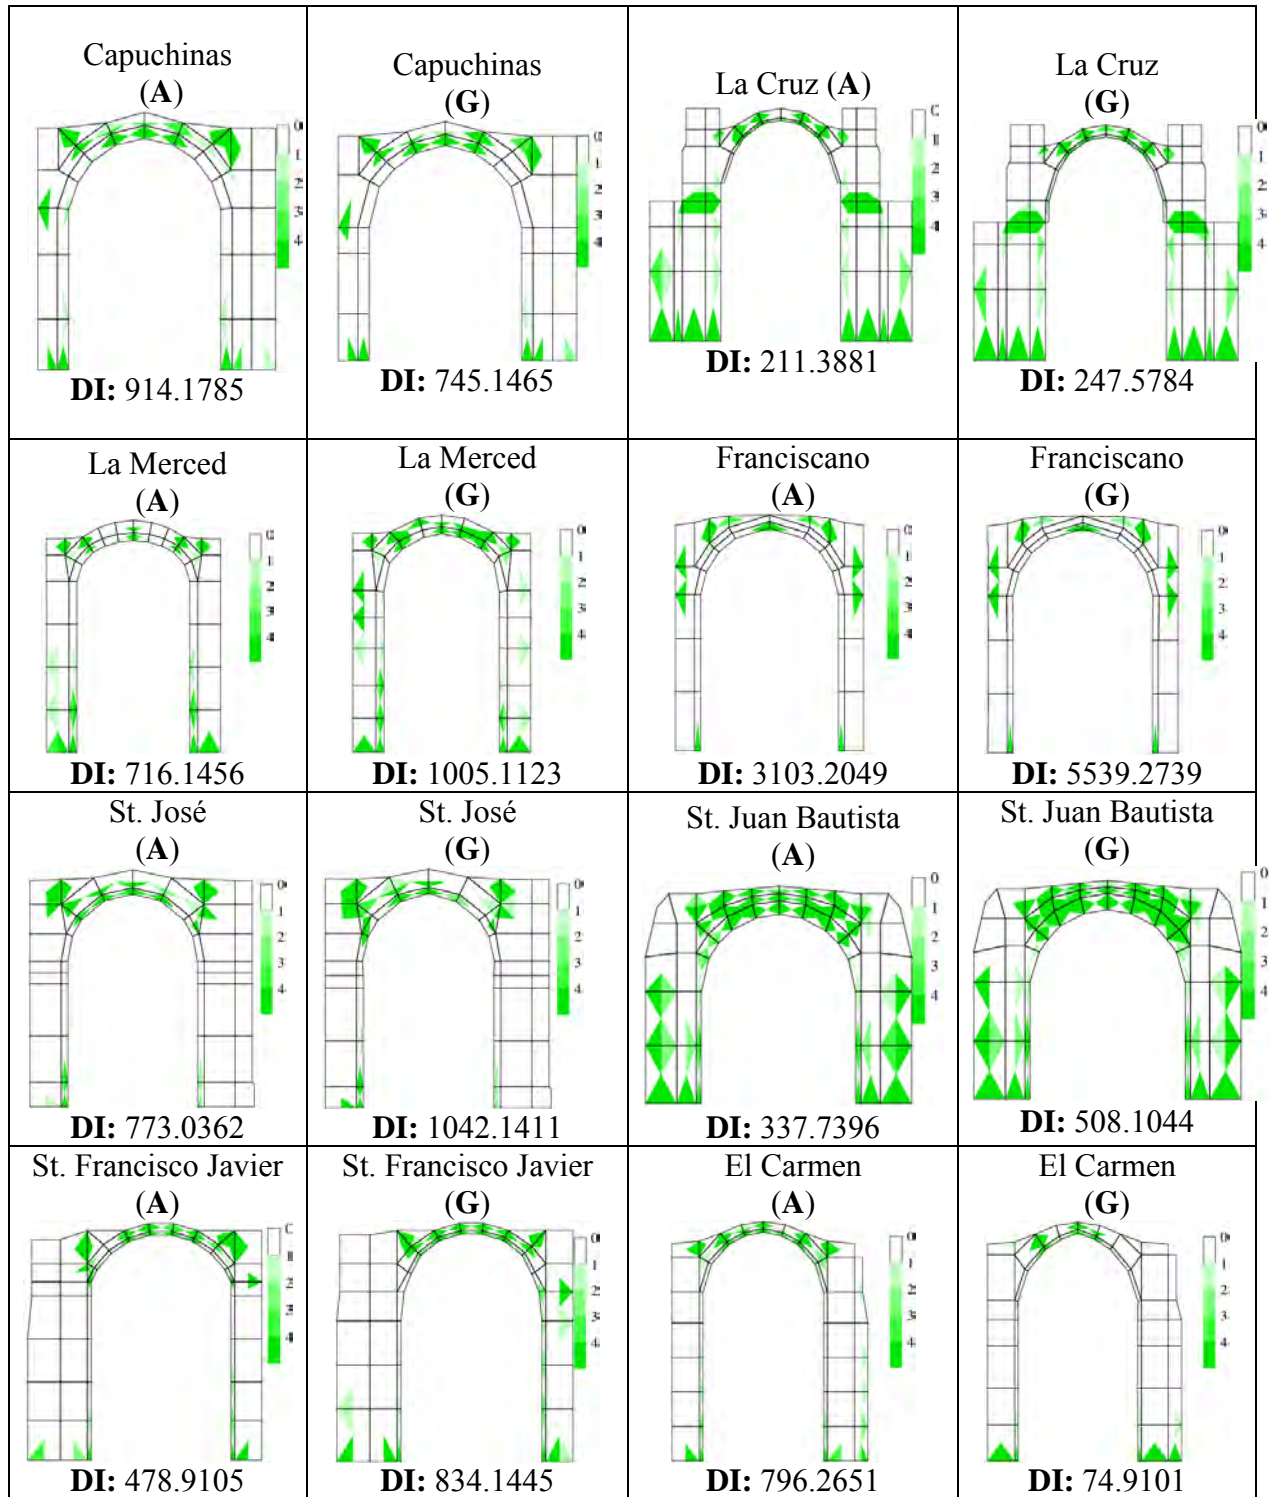
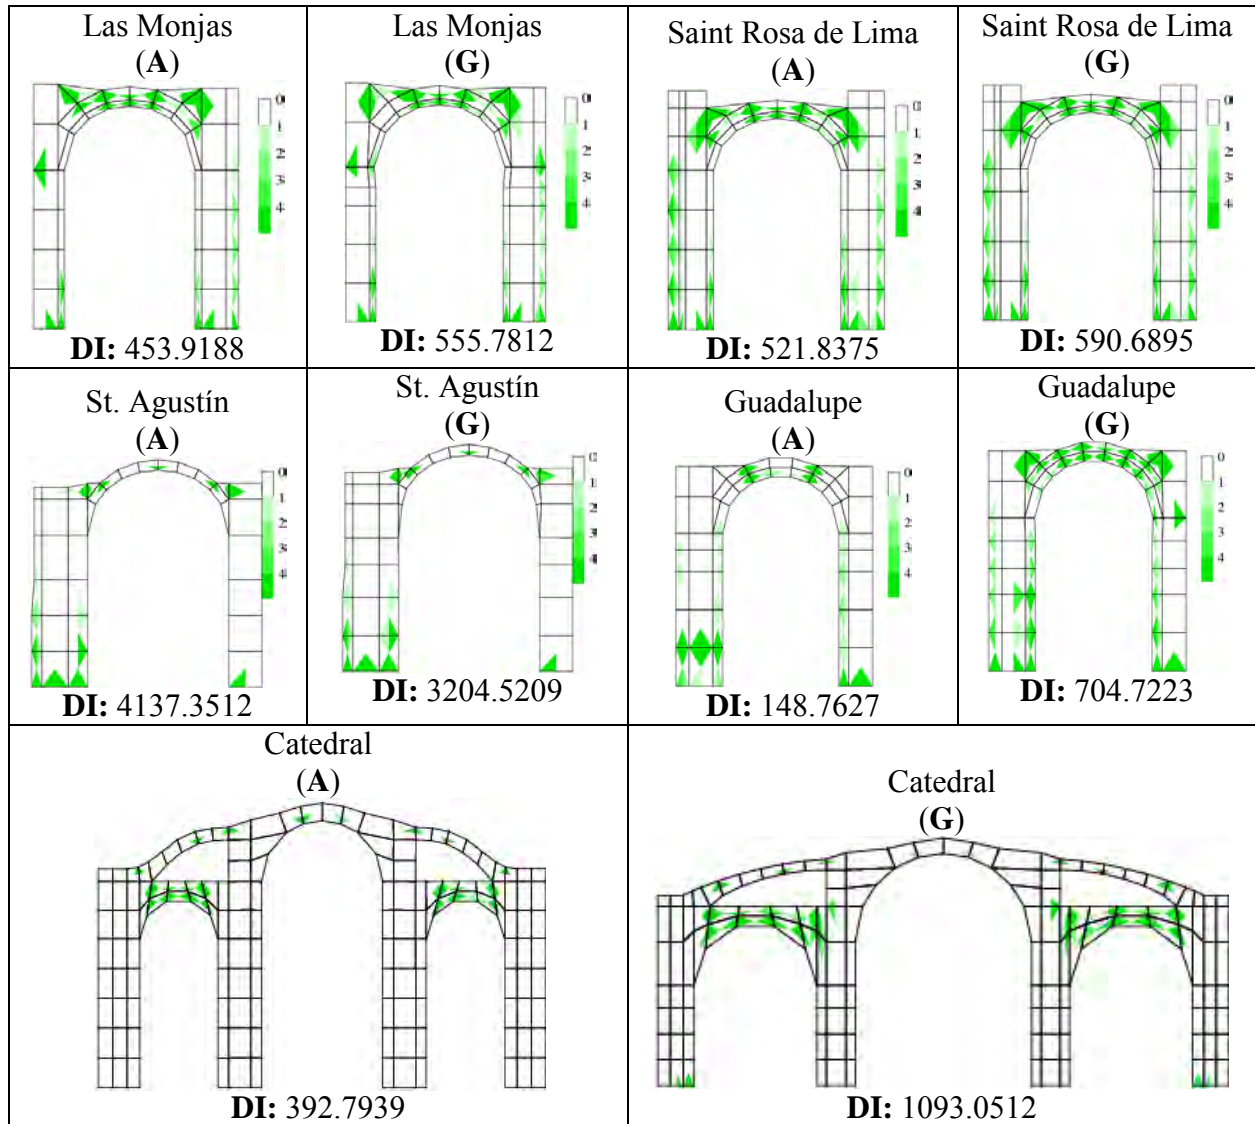
Figure 6: Comparison of damage degrees in transversal macroelements.

Figure 6: Comparison of damage degrees in transversal macroelements (Continuation).

Figures 6 and 7 shows the damage degrees and damage indexes obtained for the actual (**A**) and modified macroelements following the golden ratio (**G**). The presented results correspond to the maximum earthquake values for each structure. The damage indexes are presented in kJ and relative to the damage degrees zero means no damage and number four means extensive damage.

Figures 6 and 7 shows the degree of damage caused by tension stresses and it can be seen that the majority of macroelements in study suffer damage mainly in the regions of the arches and vaults, as well as the supports of the walls and buttresses. It is important to mention that seismic records that infringed major damages to these macroelements were the July 15th 1996 and the June 15th 1999, with epicenters located in Chilpancingo, Guerrero and Puebla City respectively.

- The above results shows that the divine proportion is not satisfactory for the major part of the studied transverse macroelements, since that the 76.9% of the modified sections have a damage index greater than that obtained for the sections with actual geometry.

- Comparing the macro elements of actual cross sections against the modified ones with the golden ratio it can be seen little differences between damage degrees, except for the churches of St. Agustin and the Franciscan St. Bonaventure where the index rise dramatically, which is mainly attributable to the reduced thickness of the vault.

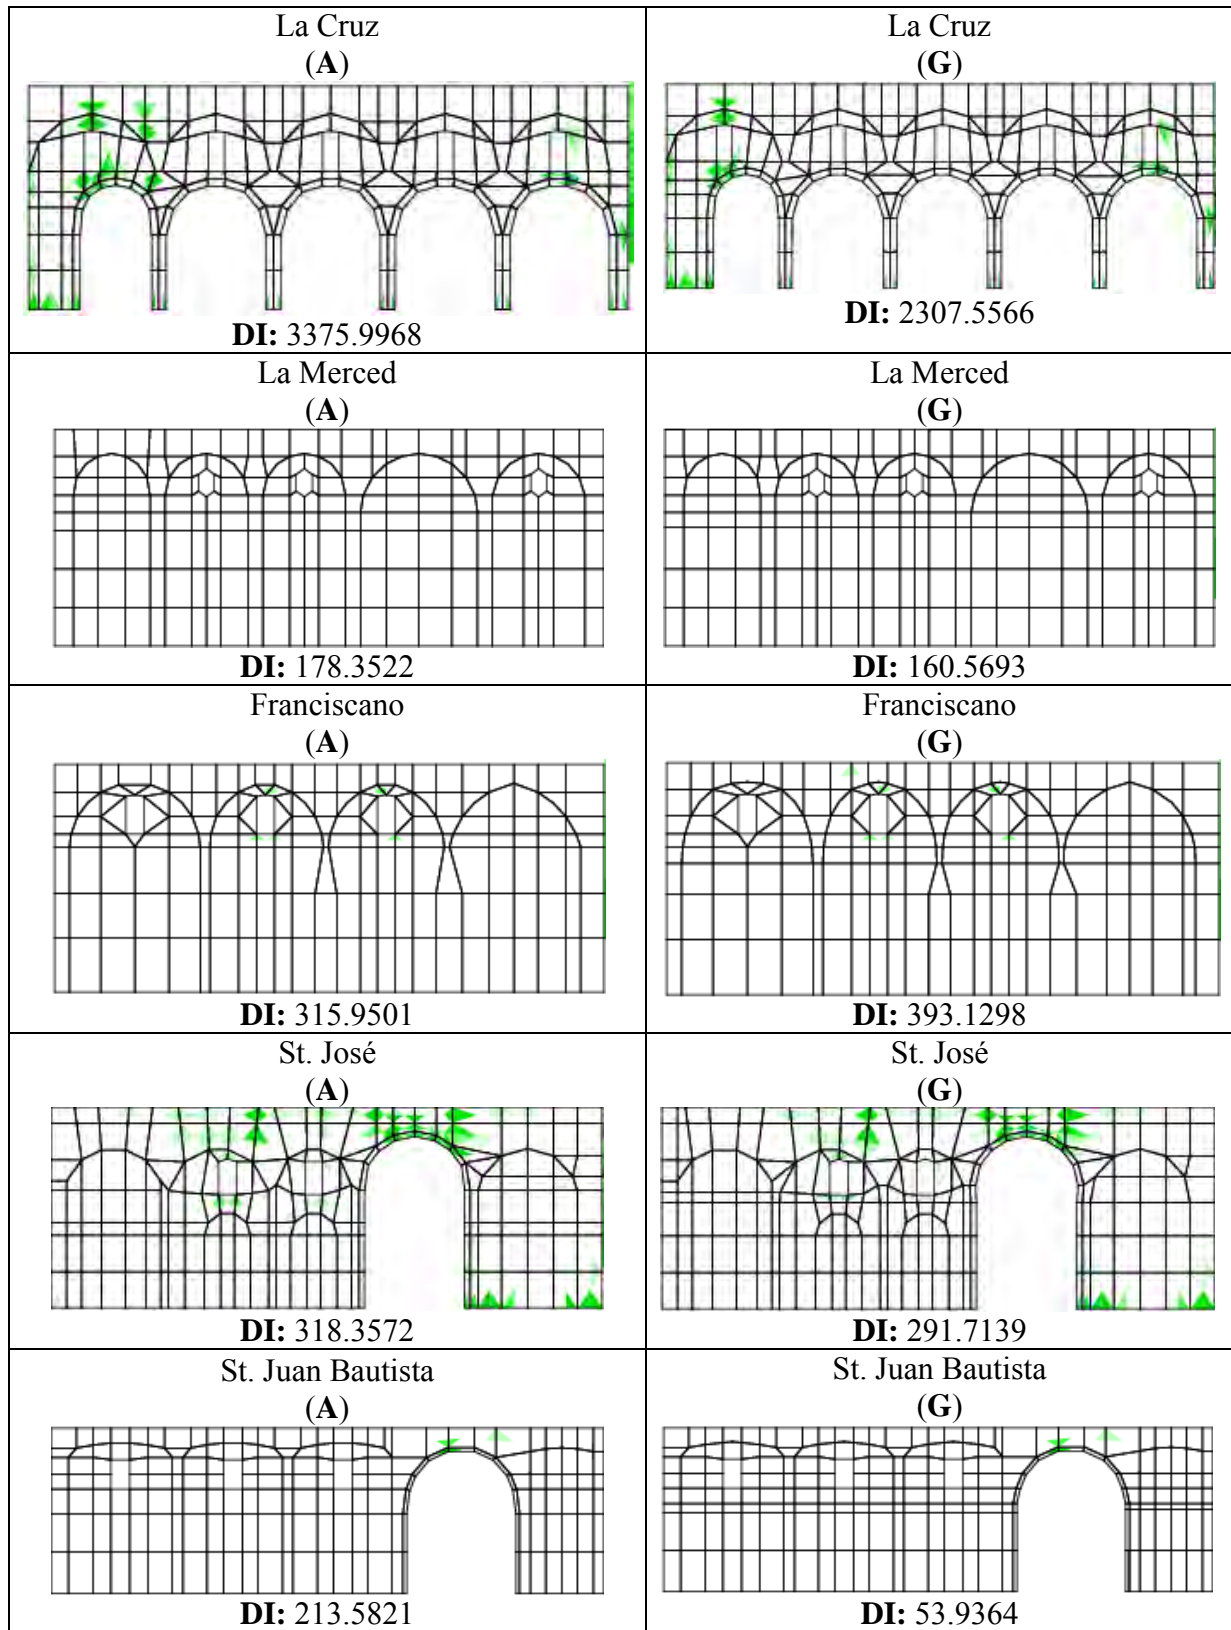
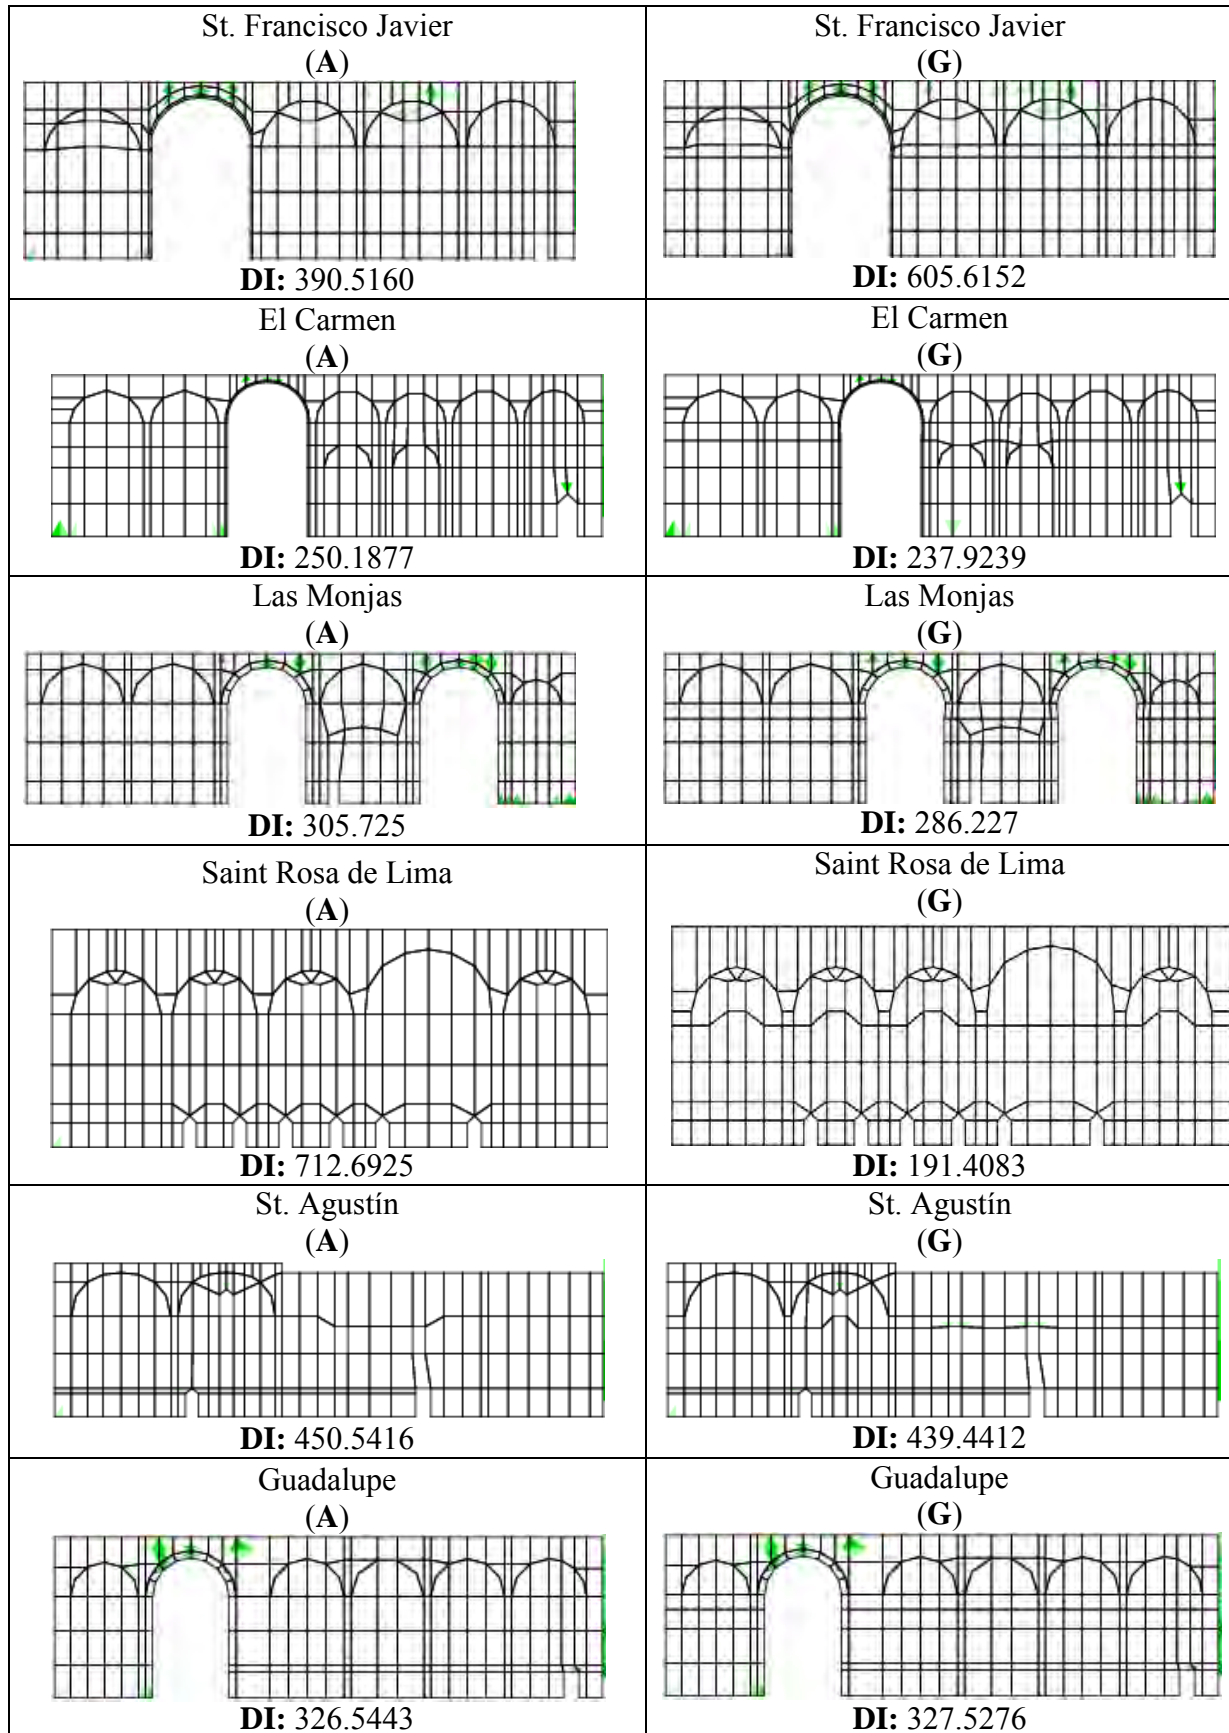
Figure 7: Comparison of damage degrees in longitudinal macroelements.

Figure 7: Comparison of damage degrees in longitudinal macroelements (Continuation).

- When comparing the longitudinal macro elements can be seen that the modified sections with the golden ratio has better seismic performance, since only 38.5% of the golden cases have a greater index damage than the actual geometrical sections. It can also be noted in these sections that the damage indices and the damage degrees are quite similar between each other.

- For the macroelements of the longitudinal sections, it was observed that the most vulnerable structures are formed by arcades as in the case of La Cruz church. Likewise similar patterns of behavior between actual and golden macroelements was observed, with the exception of Transfiguration Cathedral, which was the only building were the golden proportion was implemented in the longitudinal direction.
