FLAT-JACK TEST FOR THE ANALYSIS OF MECHANICAL BEHAVIOUR OF BRICK MASONRY STRUCTURES

Pier Paolo ROSSI

Head of Rock Mechanics Dpt. ISMES, BERGAMO - ITALY

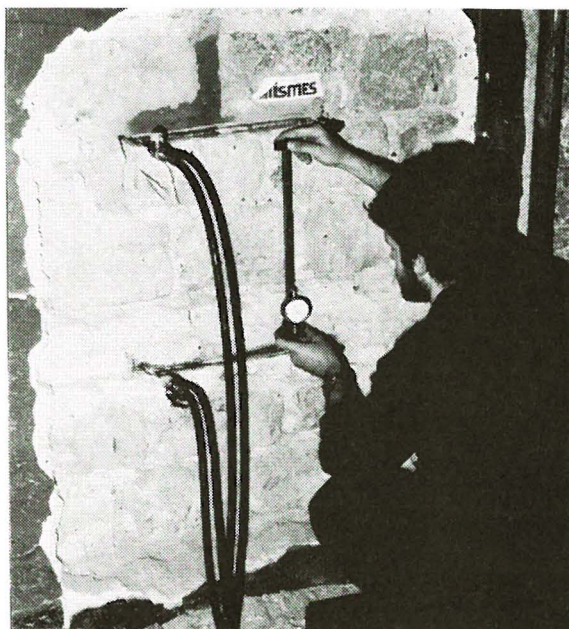
The building, which dates back to the XVIII century, is at present concerned with a plan for total rehabilitation. This has called for a detailed analysis of the static conditions of the bearing structures. Fig 14 shows a test with two jacks on a wall of the building. In this case the masonry was made by alternating layers of bricks and volcanic stones.

Fig. 14 "Collegio Massimo"- Rome
Deformability test on a
composite masonry
