## **CAPILLARITY TESTS ON HISTORIC MORTAR SAMPLES EXTRACTED FROM SITE. METHODOLOGY AND COMPARED RESULTS**

In the present paper a test method is described to evaluate water absorption capillarity and some results from Portuguese and Slovenian old mortars are presented and discussed. A comparison with results obtained for new mortars, using the same method and also the method proposed by EN standards helps to extract conclusions of the method's possibilities.

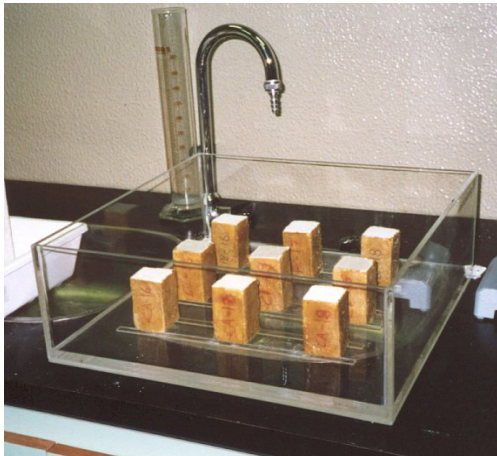
Figure 1 – Standardised capillarity test

A test method was prepared and experimented at LNEC and at the University of Ljubljana to assess the capillarity absorption coefficient of old mortar samples extracted from site. To analyse its liability the test was also applied to some lime mortars prepared in laboratory, with known capillarity absorption coefficients determined by the method proposed by EN 1015-18 (CEN 1999), which is based on the immersion in 5-10mm of water of half prismatic specimens with dimensions of 40 mm x 40 mm x 160 mm. This procedure permitted to compare the results obtained by both methods and to evaluate the correlation between them (figs. 1, 2).

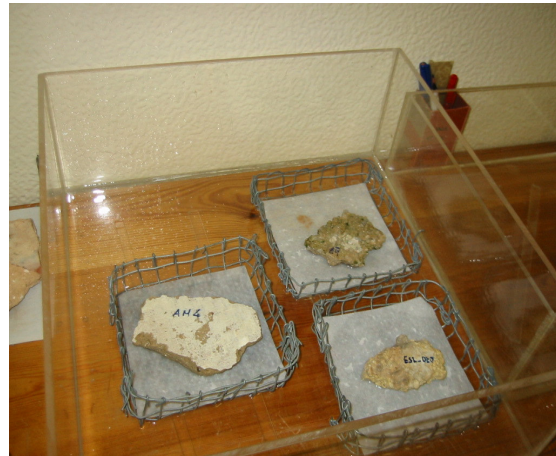
Figure 2 – Capillarity test for old mortars

The test developed to evaluate the water absorption by capillarity of irregular, friable, samples is based on the placement of the external face of the specimen in contact with water (instead of in immersion) through the use of wire basket and wet geotextile gauze. It comprises the following phases:

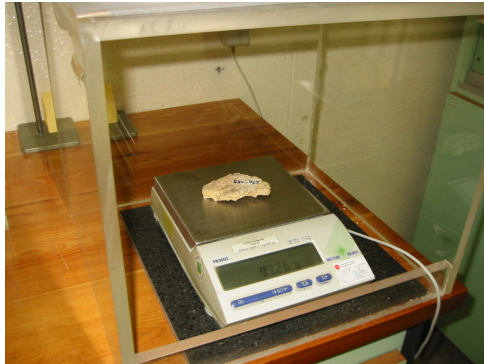
Figure 3 – Weighing the dry specimen

- b) Test Procedure – The geotextile gauze is wet before the beginning of the test, to avoid the influence of a slow initial absorption of this kind of material. The dry specimen is weighed (fig. 3) and so are the wire basket and the wet gauze (fig. 4). The basket with gauze is placed in a transparent recipient with water, on a lath, taking care that the lower face of the gauze barely touches water and the specimen is placed on the basket (fig. 5). The gauze must not enter the surface of the water more than 2 mm, so that the specimen is in contact with the wet gauze, but not in immersion in water. This situation must be kept during the test. The specimen is weighed periodically, together with the whole wire basket and wet gauze, with intervals of 5 minutes for the first 40 minutes and then at 60, 90, 180, 300, 480 and 1440 minutes. The absorbed water is quantified by the weight increase. After 1440 minutes (24 h), the whole basket, gauze and specimen remain out of water and drying period begins, with periodical weighing operations to determine the water loss.

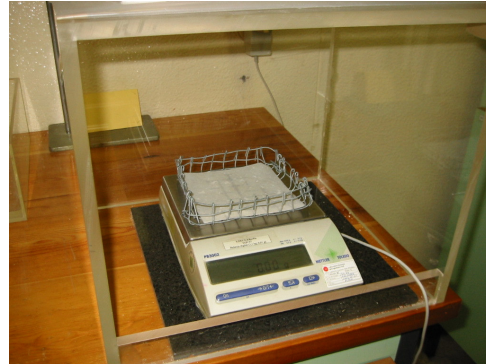
Figure 4 – Weighing basket and gauze

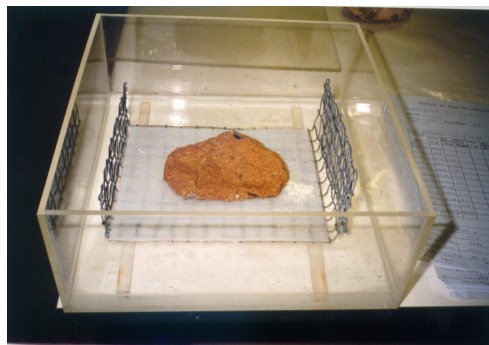
Figure 5 – Placement in a recipient with water

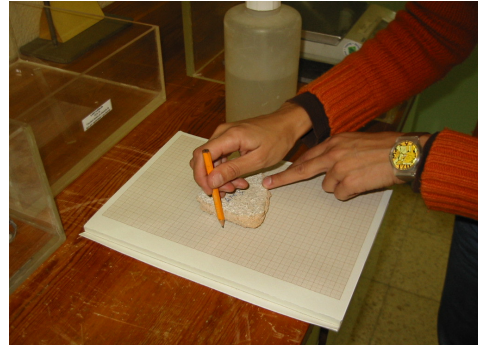
Figure 6 – Measurement of the absorption area

- c) Calculations – The absorbed water is determined through the difference between the weights measured periodically and the initial weight. To measure the specimen irregular surface in contact with water, this surface is placed on a sheet of millimetric paper and its contour is drawn (fig. 6). The obtained area is divided into geometric shapes and the total area is determined as the sum of those regular easily calculated areas. The capillarity coefficient by contact between instants  $t_1$  and  $t_2$  ( $C_{cc_{t_2-t_1}}$ ) is then calculated through the following expression:  $C_{cc_{t_2-t_1}} = (M_2 - M_1) / (\sqrt{t_2} - \sqrt{t_1})$ .
