REDESIGN OF A HISTORICAL MASONRY STRONGHOLD INCORPORATING A BASE ISOLATED FLOOR

S. SORACE⁽¹⁾, G. TERENCE⁽²⁾

SUMMARY

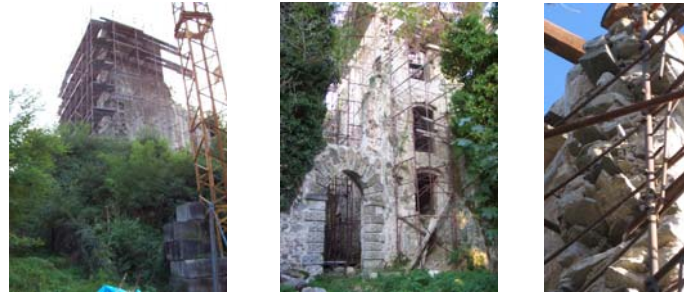
Figure 2. Views of the northern tower during the rebuilding works

A global photographic view of the northern tower during the restoration works, and detailed views of its front, including the survived main door of the central part of the castle, and the stone blocks already arranged to be connected to the perimeter walls of the central zone, when it will be rebuilt, are shown in Figure 2. It can be observed that the original stones recovered from the collapsed walls will be used for reconstruction, in combination with high-strength hydraulic-lime mortars. More photographic images of the ruined walls of the central portion of the building, currently surrounded by vegetation, are displayed in Figure 3.

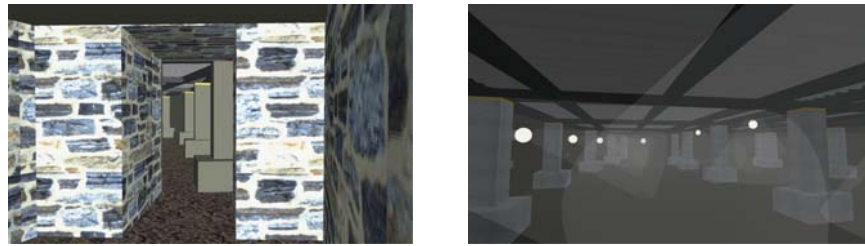
Figure 10. Basement level and bottom side of the ground floor

Two views of the basement level are reported in Figure 10, showing the main entrance and the bottom side of the floor, with the technical volume created at this level, to be used for the necessary inspection, check and maintenance activities of the isolation system.
