Influences of human activity on deformations of ancient structures Ichan-Kala in Khiva City

Nadira Mavlyanova, Vakhitkhan Ismailov, Mirabbos Zakirov and Igor Rydvansky
Institute of Seismology of the Academy of Science, Tashkent, Uzbekistan

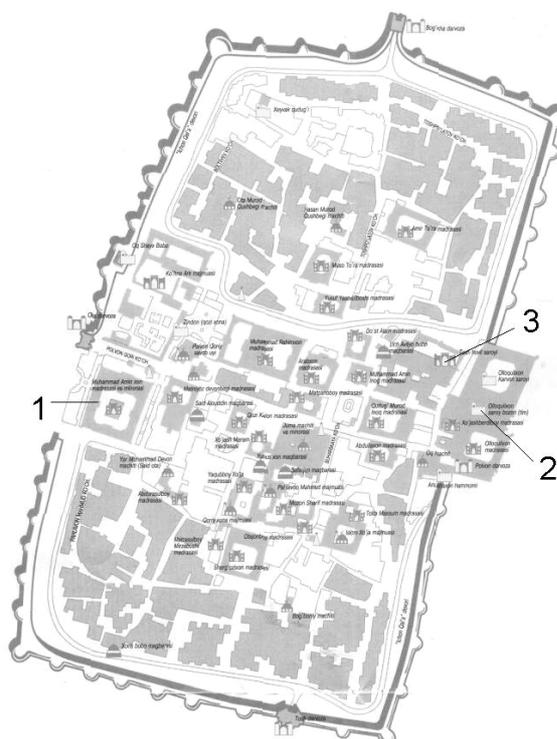
Figure 1: Plan of Ichan-Kala. 1- madrasah of Mukhammed-Amin-han; 2 – madrasah of Alla-Kuli han; 3 – palace of Tash-Hauli

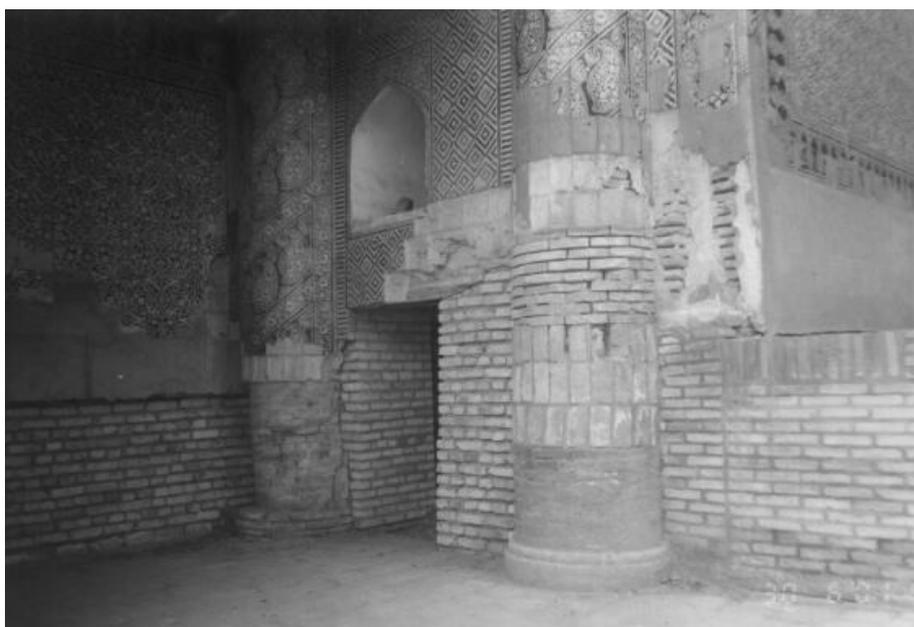
Figure 2 : Destruction of the basement of a column as result of lixiviation of salts breaking stability of monuments (Tash-Hauli)

1. To organize system of a drain of superficial waters. To develop the prevention techniques for collection and removal of precipitation water, both from the internal and external areas and historical monuments and from their roofs and floors.

2. To remove all asphalt and others (brick, stone cement) covering both on the areas, and inside historical monuments. All kinds of covering (stone, brick) should be executed without application of cement and concrete.

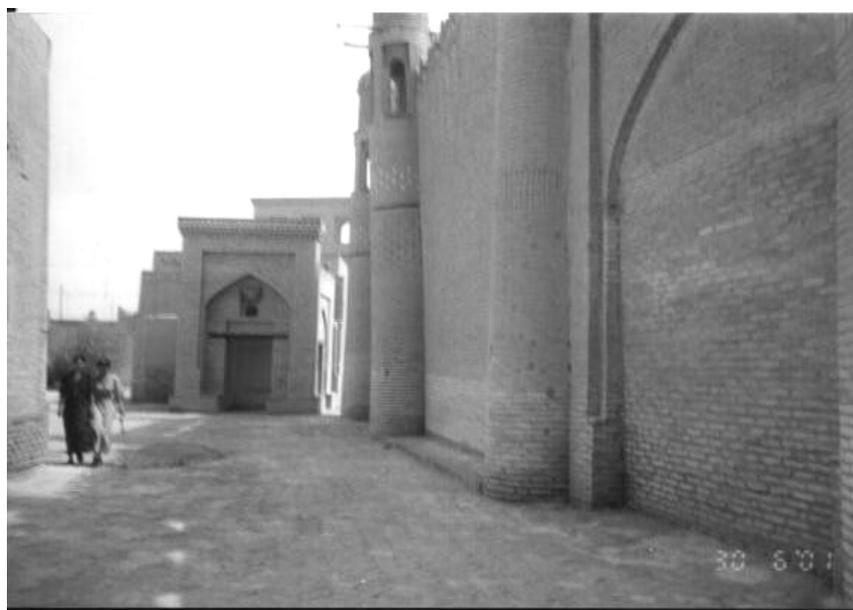
1. The first type of the earth bases is related to foundations of madrasah Alla-Kuli-khan, Mukhammed-Amin-khan, the complex Tash-Hauli (Figure 3). This type consists of filled soils (anthropogenous) with thickness from 3.2 up to 6.5 m, they include loam and sandy loam poorly condensed with inclusions of the historically usual domestic dust (fragments of brick, ceramics, bones, slag etc.). Sometimes there are layers of sand (10-15 cm) moistening from 5 up to 20 %. On the depth of 5-6 m out bricks without correct sides were found. The analysis of results of physical-mechanical properties of filled soils of this type showed, that they are various on structure and density of and they are weak and under consolidated. The wide limits of change deformation properties of filled soils are connected to inclusions, lenses and layers of sand.

Deformation properties of filled soils are characterized by values of the module of general deformation (from 6.5 up to 30 MPa), natural moisture from 7 till 18-22% and high porosity from 43.4 up to 49.5%. Investigation has shown, that the monuments located on filled soils are subject to the greatest deformation. The ancient architects foresaw such moistening, therefore in the bases one or two layers (with an interval from 1 up to 2.5 m) of "baira" made from a cane were pawned. "Baira" (bulrush intercalation) is capable evaporate a moisture vertically driven on capillary pore. At realization of restoration works for 1960-1970 "baira" was withdrawn and partially replaced with ruberoid. Such replacement complicates evaporation of moisture from the bases.

Figure 3 : Tilting of the portal of Tash-Hauli

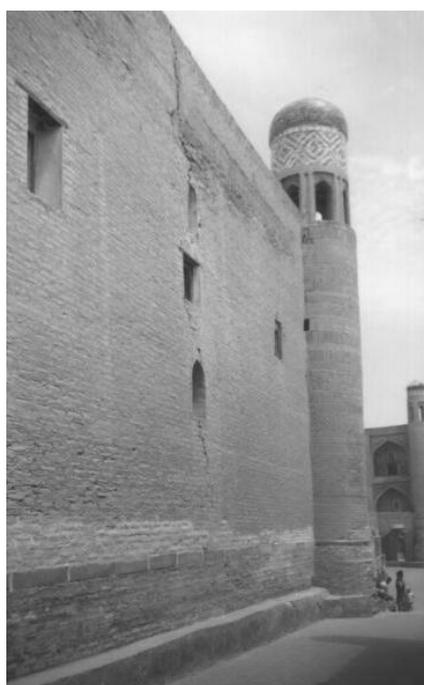
Figure 4 : Cracks in the wall of caravan-saray of the complex Alla-Kuli-khan

The complex of Alla-Kuli-khan consists of the caravan-saraya, "tim" (trade places) and madrasah. Now caravan-saraya of Alla-Kuli-khan has many developed cracks (Figure 4). At the present time the caravan-saraya is used as department store with a complex of municipal systems. The ground foundations of the caravan-saraya of Alla-Kuli-khan are filled soils by capacity more than 5 m, under laid by sand. The deformation is shown as vertical cracks on northern and eastern walls. Cracks occur at the expense of non-uniform subsidence of filled soils of the bases of the northeast corner (column to the bottom diameter 1.5 m) caravan-saraya. It was found by researches, that cracks and subsidence of the basis are connected with moistening process of the filled soils (Zakirov, M. 2000).

3. To clear all filled-up wells both inside historical monuments, and on the areas.
4. To restore the drainage network around of Ichan-Kala. It is originally necessary to lay horizontal drainage on Eastern and Southern part of the external wall of Ichan-Kala. The depth of drainage network is necessary to design depending on the mark of a surface.

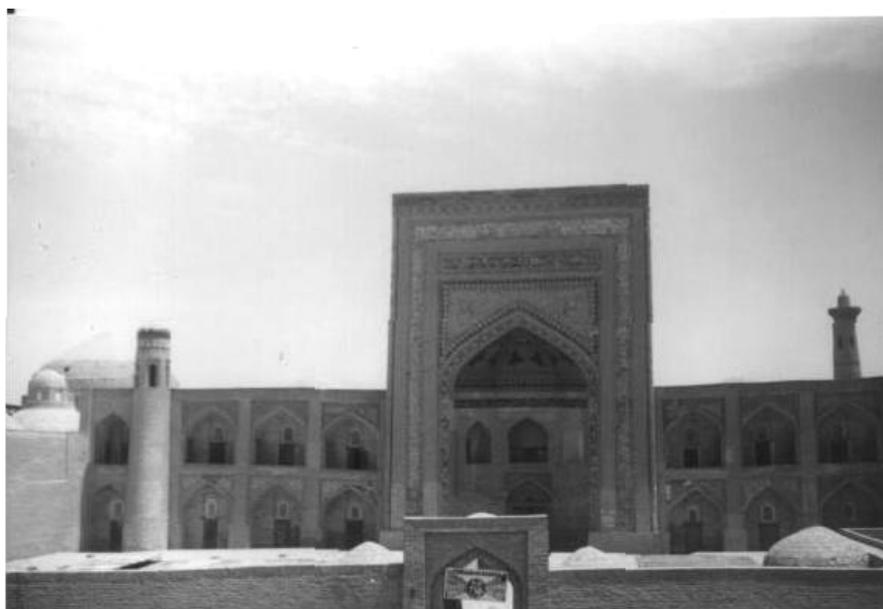
Alla-Kuli-Khan, at the time of whose government the main building works were performed, decided to immortalize his own name by construction of madrasah and selected place for it between the tim, madrasah Khodjam-Berdy-Bay and Polvan-darvaza. The base of this madrasah consists of filled soils formed from fragments of the ancient city wall. Thickness of the filled soils is more than 5 m, underground waters are on the depth of more than 5 m. At the present time this madrasah is in a catastrophic situation because of non-uniform settlements of the grounds causing deformation of portal and facade parts of the madrasah (Figure 5).

Figure 5: Non uniform deformation of facade of the madrasah Alla-Kuli-khan
