## Bam Citadel after the Earthquake

Mehrdad Hejazi

*Department of Civil Engineering, Faculty of Engineering, University of Isfahan, Isfahan, Iran*

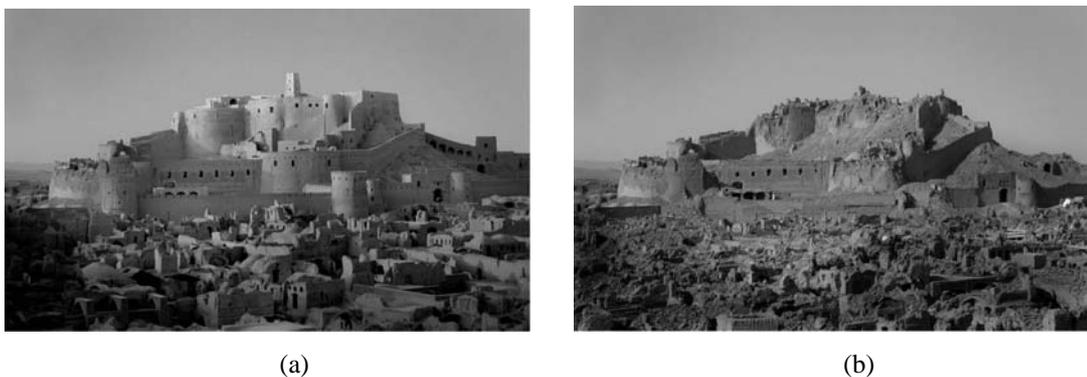
Figure 1: Bam Citadel: (a) before and, (b) after the earthquake.

The Bam Citadel stands on a rocky slope at an altitude of 1065 m, latitude  $26^{\circ}5'$  North and longitude  $58^{\circ}27'$  East, with a hot-dry climate, on the North-east side of the city of Bam, South-east Iran. The Citadel, with a area of about  $200000 \text{ m}^2$ , is one of the largest mud complexes in the world, which dates back to near 2000 years ago (Fig. 1).

The 6.5 Richter scale earthquake which struck the city of Bam on 26 December 2003 was originated in the Bam fault at less than 10 km from the Citadel. The depth of the focus was about 8 km. The horizontal and vertical accelerations were 0.8g and 1.1g, respectively (Zare 2004). The buildings of the Citadel have been damaged to a serious degree, ranging from 80 to 100% (Fig. 1(b)).

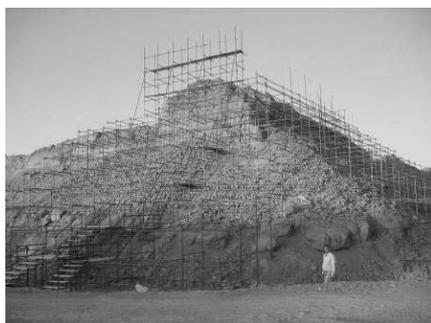
Figure 2 : Scaffolding and shoring the surrounding walls.

- main entrance
- tower No.1
- some parts of surrounding walls (Fig. 2)
- Mirza Naeim complex
- second entrance
- a number of workshops inside the Citadel
