Italian Standardisation Activity in the Field of Diagnosis and Restoration of Ancient Timber Structures

Nicola Macchioni

Maurizio Piazza

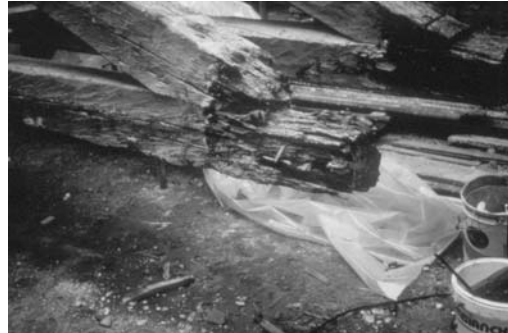
Figure 1 : Localized biological decay (rot) at the end of a roof timber truss, at the connection with masonry walls.

The *characterization of decay* helps to analyze the interaction between biotic decay and microclimates that have established around the wooden member or a part of it (figure 1). Decay may have established by non biotic causes, therefore, this type of analysis must also keep in mind the state of stress and the interaction between the timber members.

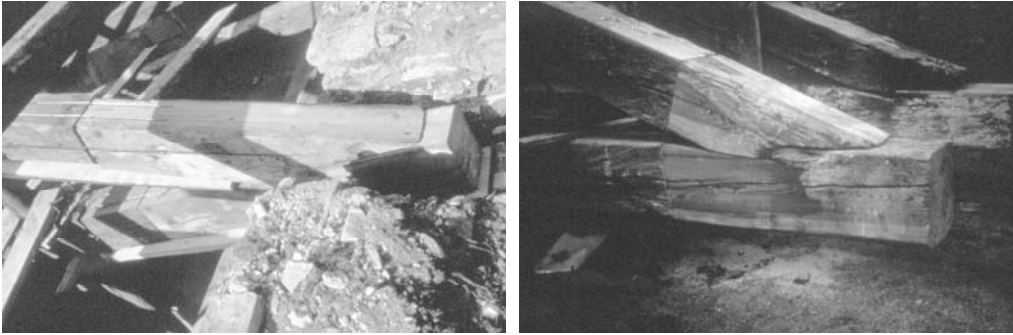
Figure 2 : On the left, integration with new wooden pieces of the elements of a roof timber truss; on the right, on site integration of timber elements in an ancient queen post truss.
