Preservation of historic structures using Screw-Pile foundations

ABSTRACT: The structural integrity of historic buildings is often compromised over the life of the structure as a result of foundation deformations over time. Foundation deformations can be created by a number of problems related to the subsurface conditions, groundwater removal, softening of the bearing soils, or simply from long-term soil consolidation. Often times, such deformations produce large and usually differential settlements that lead to a condition of imminent collapse or unsafe conditions and place the structure in jeopardy. The preservation of these structures requires innovative foundation repair approaches that will not unnecessarily disrespect the historic nature of the structure. This paper describes the preservation of several historic structures by foundation underpinning using helical Screw-Pile foundations. Five case histories are presented where helical Screw-Piles were used to preserve the foundations of structures ranging in age and use from the stone gate house of an 11th century castle to a late 19th century university brick classroom. The cases illustrate the economic and effective use of

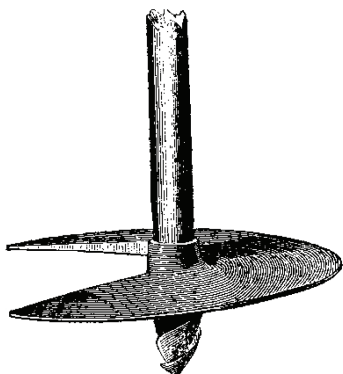
Figure 1. Typical geometry of Screw Pile used by Mitchell (1836–1880).

Figure 1 shows the geometry of a typical Screw-Pile used by Mitchell at the Maplin Sands Lighthouse in the Thames estuary. All of the Screw-Piles used by Mitchell were fabricated by a combination of cast-iron plates and wrought-iron shafts, both of which could be readily manufactured in England during this time period. In nearly every case of Screw-Pile installation before about 1900, the Screw-piles were installed by manual labor using a large capstan attached to the top of the shaft and turned by as many as 40 men. No vertical load was applied to assist the installation, the pitch of the screw blade was sufficient to produce advance of the crew with rotation of the shaft.

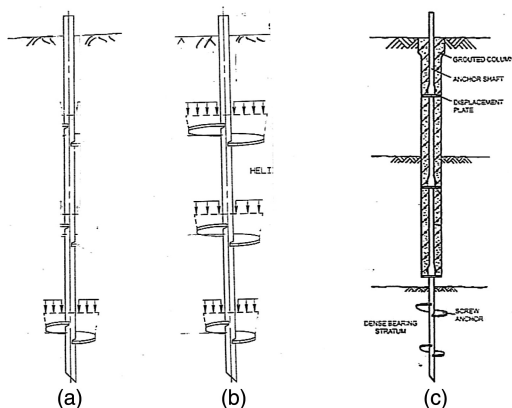
Figure 2. Configuration of modern Screw-Piles: (a) single helix; (b) multi-helix; (c) grouted shaft.

Modern Screw-Piles have a variety of names, such as Helical Pier, Screw Anchor, or Helical Pile but they are all generally fabricated as one of three general configurations as shown in Figure 2. They may consist of a single helical element, a multi-helix lead section or a helical lead section with a grout column. The central shaft may be square or round. If a grout column is used, an appropriate amount of time is allowed for the grout to achieve sufficient strength before load transfer. Grout columns may be used to provide additional load capacity, working in combination with the lead helical section, or they may be used to simply transfer the load to the lead helical section, as in the case of short Screw-Piles end-bearing on rock or other hard material. The grout column typically consists of a Portland cement based neat grout or some similar material.

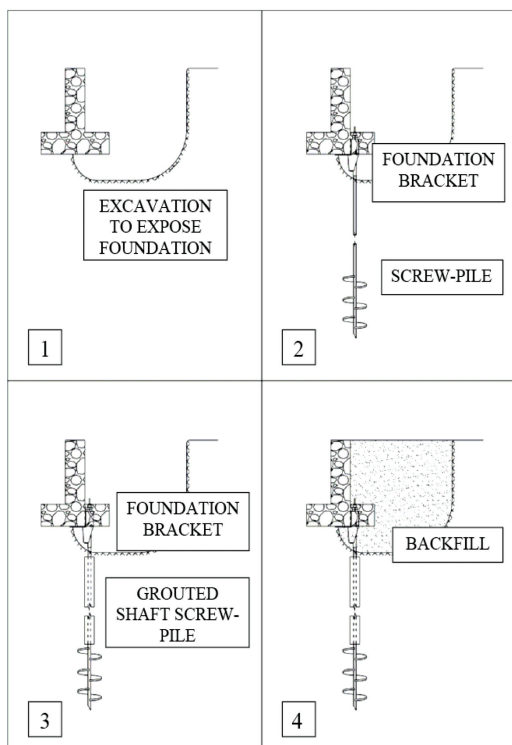
Figure 3. Sequence of underpinning existing foundations with Screw-Piles.

When using Screw-Piles for underpinning, it is first necessary to make a small excavation to expose the base of the existing foundation. The Screw-Pile is then installed using hydraulic torque motor to the required design depth or a sufficient depth as determined by the installation torque to develop sufficient load capacity. A foundation "L" bracket is then attached to the shaft of the pile and to the existing foundation to provide a

If appropriate, given the condition of the structure and the degree of distress, a small amount of lifting may also be performed using hydraulic jacking system to provide vertical adjustment to the structure and preloading of the screw-pile. This load is then locked off and the final position of the foundation bracket is achieved. If needed, the existing foundation may also be reinforced using either thread bars or grouted bars inserted into the existing foundation blocks or a small section of reinforced concrete may be cast in place and tied to the existing foundation. The underpinning sequence is illustrated in Figure 3. Note that Figure 3 illustrates that the Screw-Pile can include a grout column around the central shaft or it may be installed without a grout column, depending on the soil conditions and the design of the pile for bearing capacity.

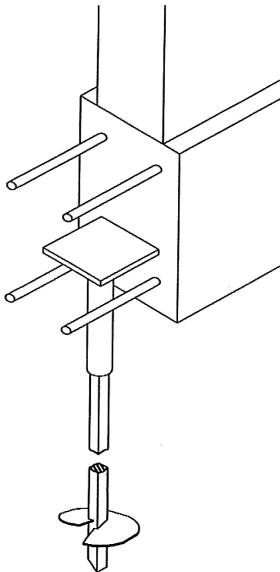
Figure 4. New construction bracket attached to Screw-Pile for new foundation or extension of existing foundation.

in the case of the existing stairwell or new construction brackets as shown in Figure 4 for the new construction.

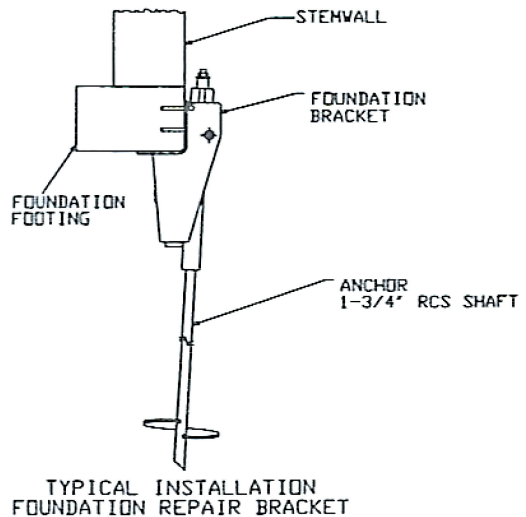
Figure 5. Heavy duty foundation bracket attached to Screw-Pile and existing foundation.

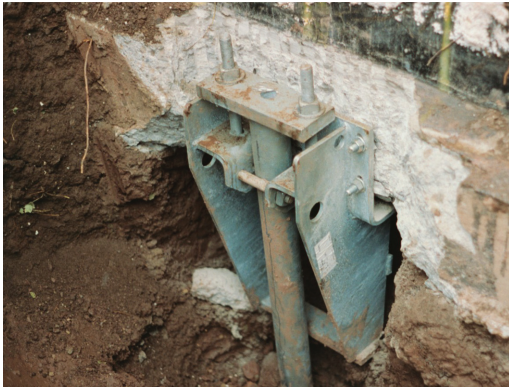
Figure 6. Heavy duty foundation bracket attached to existing foundation.

Screw-Piles were used to underpin the foundations to prevent additional subsidence. Triple-helix screw-piles (8/10/12) with 44.4 mm square shafts were installed to a depth of about 4.6 m below existing foundation levels and were attached using heavy duty foundation brackets from the outside of the structure to provide load capacity of 120 kips each. Figure 6 shows a typical heavy duty foundation bracket attached to an existing foundation.

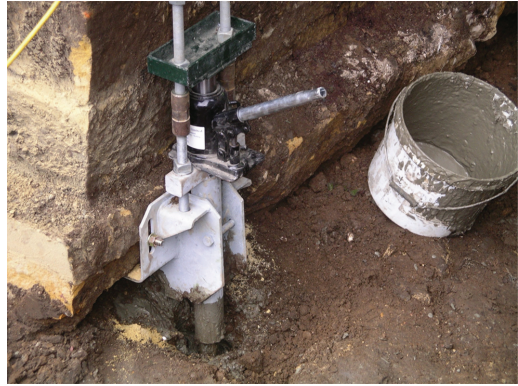
Figure 7. Foundation bracket and leveling jack used at Forest Lodge.

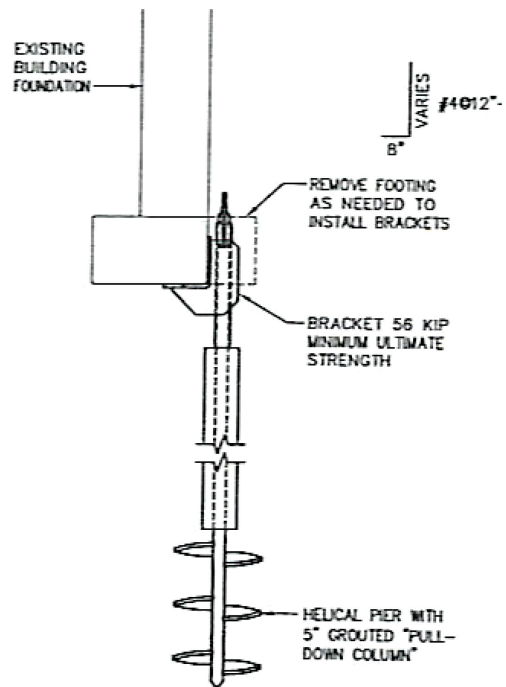
Figure 8. Screw-Pile with grouted shaft used for underpinning.

Screw-Piles consisted of twin helix lead sections (10/12) with a 38.1 mm square shaft with a grouted column as shown in Figure 8. Displacement plates were used to produce a 100 mm grout column. The piles were installed to bedrock which varied between 6 and 8 meters below existing foundations so that they would act in end bearing. Work was performed both inside the cellar of the gate house which included a

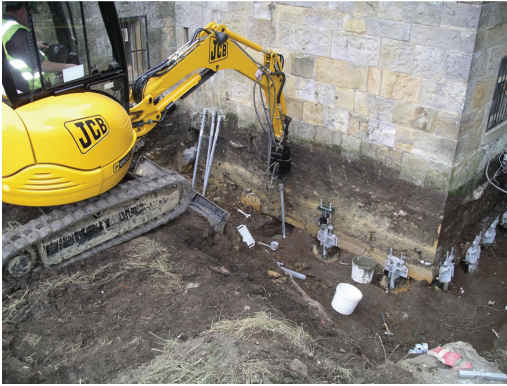
Figure 9. Installing Screw-Piles at Forest Lodge.

Figures 9 and 10 show some of the Screw-Piles and foundation brackets installed at the Forest Lodge Gate House during the underpinning and restoration work.

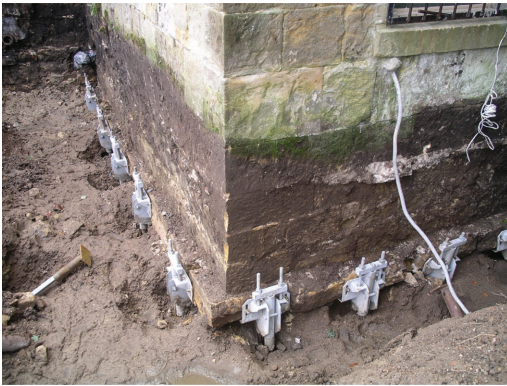
Figure 10. Corner of Forest Lodge Gate House after installation of Screw-Piles and foundation brackets.
